# Phase I Environmental Site Assessment of 3744 Depot Road Hayward, California

Prepared By:
PIERS Environmental Services, Inc.
1330 S. Bascom Avenue, Suite F
San Jose, CA 95128

August, 2000 Project: 00214

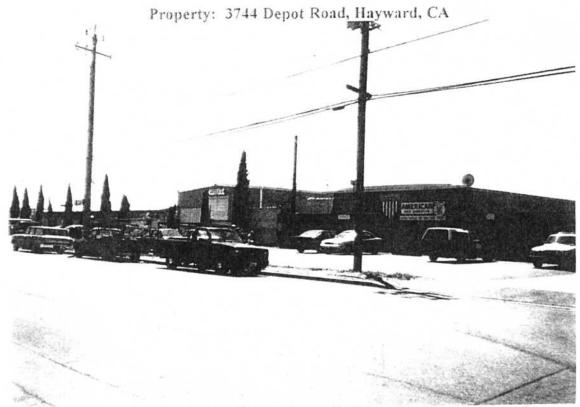
Oil staining was noted at numerous locations in the paved yard, and also on the unpaved, exposed soil portion at the rear of the Property. Portions of the eastern and western perimeter of the site are particularly stained. Portions of the paved lot have cracked and degraded to the point that vegetation is growing through the pavement, and the potential exists to discharge waste oils to soil. PIERS recommends that all vehicle draining be performed on the concrete pad areas of the lot, or in the building itself. Also, there is an area of exposed soil approximately 2.5 feet wide along a portion of the western perimeter of the Property. PIERS recommends that the unpaved portion at the rear of the Property and the western perimeter be paved, or not used for the storage and/or dismantling of vehicles or parts, and measures taken to insure that runoff does not contact these exposed soil areas.

Photo #2: Oil stained pavement, northern portion of Property.

PIERS recommends that all vehicle draining be performed on the concrete pad areas of the lot, or in the building itself, and that all fluid drained from vehicles be promptly taken to and stored in secondarily contained drums. In addition, PIERS recommends that the unpaved portion at the rear of the Property and the western perimeter be paved, or not used for the storage and/or dismantling of vehicles or parts, and measures taken to insure that runoff does not contact these exposed soil areas.

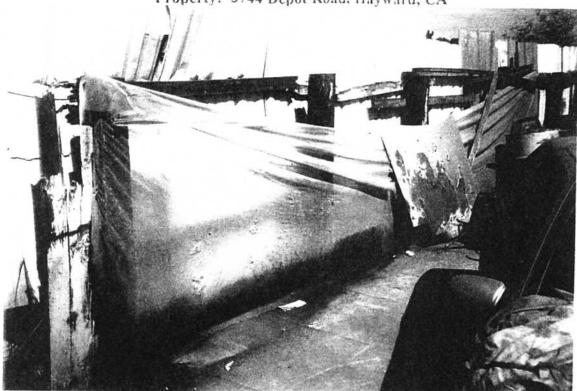
Photo #4: Oil container and stained pavement, northern portion of Property.
