PHOTOS TAKEN BY RON OWCARZ
AT UGT MODIFICATION AT VICKY
SHELL, 2120 MONTANA ST. IN OAK,
ON 7/6, 7/19 + 7/20/93

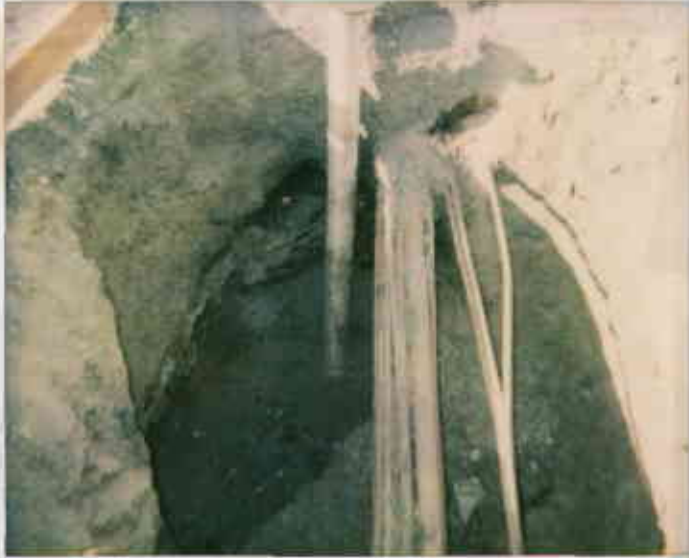
7/20/93-Photo taken by Ron Owcasz at Bangal shell, 2120 Montana Ave. in Oak. Red caps indicate soil sample locations in side wall of pit overexcavation for UGT pipe work. ©

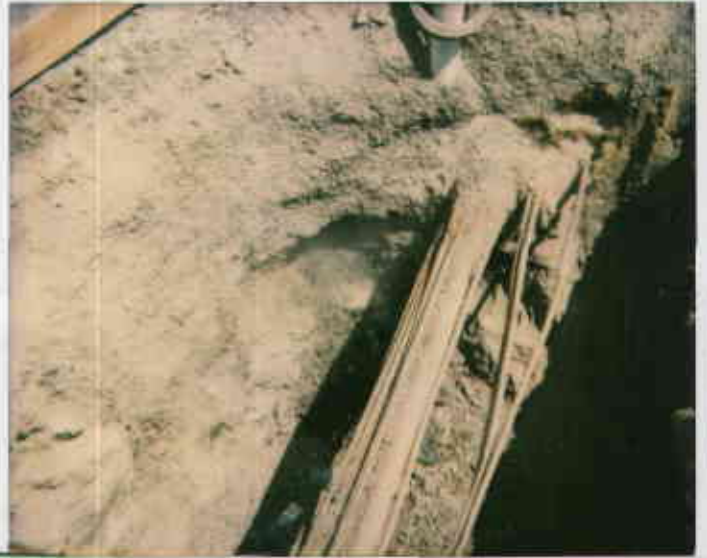
7/20/93 Photo taken by Ron Owcasz at shell station @ 2120 Montana Ave. in Oak for piping of UGT work where soil contamination was found at pit overexcavation. ©

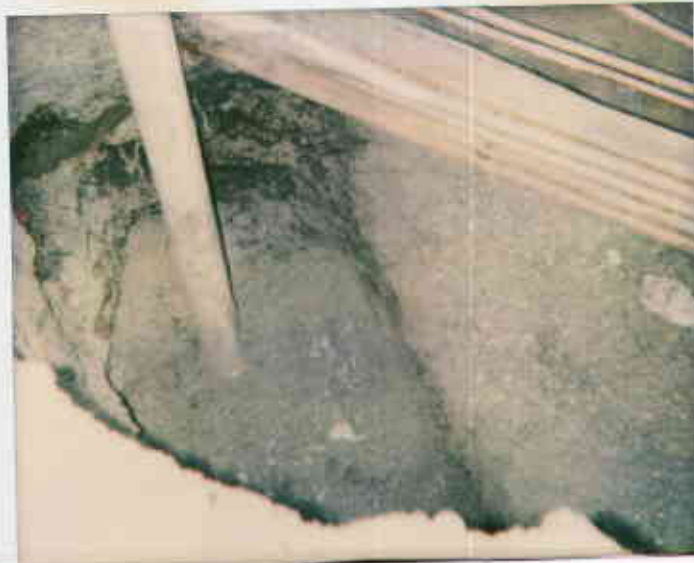
7/20/93-Photo taken by Ron Owcasz at Bangal shell, 2120 Montana Ave. Oak. Shown is soil cont. at side wall of pit overexcavation for UGT pipe work. ©

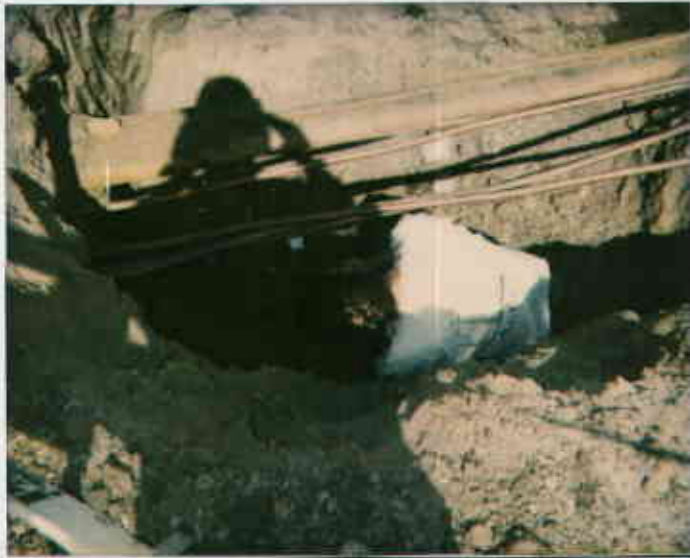
7/19/93-Photo taken by Ron Oweasz at Banzal
Shell, 2120 Montana Ave, Oak. Shown is Allison
Watts taking soil samples at pit overexcavation. ©

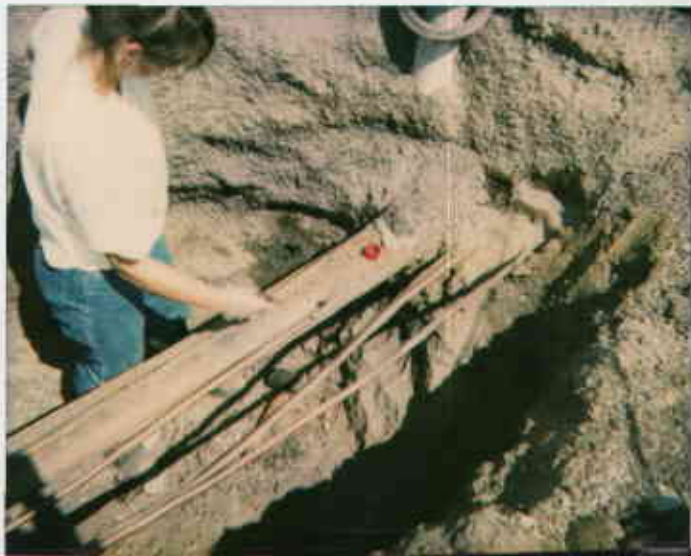
7/19/93-Photo taken by Ron Oweasz at Banzal
Shell, 2120 Montana Ave, Oak. Shown is Allison
Watts taking soil samples after pit reexcavation. ©

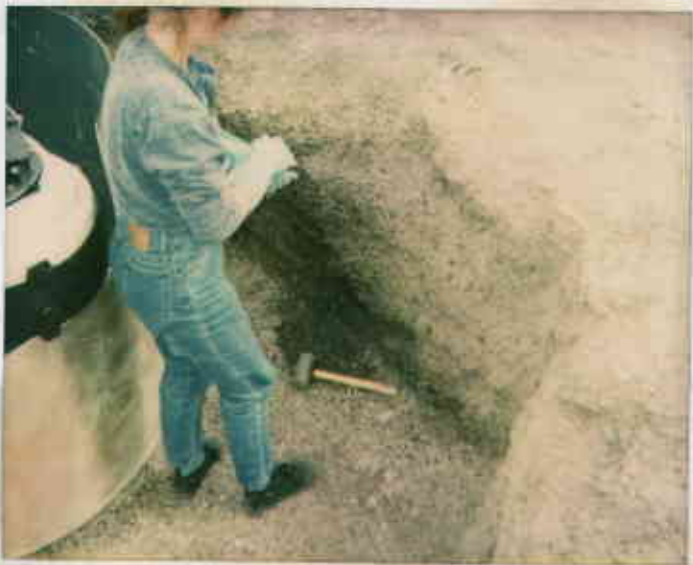
7/6/93-Photo taken by Ron O'Carroll at Bansal shell, 2120 Montana Ave, Oak. Shown is Allison Watts taking soil sample in side wall of pit where cont. was found at UGT piping mod. @

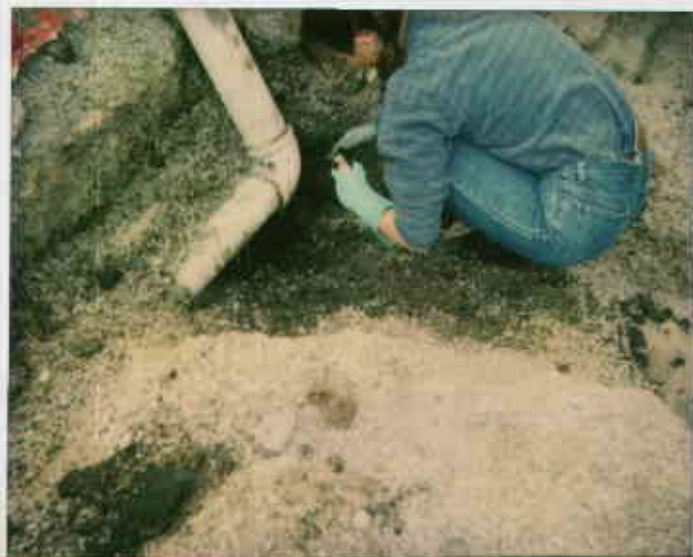
7/6/93-Photo taken by Ron O'Carroll at Bansal shell, 2120 Montana Ave, Oak. Shown is Allison Watts taking soil sample at end of old piping where some soil cont. was observed. @

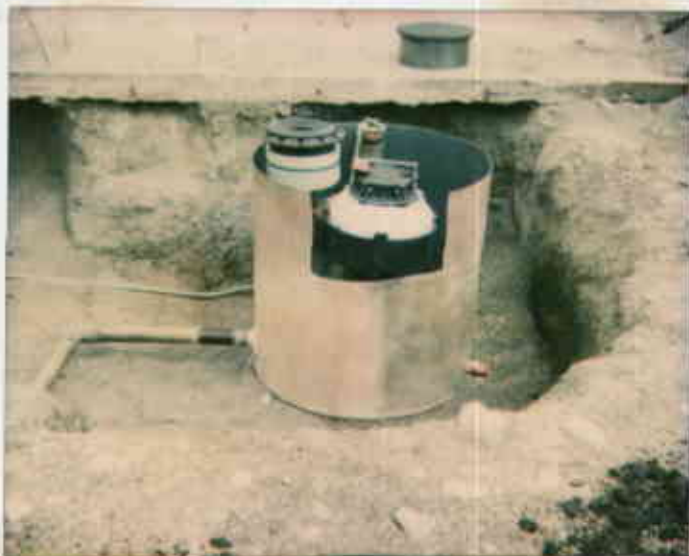
7/6/93-Photo taken by Ron O'Carroll at Bansal shell, 2120 Montana Ave, Oak. Shown is new sump that failed sump test twice. Also note oil cont. of side wall adjacent to it. @

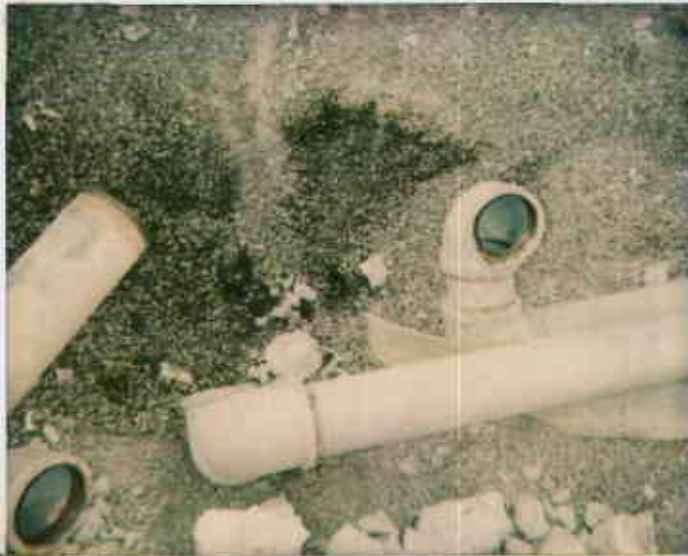
7/6/93-Photo taken by Ron Owcasz at Banzal shell, 2120 Montana Ave. Oak. Shown is soil sample location at end of old pipe line for UAT mud. 12215117976-B

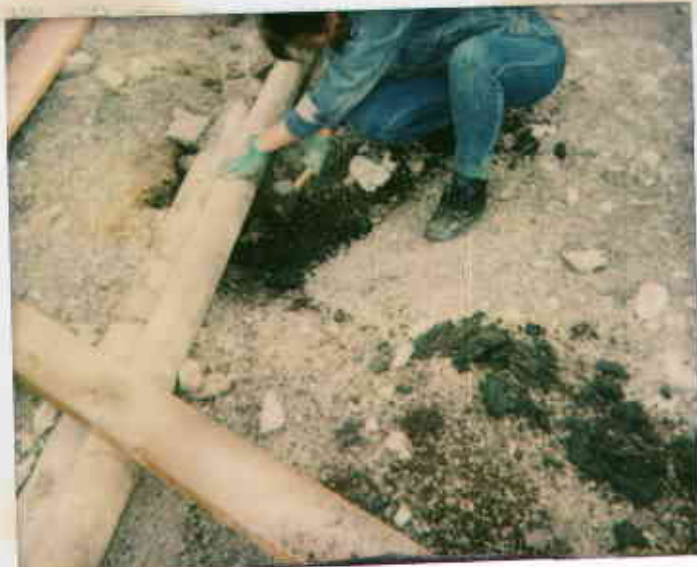
7/6/93-Photo taken by Ron Owcasz at Banzal shell, 2120 Montana Ave. Oak. Shown is Allison Watts taking soil sample under middle of old piping where some soil cont. was observed. 12215117976-B
