SUMMIT ENGINEERING

Re : Soil and Groundwater Sampling at 5812 Hollis Street, Emeryville, California.

SOIL AND GROUNDWATER SAMPLING FOR THE PROPERTY LOCATED AT 5812 HOLLIS STREET EMERYVILLE, CALIFORNIA

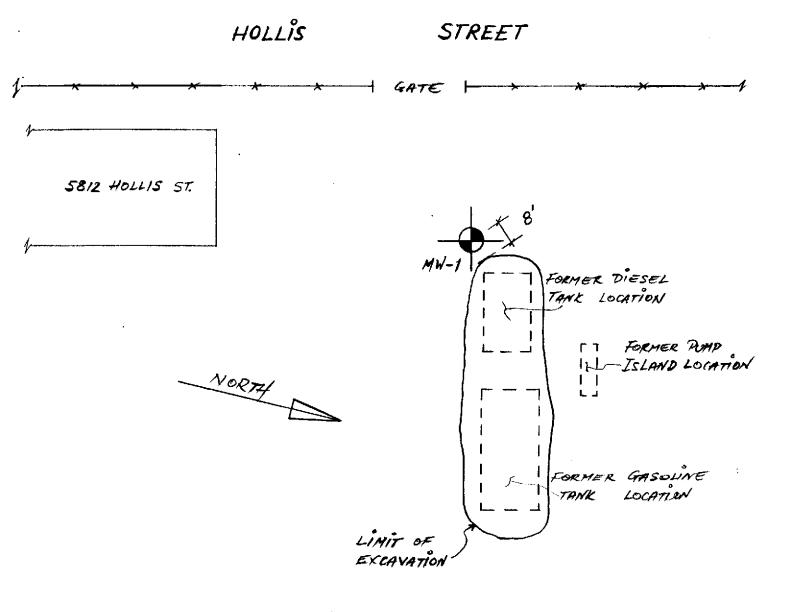
FIGURE 2 - SITE PLAN AND WELL LOCATION

A monitoring well was installed west-southwest, downstream of the former excavation area in a downgradient location, and about 8 feet from the edge of the excavation of previously existing underground tanks (Figure 2). There is abundant information in RWQCB files showing that in the Emeryville area the groundwater travels generally towards the San Francisco Bay along west-to-southwest directions. Some of the files reviewed have the following numbers:

MONITORING WELL

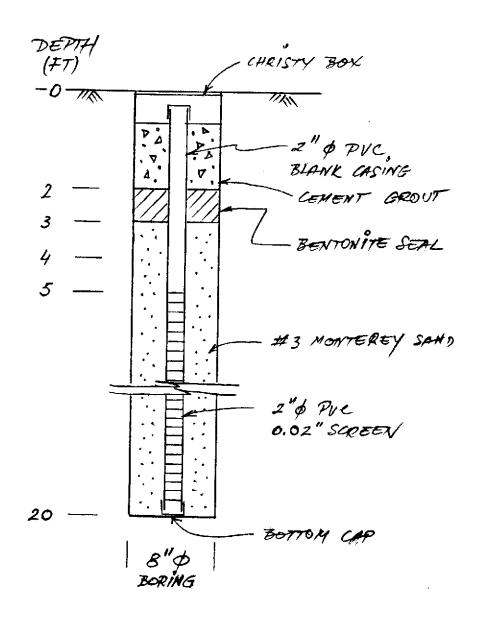
FIGURE 3 - WELL DIAGRAM

The well was drilled using a truck-mounted drill rig and an 8-inch hollow stem auger. The soil was sampled in 2-in x 6-in brass tubes every 5 feet as shown in the boring log attached in the Appendix. Because groundwater was first found at a depth of 12 feet below the ground surface, the well was extended to a depth of 20 feet. The well consists of a 2-inch diameter PVC casing with the top 5 feet of blank pipe, and the remaining 15 feet of 0.020-inch screen. The lower end of the well was capped and converted to a silt catcher. The well was be completed with No. 3 Monterey sand backfill, a 2-foot thick bentonite seal, and a Christy box in cement grout as well as a lock-cover for the top end of the well (Figure 3).
