ASBESTOS SURVEY

UNOCAL Service Station 5325
3220 Lakeshore Avenue
Oakland, California

GeoStrategies Project Number: 5180.01

April 6, 1994

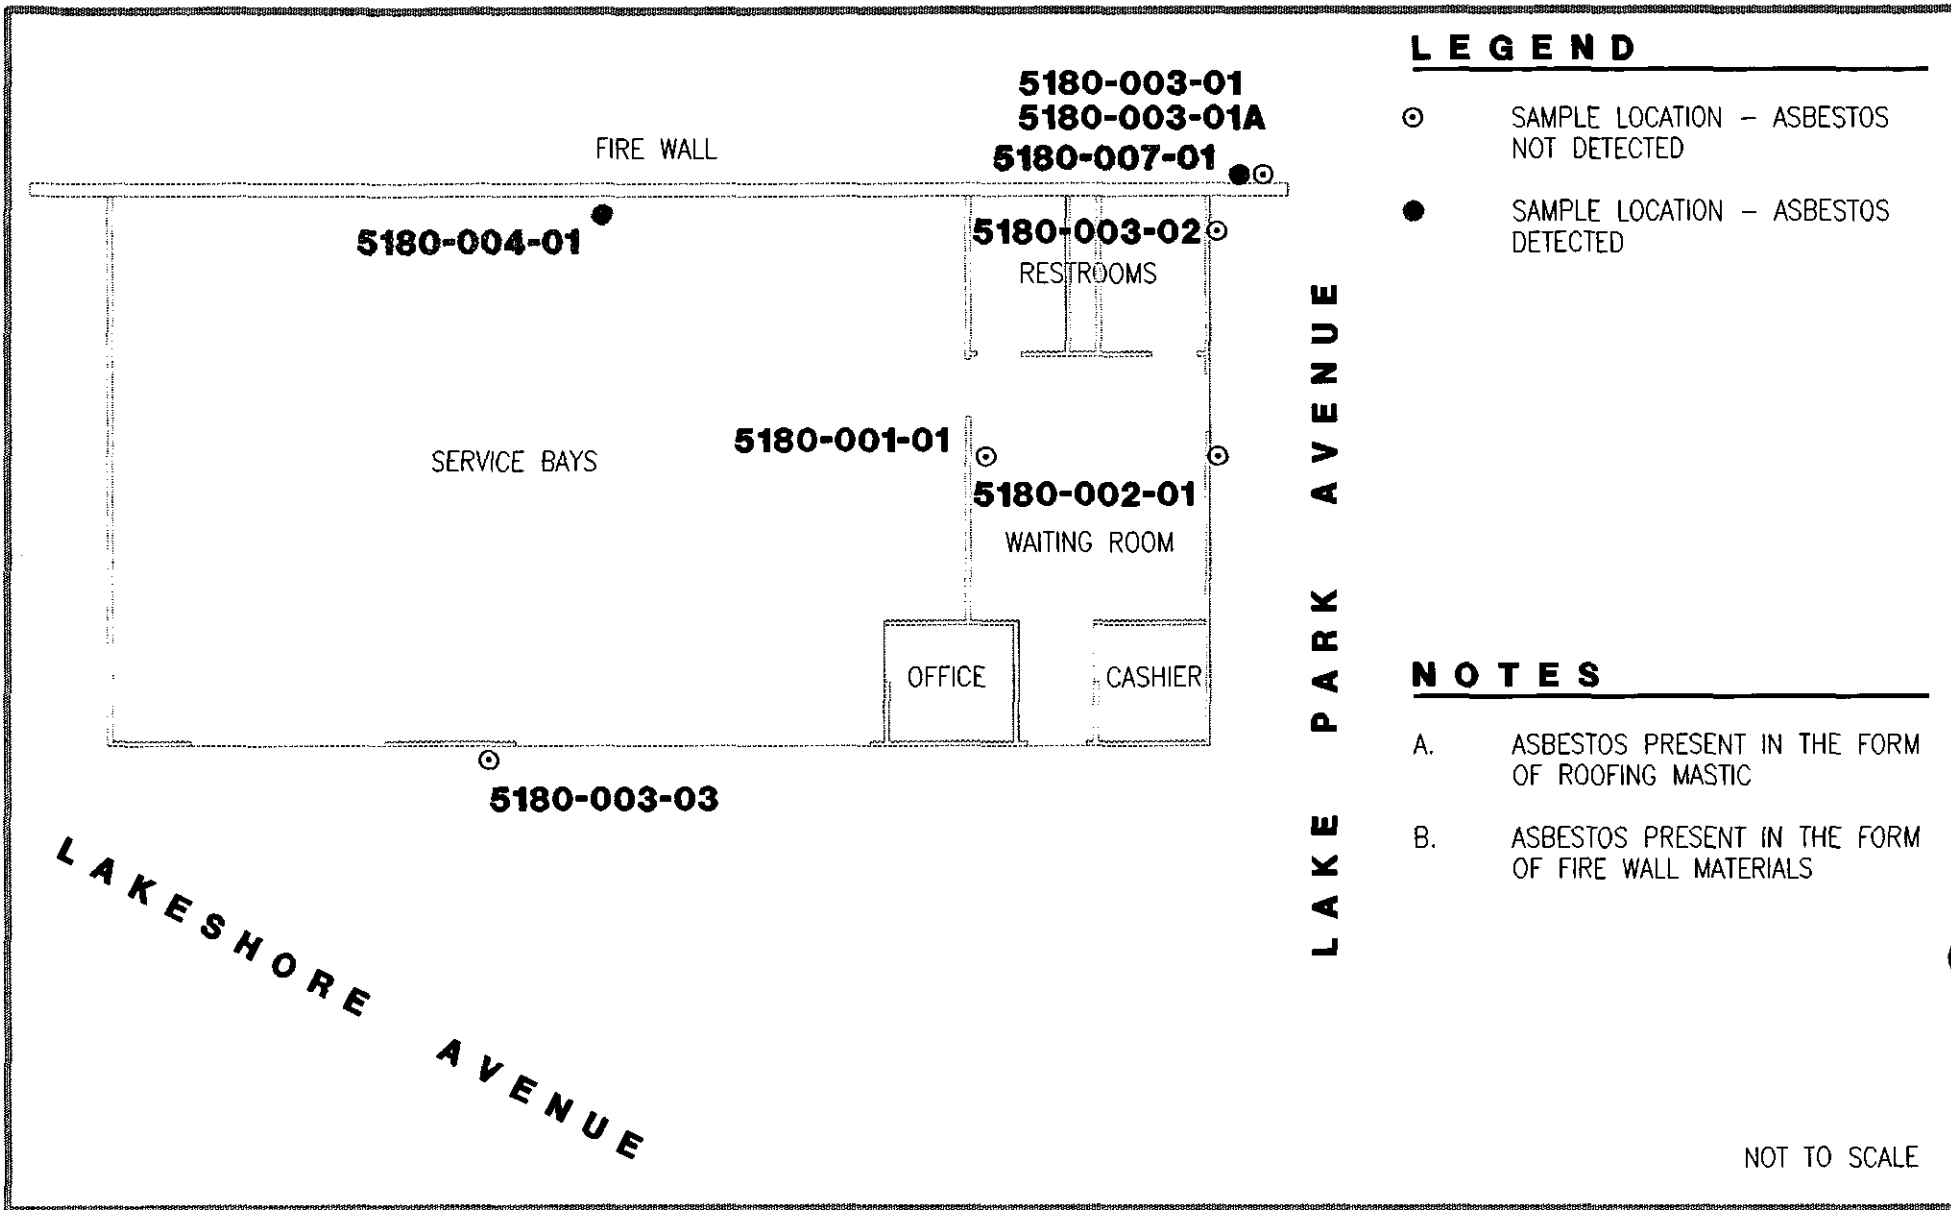
ASBESTOS SAMPLING PLAN
 UNOCAL Service Station #5325
 3220 Lakeshore Avenue
 Oakland, California

The black roofing mastic, associated with all roof surfaces was identified as containing 15-20 percent chrysotile asbestos. This material is nonfriable and has a low level of damage.

The fire wall material, located on the wall adjacent to the back of the structure was identified as containing trace amounts of chrysotile asbestos. This material is nonfriable and has a low level of damage.

- A. ASBESTOS PRESENT IN THE FORM OF ROOFING MASTIC
- B. ASBESTOS PRESENT IN THE FORM OF FIRE WALL MATERIALS

It is GSI's understanding that the station will be remodeled as a part of the retail reformat program. If the structure is slated for demolition the local Air Quality Management District must be notified at least 10 working days prior to the start of work. The roofing sealants and fire are Category I nonfriable asbestos-containing materials and GSI does not anticipate that these materials will become friable or be subjected to sanding, grinding, cutting, or abrading during the course of demolition activities and may remain in place. The fire wall materials are Category II nonfriable materials. GSI recommends that tenants of the property be notified according to State Assembly Bill 3713, and that all renovation or demolition activities involving the fire wall be conducted by a licensed and

registered asbestos abatement contractor according to all existing Federal, State, and local regulations.
