# **Q3/Q4 2008 BIOVENTING STATUS AND ANNUAL SUMMARY REPORT**

**REDWOOD REGIONAL PARK  
SERVICE YARD  
OAKLAND, CALIFORNIA**

**STELLAR ENVIRONMENTAL SOLUTIONS  
2198 SIXTH STREET, SUITE 201  
BERKELEY, CALIFORNIA 94710**

**January 15, 2009**

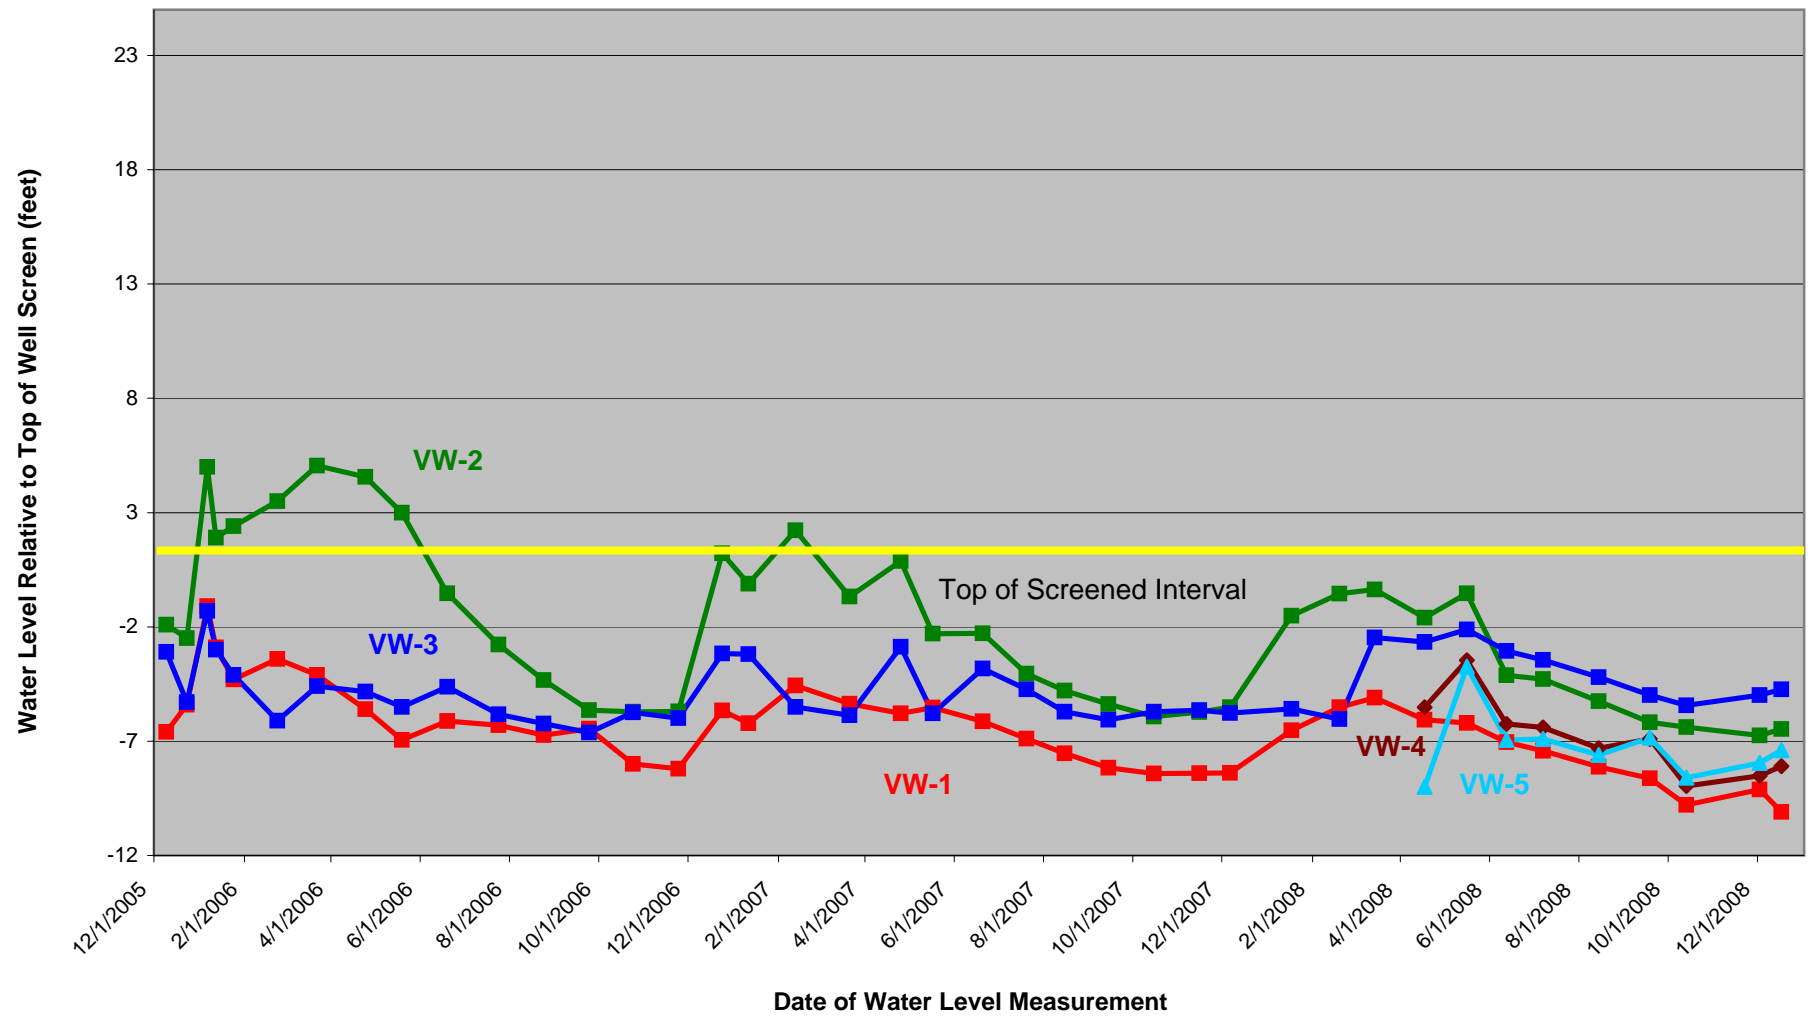
**Figure 6 - Historical Groundwater Levels Relative to Top of VW Screened Intervals  
Redwood Regional Park Service Yard - Oakland, California**

- Water levels in the VWs showed a general increase after the wells were installed, resulting in partially or fully flooded well screens in VW-1, VW-2, and VW-3. VW-1 and VW-3 showed a water level decrease through September 2006; the water levels in these VWs have fluctuated since then, but have always been below top of screen. As stated previously, VW-3 was decommissioned in March 2008. The water levels in VW-4 and VW-5 have been below the wells screens since installation.

- Figure 6 shows groundwater levels in VWs relative to the top of the screened interval. The screen in VW-2 was fully flooded as of May 2006, was lower than the screen interval until October 2006, and had fluctuated above and below the screen since then. As of May 2007, the water level in VW-2 has been below the screen interval. Water levels in VW-1, VW-4, and VW-5 have been below the screen intervals since installation in 2005 and 2008, respectively.

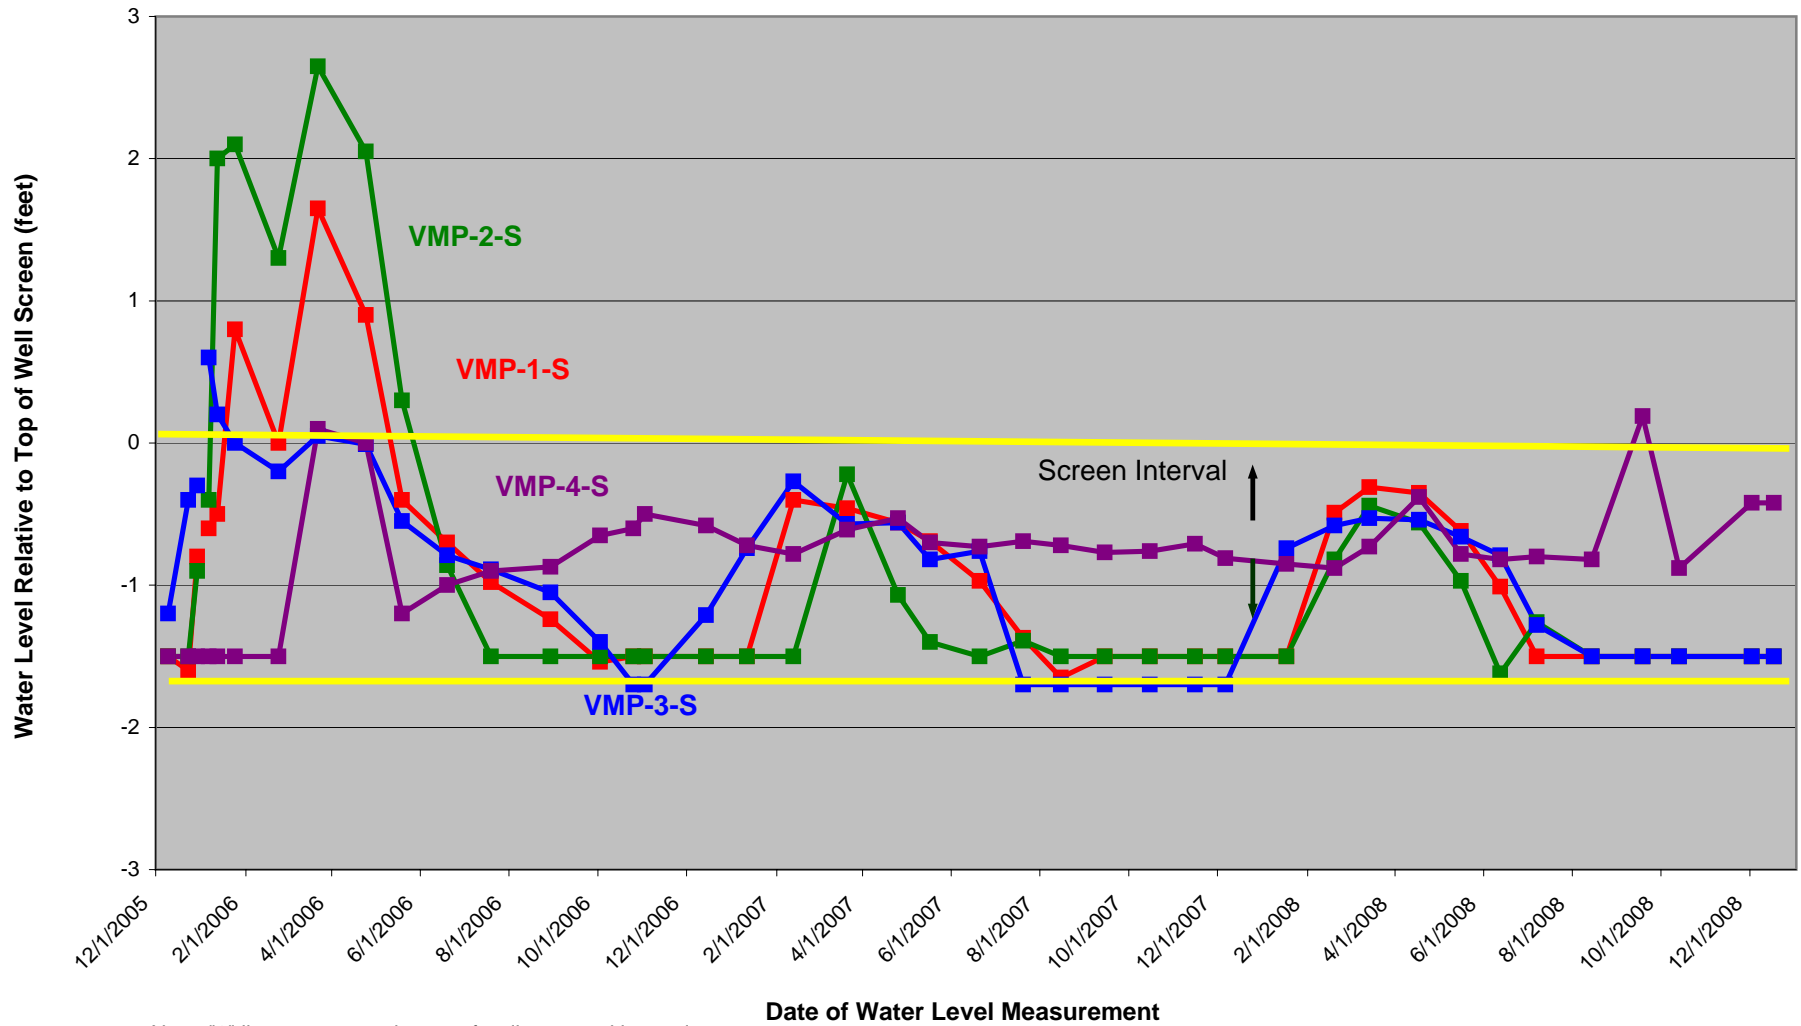
**Figure 7 - Historical Groundwater Levels Relative to Top of Shallow VMP Screened Intervals  
Redwood Regional Park Service Yard - Oakland, California**

- As shown on Figure 7, groundwater levels in the shallow VMPs have fluctuated slightly since March 2006. However, all of the VMPs have been below the top of the well screen since May 2006, with the exception of VMP-4. VMP-4 was fully saturated in September 2008, but was below the screen interval in subsequent events.

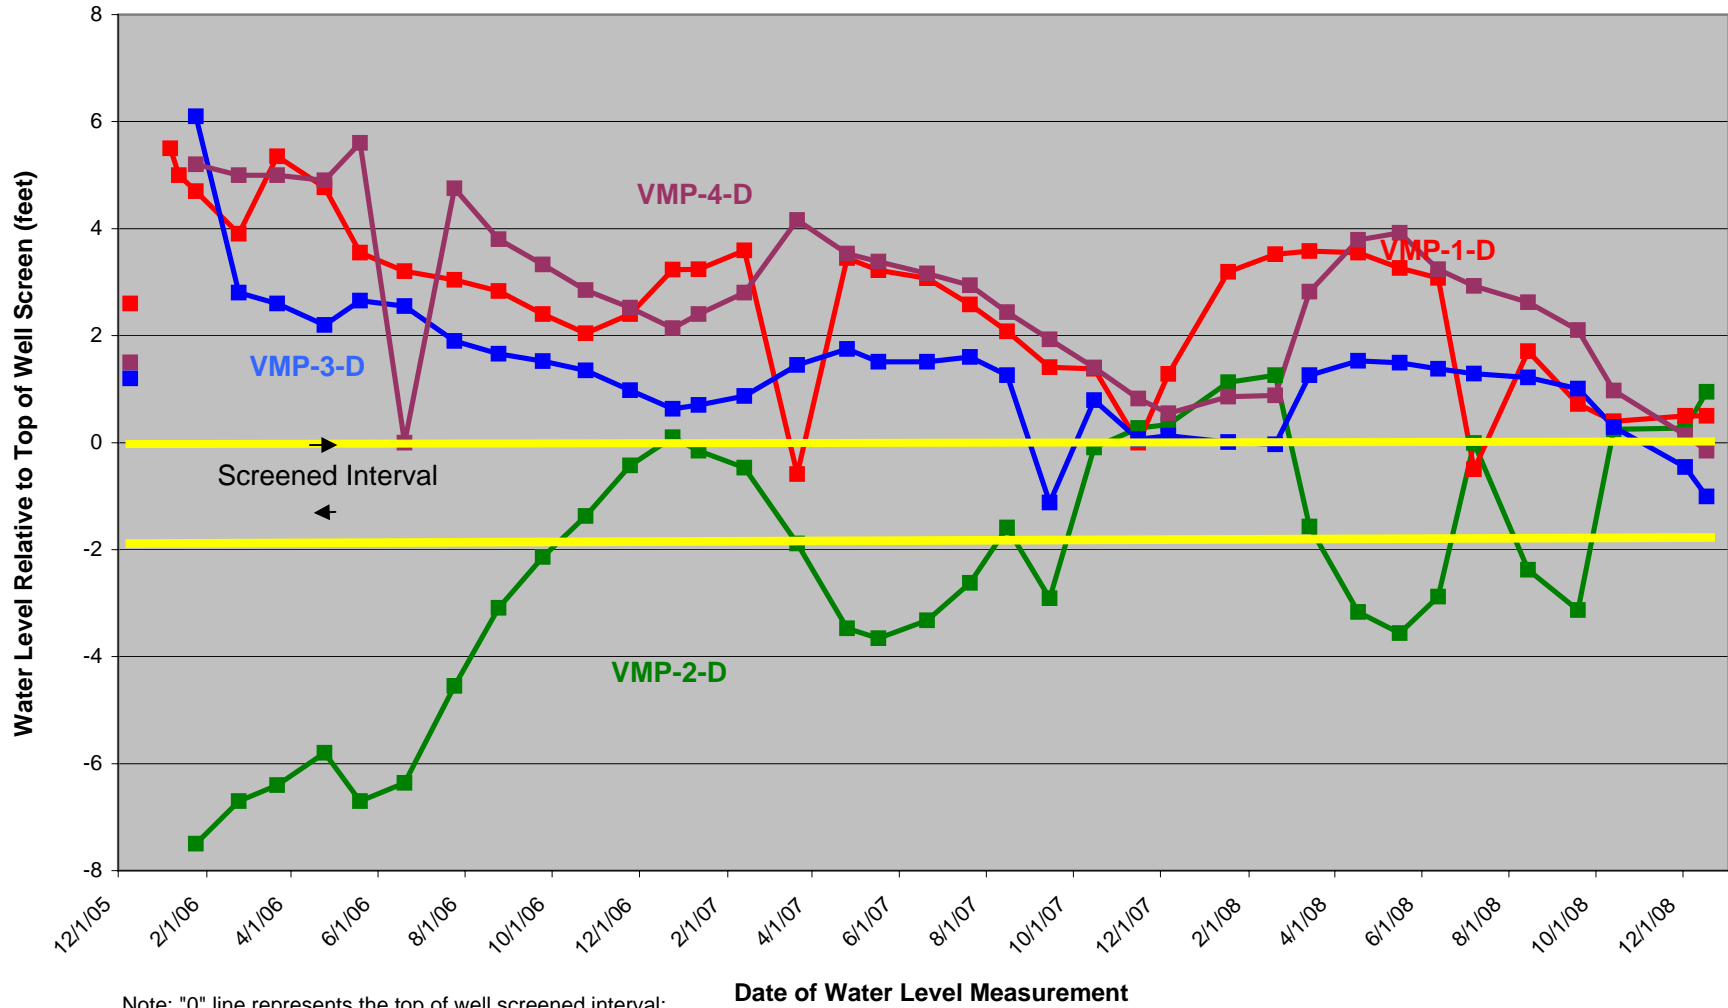
**Figure 8 - Historical Groundwater Levels Relative to Top of Deep VMP Screened Intervals  
Redwood Regional Park Service Yard - Oakland, California**

- As shown on Figure 8, water levels in deep VMPs have been relatively stable since the VMPs were installed. The exception is VMP-2-D, which showed an increase from March 2006 to February 2008, and then showed a sharp decrease to below the screened interval. A slight rise was observed between May and June 2008, but the water level remains below the screened interval. Since the deep VMPs were installed, water levels in three of the four deep VMPs have been above the top of the well screen; only VMP-2-D has an exposed well screen above the water table.

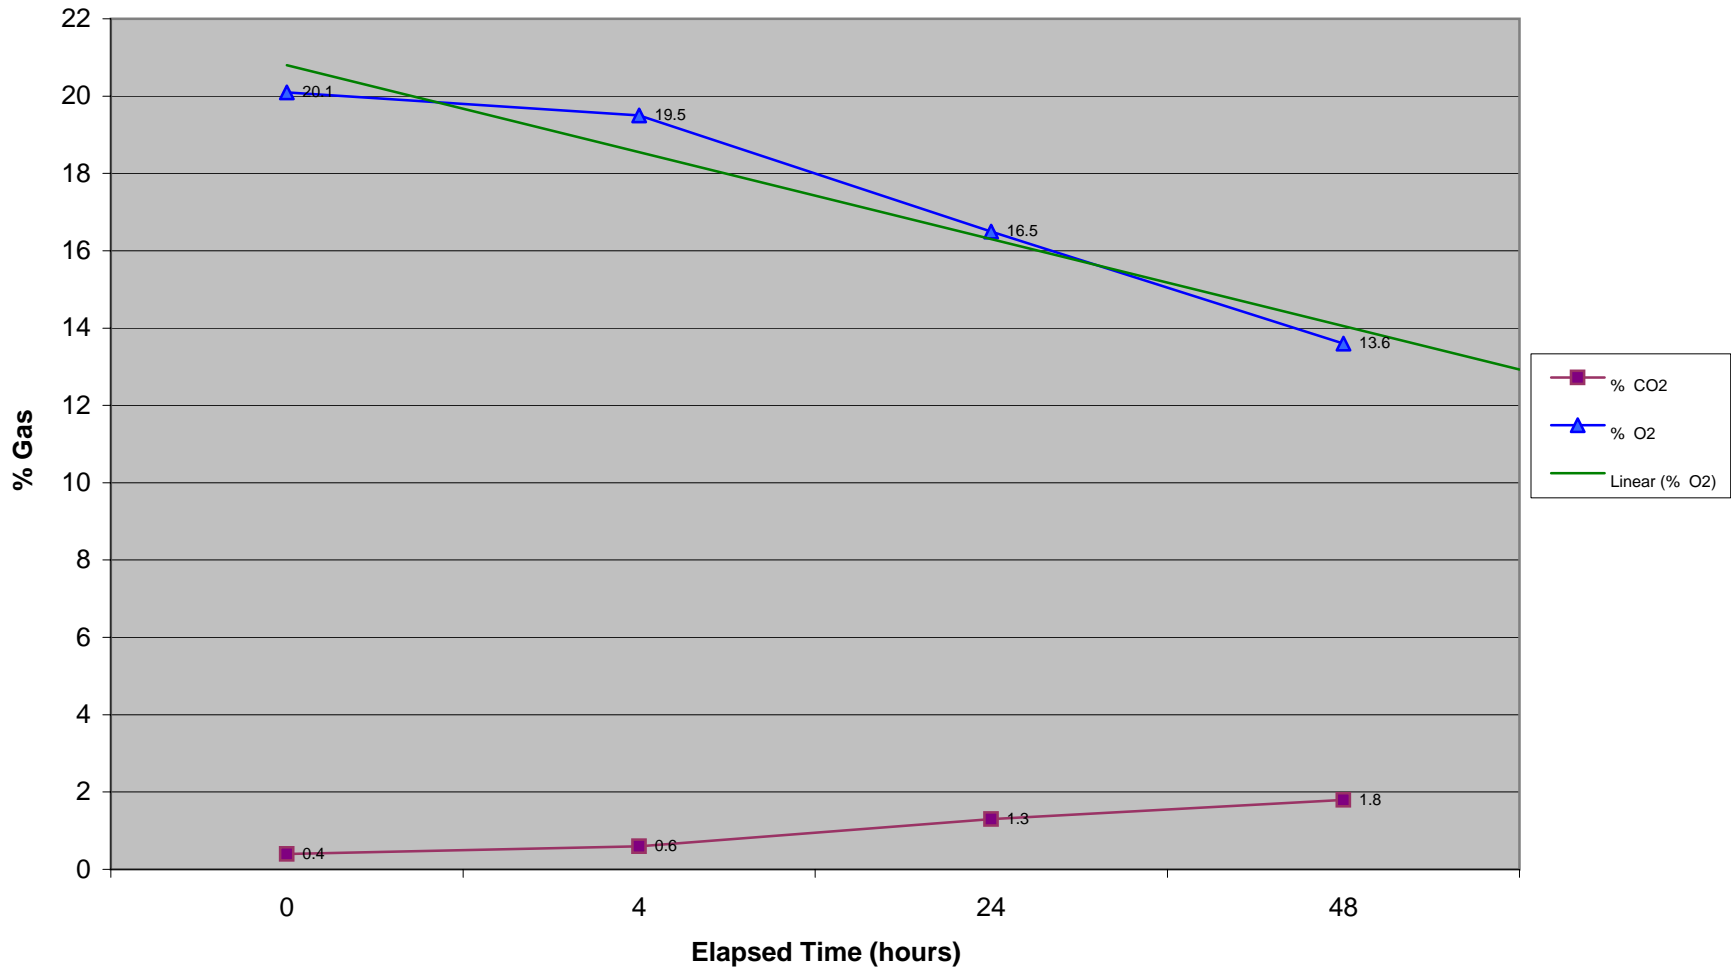
**Figure 9: Respiration Test VMP-2 O<sub>2</sub>-CO<sub>2</sub> Trend Plot**  
**October 13-15, 2008**  
**Redwood Regional Park Service Yard, Oakland, CA**

VMP-2 and, to a lesser extent, VMP-1 showed a significant decrease in oxygen that would indicate microbial activity. The position of VMP-2 (nearly midway between the two vent wells) and its relatively higher elevation likely resulted in increased aeration and microbial activity at this point.

Figure 9 shows the respiration test results. The oxygen utilization within the first 24 hours is 3.6 percent. This value is lower than the 5.8 and 6.1 percent oxygen utilization within the first 24 hours exhibited in the 2007 and 2006 respiration tests, respectively. The same decreasing utilizing trend occurred in the 48-hour measurement where the oxygen utilization was 6.5 percent in 2008 compared with 11.1 percent in 2007 and 11.1 percent in 2006. Ideally, in the absence of additional hydrocarbon input from leaching residual hydrocarbons entrained in the soil of the original UFST source area, the oxygen utilization rate should decrease due to a reduction in mass over time. However, based on the 2008 data from MW-2, more source contamination is entering the system.

Using the above assumptions, an oxygen utilization rate of 5.8 percent of oxygen per day would correspond to a biodegradation rate of approximately 1.8 milligrams per kilogram (mg/kg) per day. This translates into a hydrocarbon reduction of 657 mg/kg per year. During the initial respiration test in 2006, it was found that, by using the initial average TPH concentration in soil of 6,000 mg/kg (based on the average of the soil samples from the source area), the oxygen utilization was 4.1 mg/kg per day; this would require approximately 5 years of remediation. However, the lesser utilization rate and the continued input from the source area negate the original estimate.

In-situ respiration testing should be used as the primary indicator for site closure. When the in-situ respiration rate in the contaminated area is similar to that in the uncontaminated area, it is likely that the site has been remediated and that final soil sampling can be conducted. In-situ respiration testing to determine remediation success is economically preferable to soil sampling because it eliminates the high cost of intermediate soil sampling. A 2009 respiration test will be performed to evaluate changes in the apparent oxygen utilization rate.
