SECOND QUARTER 2006 BIOVENTING STATUS REPORT

**REDWOOD REGIONAL PARK
SERVICE YARD
OAKLAND, CALIFORNIA**

Subject: Second Quarter 2006 Bioventing Progress Report
Redwood Regional Park Service Yard Site, Oakland, California – RO #0000246

Project No. 2006-17

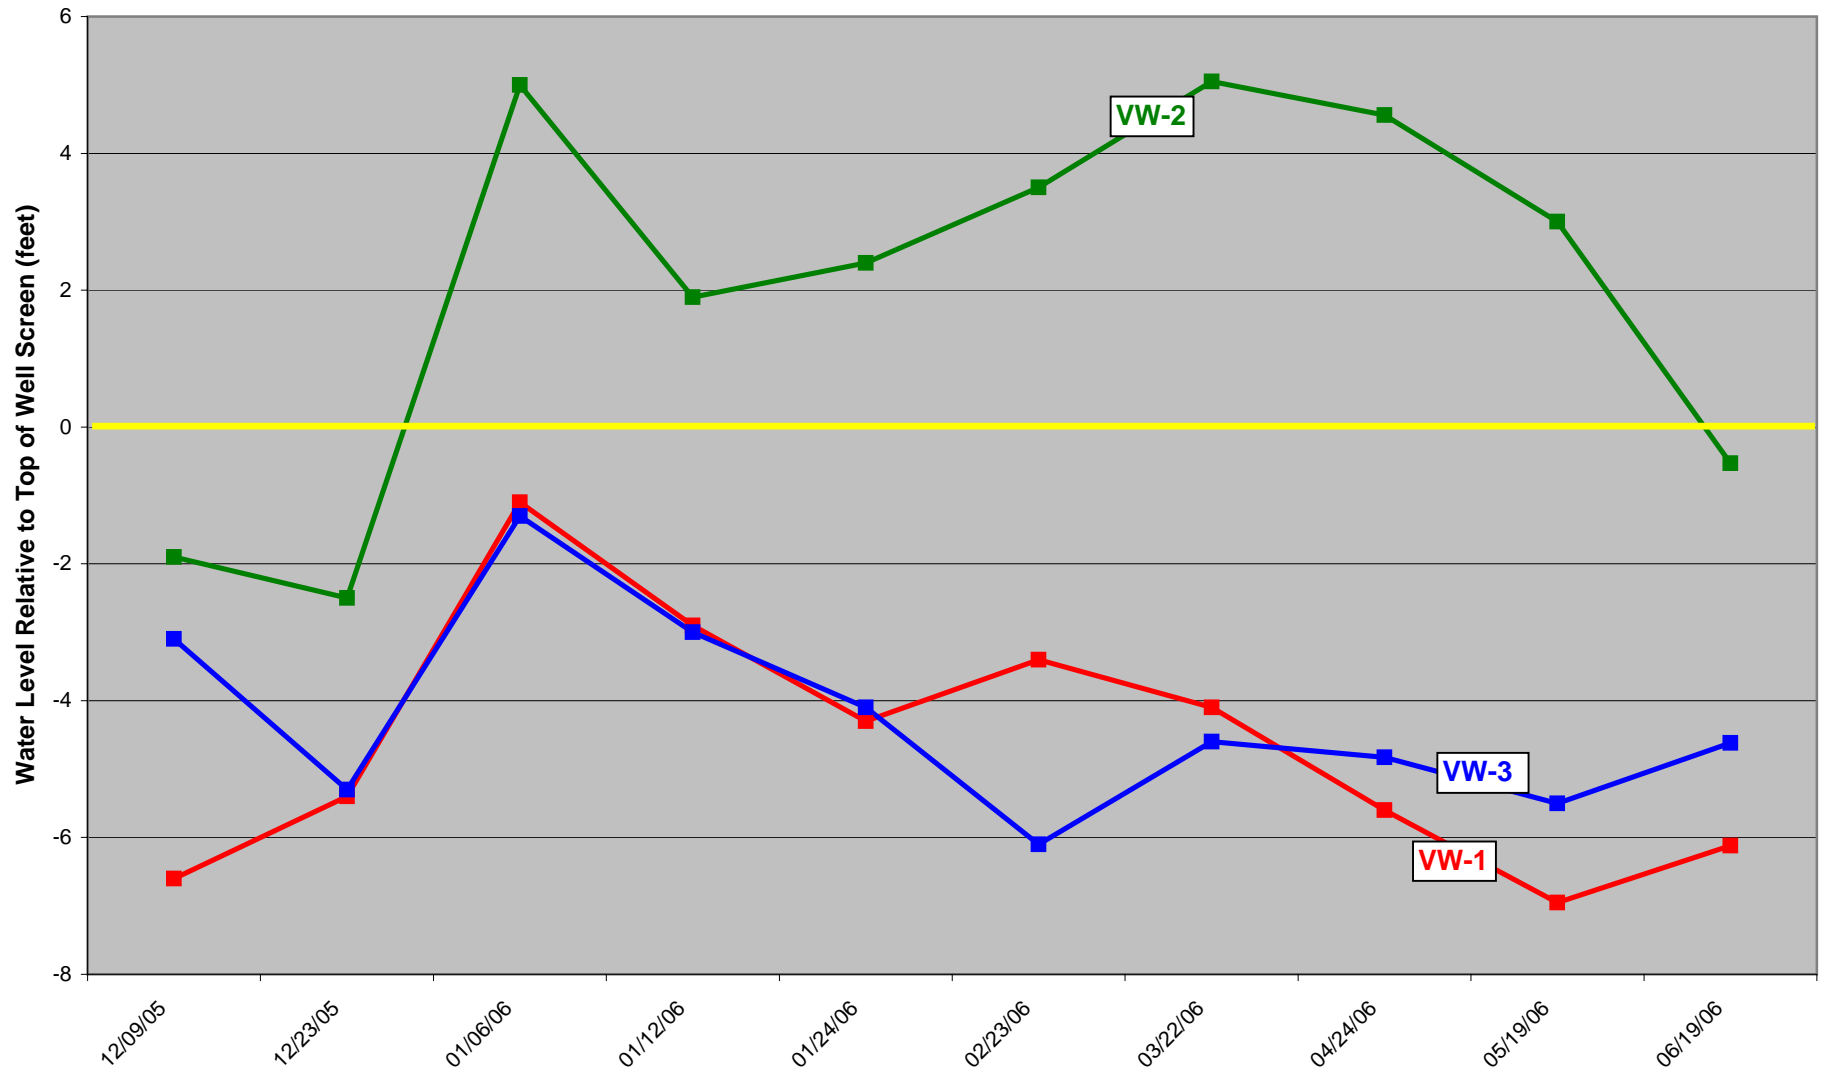
**Figure 6 - Historical Groundwater Levels Relative to Top of VW Screened Intervals
Redwood Regional Park Service Yard - Oakland, California**

- Water levels in VWs showed a general increase after the wells were installed, resulting in partially or fully flooded well screens in all VWs. VW-1 and VW-3 showed a water level decrease through May 2006, and were slightly higher in June 2006. VW-2 showed an initial increase in water levels through March 2006, and has since shown a decrease. Figure 6 shows groundwater levels in VWs relative to the top of the well screened interval. The screen in VW-2 has been fully flooded since installation. Wells VW-1 and VW-3 have had partially exposed screens since installation.

- Air is being injected (and has been since system startup) in the non-flooded portion of the VW-1 screen, but at flow rates less than optimum due to the partially flooded screen. A significant increase in apparent air flow in VW-1 was observed between the May and June 2006 events.

- No measurable air injection has occurred in VW-2 since system startup, due to the fully flooded screen. The June 2006 event was the first event in which the water level was below the top of well screen (approximately 0.5 feet).

- No measurable air injection has occurred in VW-3 since system startup, although that well's screen has been at least partially exposed (not flooded) since installation. SES confirmed (by physical probing) that the screened interval of that well is properly installed (from 8 to 18 feet), and water is infiltrating into the well (confirming that the annular filter pack was not inadvertently cemented in during well installation). The inability to inject air may be due to residual saturation in the well filter pack and/or surrounding soils, or because the native soils in the borehole annulus may have been smeared during installation.

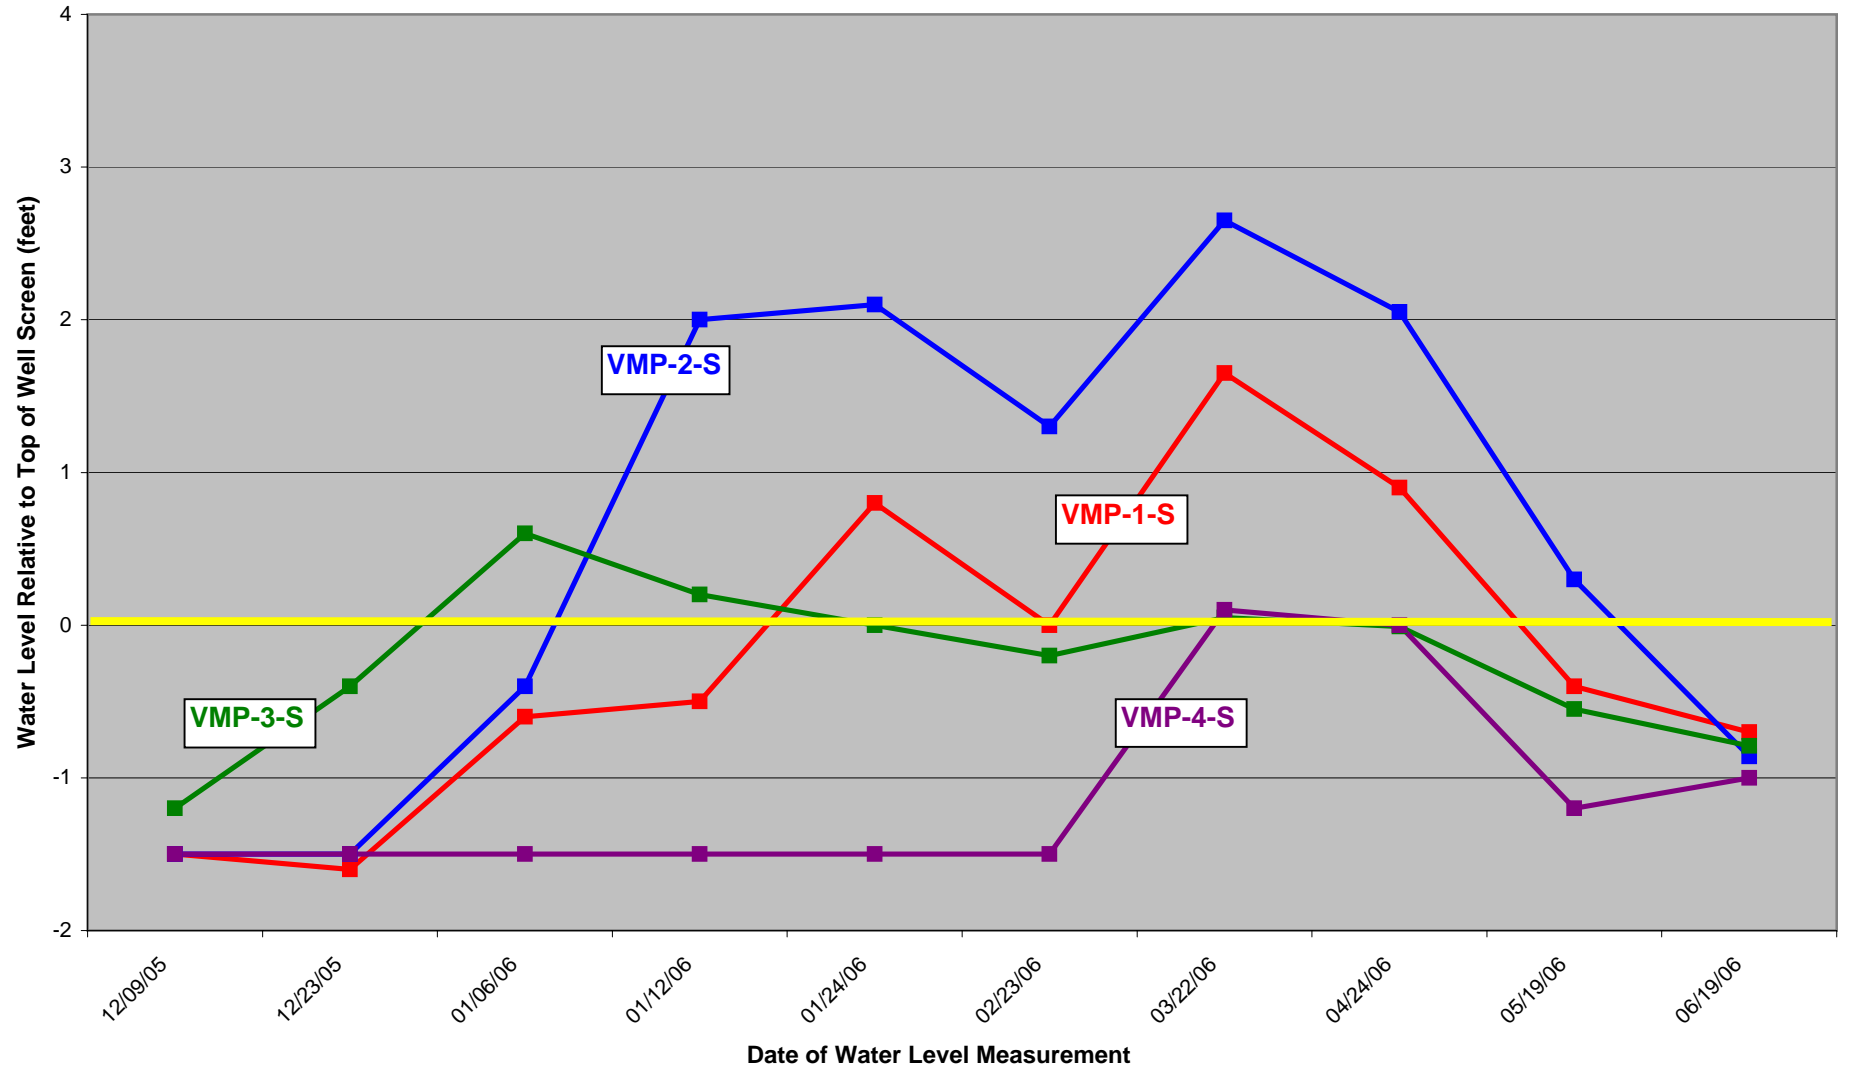
**Figure 7 - Historical Groundwater Levels Relative to Top of Shallow VMP Screened Intervals
Redwood Regional Park Service Yard - Oakland, California**

- As shown on Figure 7, water levels in shallow VMPs showed a general increase (between 1.5 and 4.5 feet) between VMP installation and March 2006. Water levels have since begun to drop. As of May 2006, three of the four shallow VMP water levels were below the top of well screens.

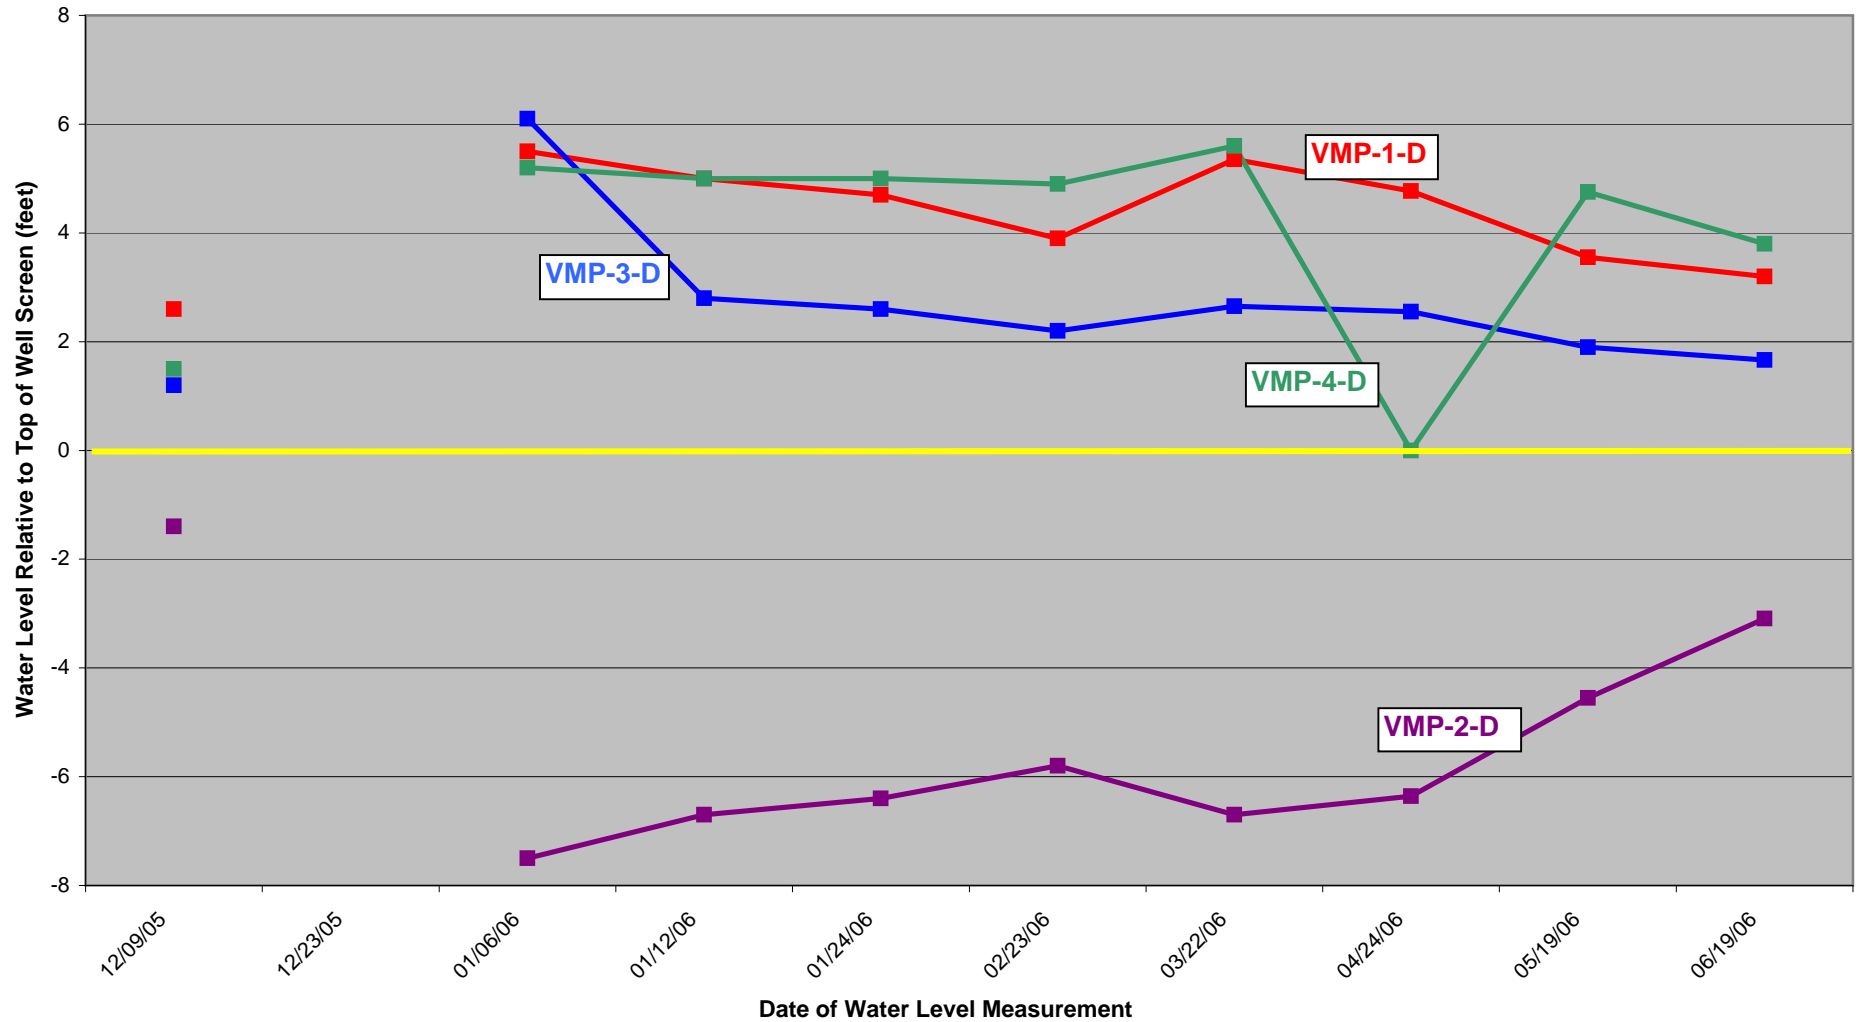
**Figure 8 - Historical Groundwater Levels Relative to Top of Deep VMP Screened Intervals
Redwood Regional Park Service Yard - Oakland, California**

- As shown on Figure 8, water levels in deep VMPs have been relatively stable since the VMPs were installed, with the exception of VMP-2-D, which has shown an increase since March 2006. Since the deep VMPs were installed, water levels in three of the four deep VMPs have been above the top of the well screen; only VMP-2-D has exposed well screen.
