# **Q3/Q4 2006 BIOVENTING STATUS AND ANNUAL SUMMARY REPORT**

**REDWOOD REGIONAL PARK  
SERVICE YARD  
OAKLAND, CALIFORNIA**

**EAST BAY REGIONAL PARK DISTRICT  
OAKLAND, CALIFORNIA**

**December 27, 2006**

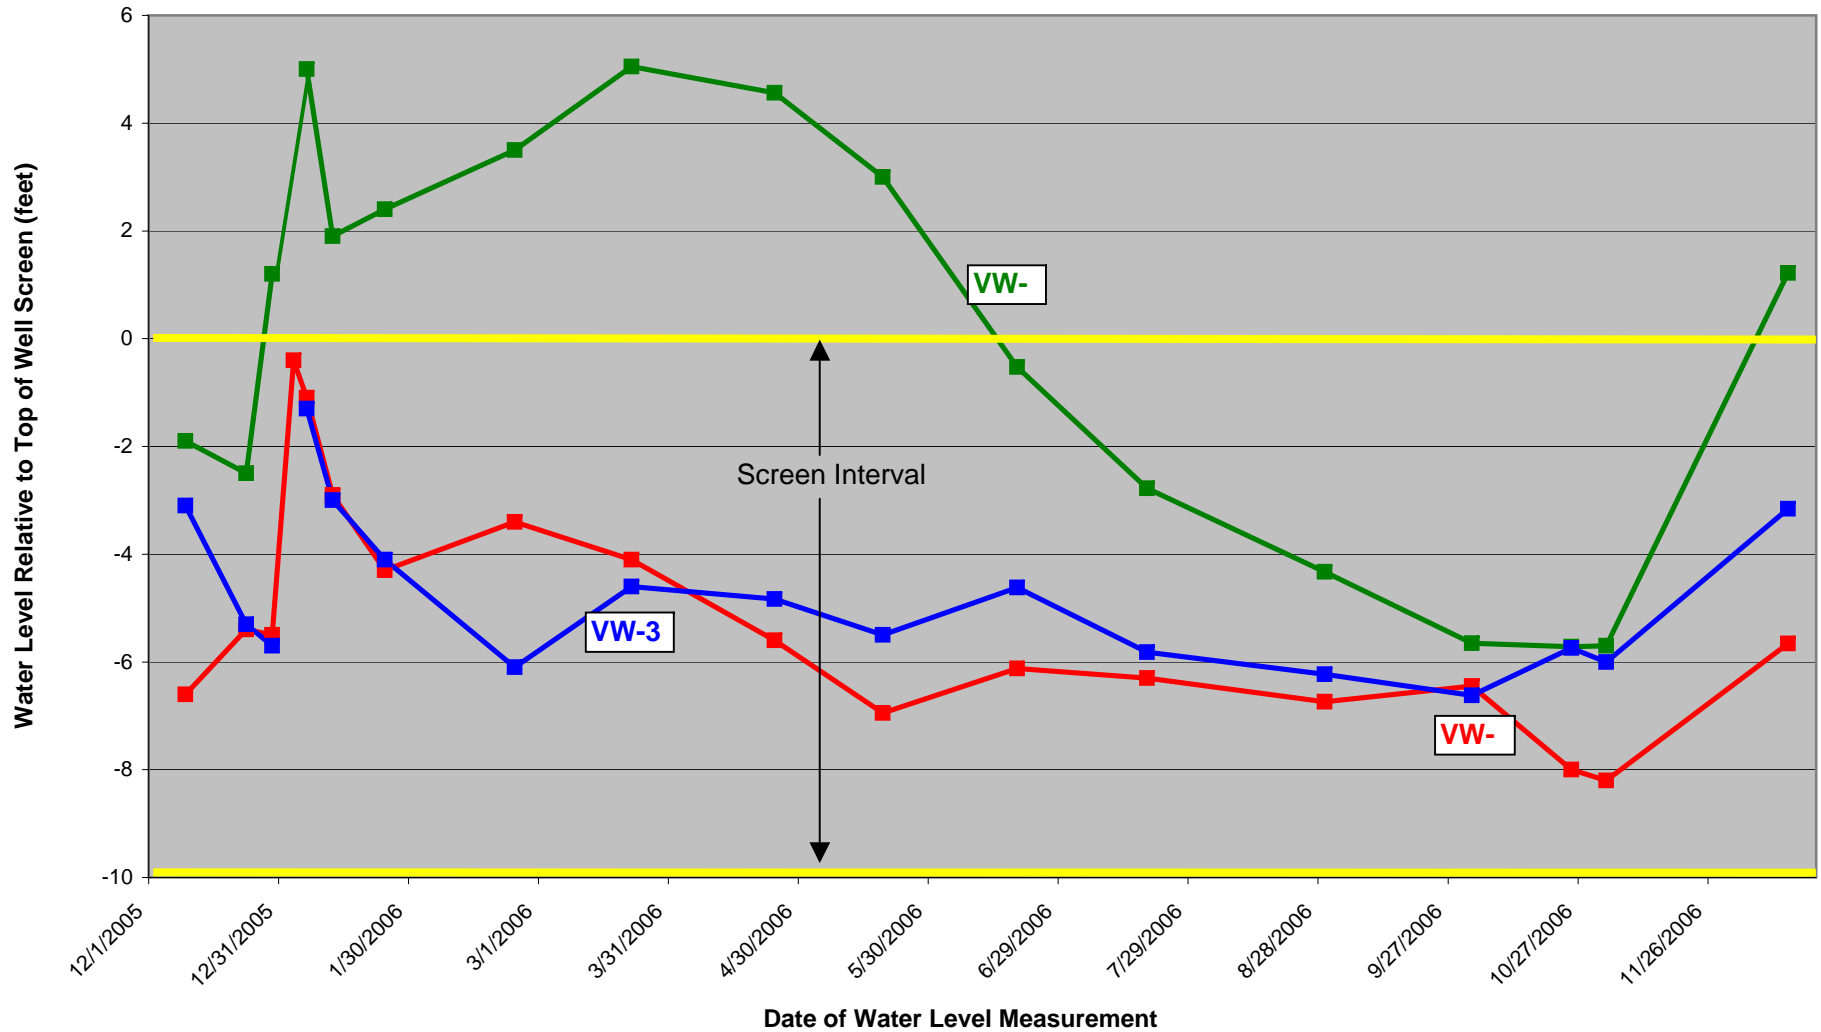
**Figure 6 - Historical Groundwater Levels Relative to Top of VW Screened Intervals  
Redwood Regional Park Service Yard - Oakland, California**

- Water levels in VWs showed a general increase after the wells were installed, resulting in partially or fully flooded well screens in all VWs. VW-1 and VW-3 showed a water level decrease through May 2006; the water levels in these VWs have fluctuated since then, but have always been below top of screen. Figure 6 shows groundwater levels in VWs relative to the top of the screened interval. The screen in VW-2 was fully flooded as of May 2006, at which point the water level began to lower. Wells VW-1 and VW-3 have had partially exposed screens since installation. Water levels in all of the VWs have begun to increase since the end of November.

- Air is being injected (and has been since system startup) in the non-flooded portion of the VW-1 screen, but at flow rates less than optimum due to the partially flooded screen. Monthly system monitoring has shown a significant increase in air flow as groundwater lowers.

- No measurable air injection occurred in VW-2 since system startup until mid-October, due to the fully flooded screen. Air flow occurred through the VW-2 screened interval from approximately mid-October through November (until the first significant rains in late November/early December), presumably due to the raised groundwater level and the corresponding saturation of the well screen interval.

- No measurable air injection has occurred in VW-3 since system startup, although that well's screen has been at least partially exposed (not flooded) since installation. SES confirmed (by physical probing) that the screened interval of that well is properly installed (from 8 to 18 feet), and that water is infiltrating into the well (confirming that the annular filter pack was not inadvertently cemented in during well installation). The inability to inject air may be due to residual saturation in the well filter pack and/or surrounding soils, or because the native soils in the borehole annulus may have been smeared during installation.

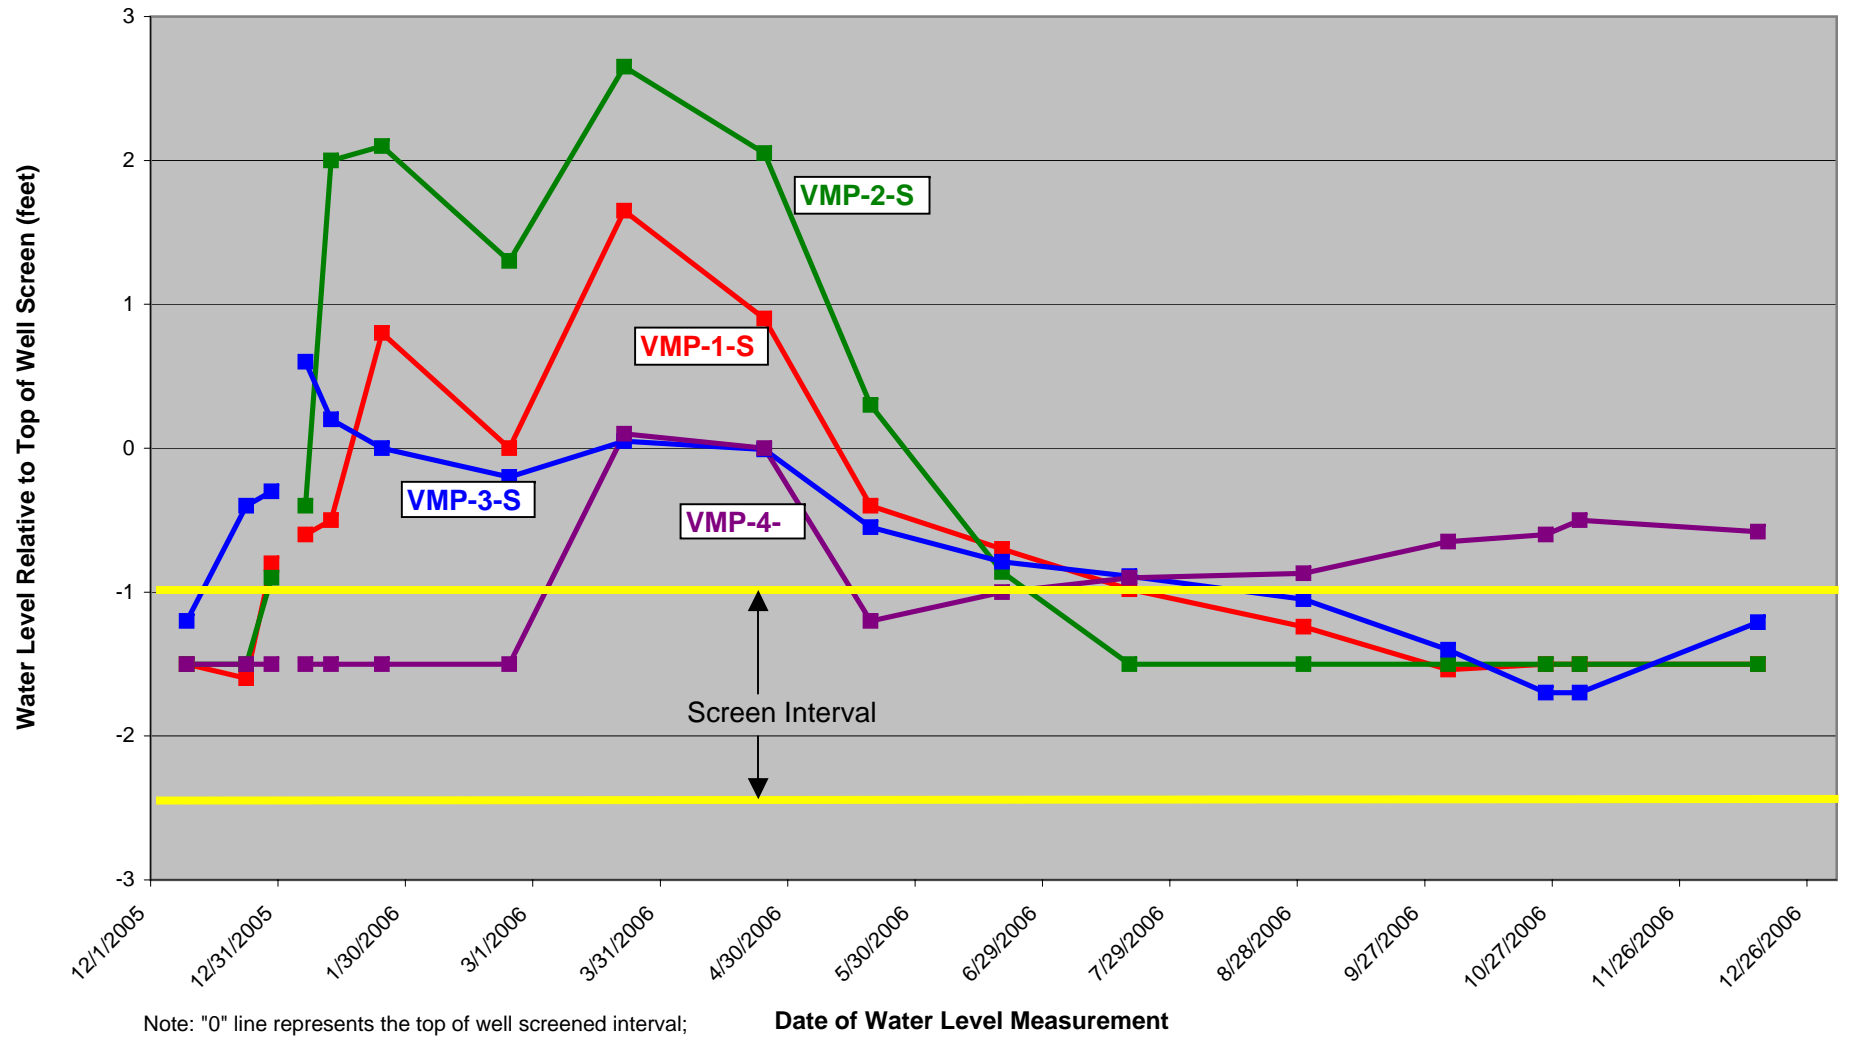
**Figure 7 - Historical Groundwater Levels Relative to Top of Shallow VMP Screened Intervals  
Redwood Regional Park Service Yard - Oakland, California**

- As shown on Figure 7, water levels since March 2006, have begun to drop. As of May 2006, all of the shallow VMP water levels were below the top of well screens.

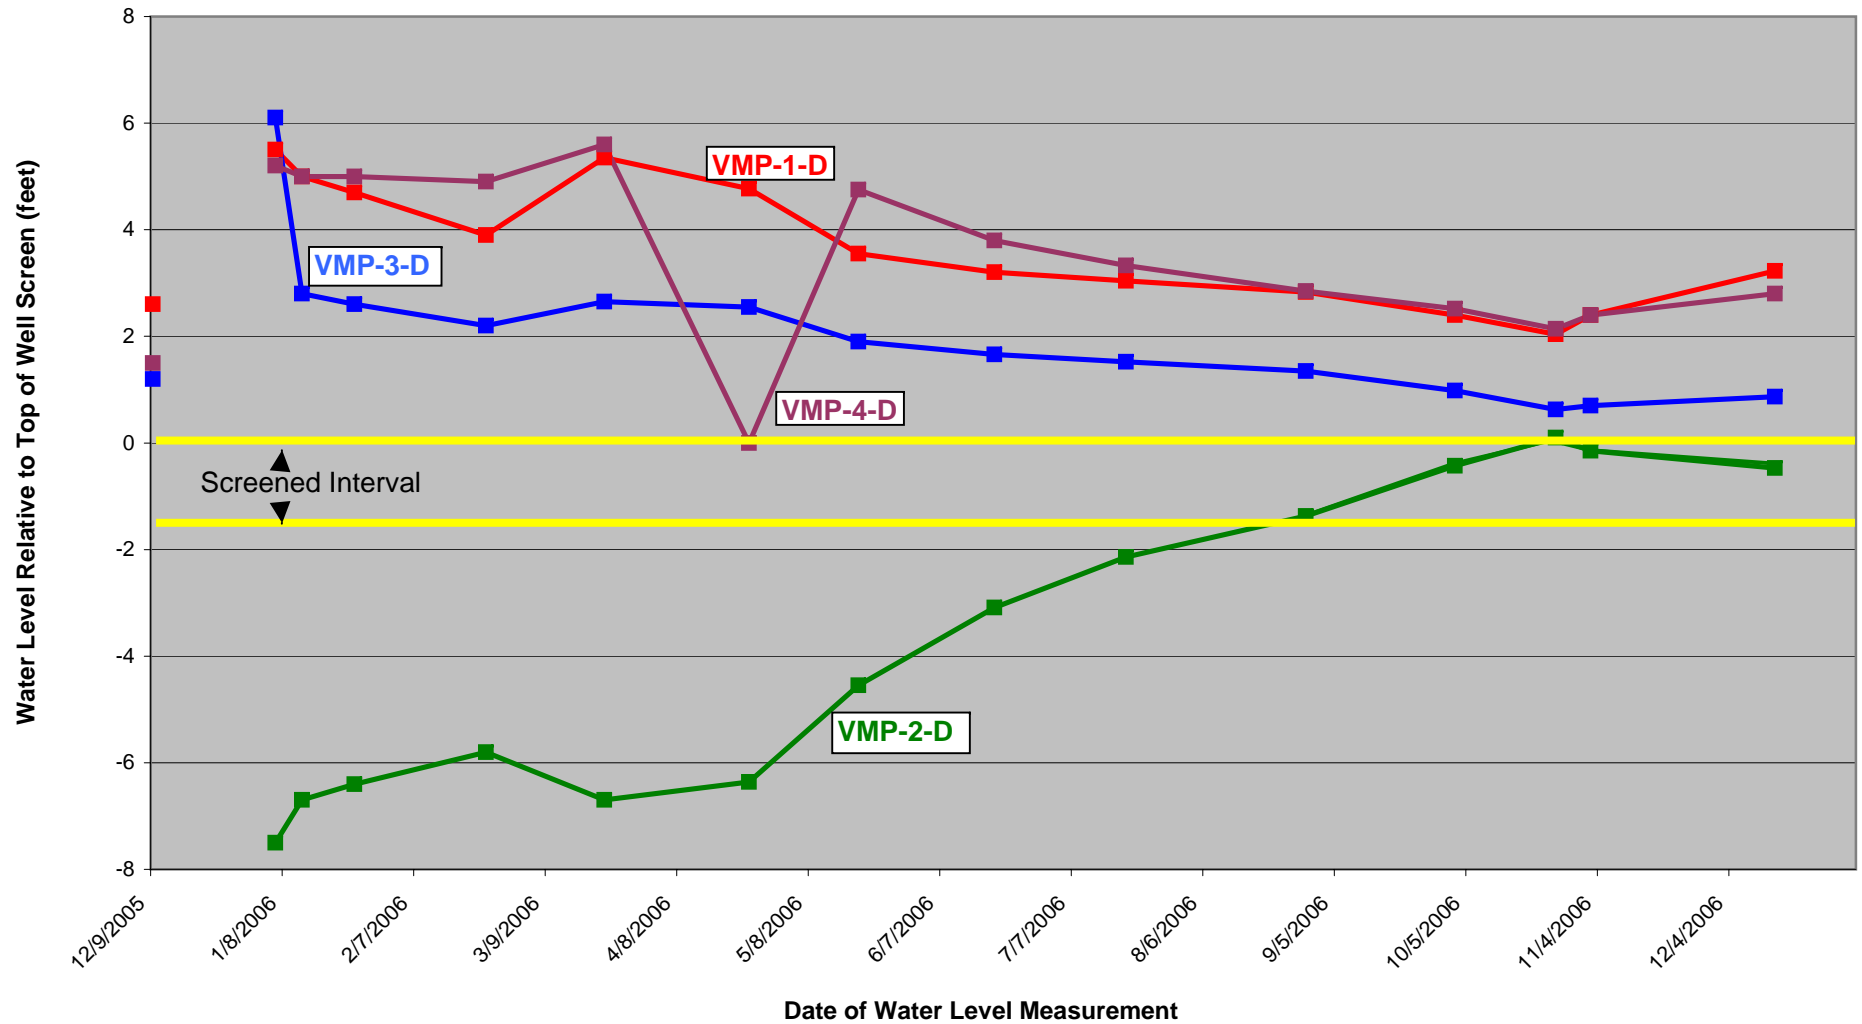
**Figure 8 - Historical Groundwater Levels Relative to Top of Deep VMP Screened Intervals  
Redwood Regional Park Service Yard - Oakland, California**

- As shown on Figure 8, water levels in deep VMPs have been relatively stable since the VMPs were installed, with the exception of VMP-2-D, which has shown an increase since March 2006. Since the deep VMPs were installed, water levels in three of the four deep VMPs have been above the top of the well screen; only VMP-2-D has exposed well screen.

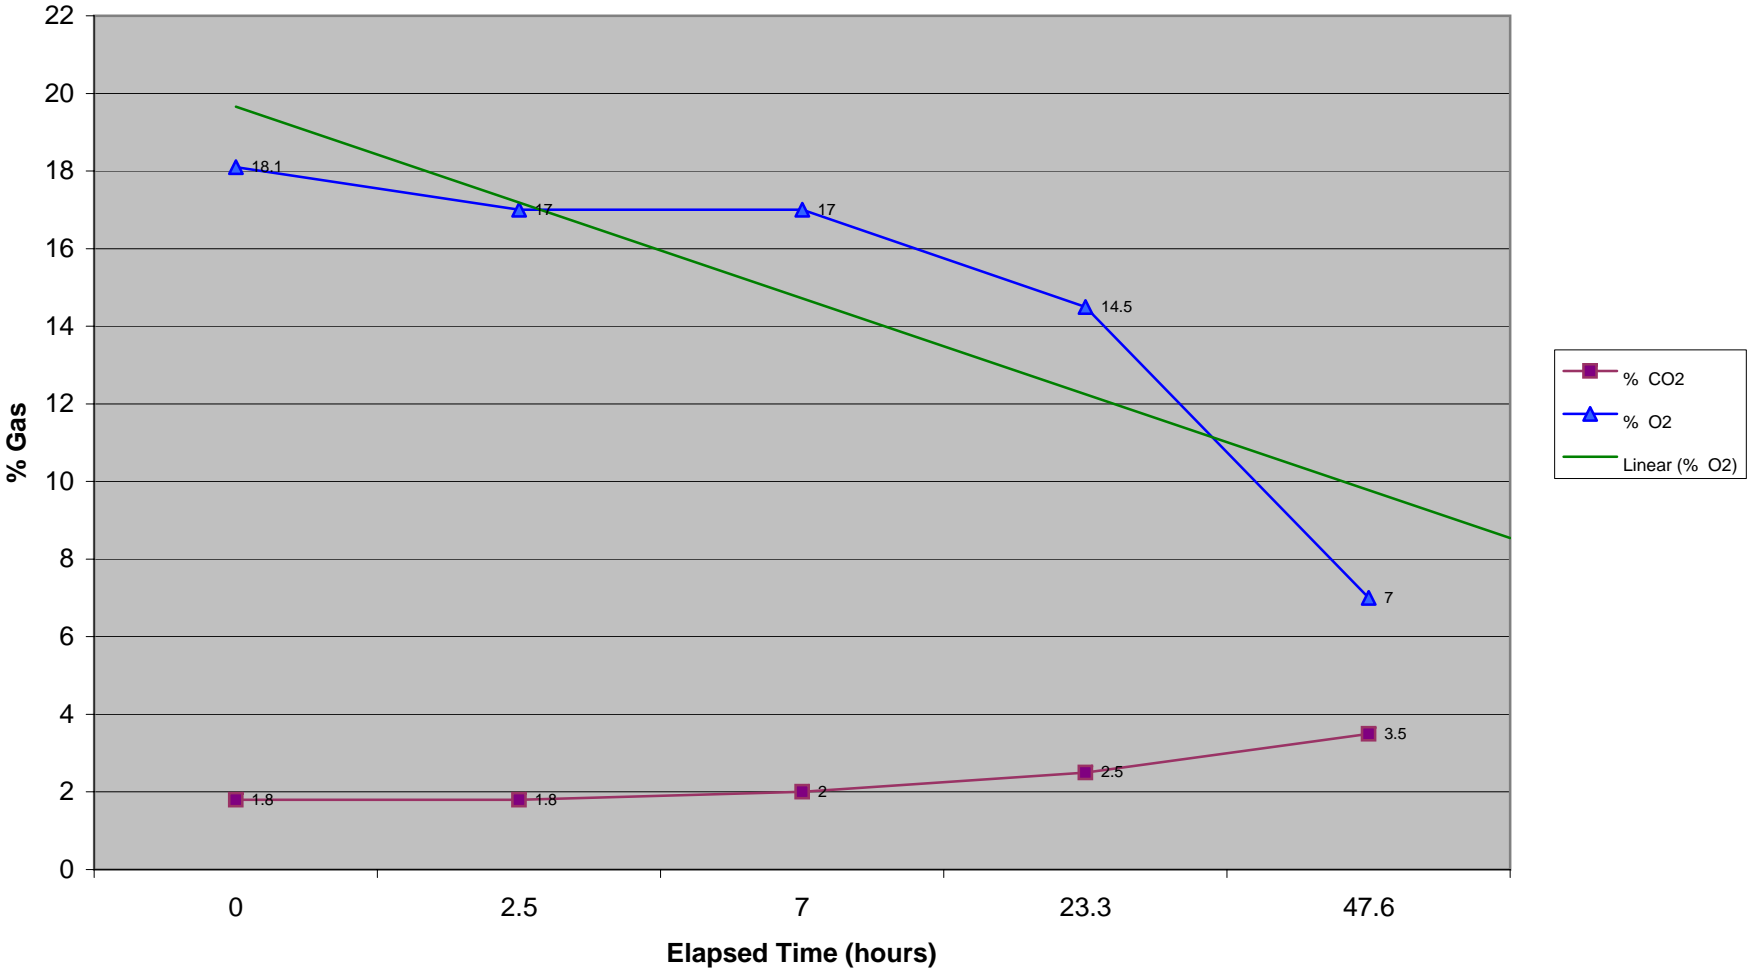
**Figure 9: Respiration Test VMP-2 O<sub>2</sub>-CO<sub>2</sub> Trend Plot**  
**October 31- November 2, 2006**  
**Redwood Regional Park, Oakland, CA**

Only VMP-2 showed a significant decrease in oxygen that would be indicative of microbial activity. The position of VMP-2 (nearly midway between the two vent wells) and its relatively higher elevation likely resulted in increased aeration and microbial activity at this point. The highest TVH measurements were also collected from VMP-2, ranging from 844 to 1,202 ppm.

Figure 9 shows the respiration test results. The oxygen utilization within the first 24- hours is approximately 6%. The oxygen utilization are of the only respiration test derived value, the other terms of the equation used to estimate the Biodegradation rate,  $K_B$ , are literature derived, summarized by Leeson and Hinchee (1996), such as the soil bulk density, density of oxygen, and mass of hydrocarbon to oxygen required for mineralization (1/3.5).

Using the above assumptions, an oxygen utilization rate of 6% O<sub>2</sub>/day would correspond to a biodegradation rate of approximately 4.1 mg/kg-day. Given that the initial soil concentration is 6,000 mg/kg, an estimate of cleanup time is calculated as follows:

In-situ respiration testing should be used as the primary indicator for site closure. A good indication that the site is remediated and that final soil sampling can be conducted is when the in-situ respiration rate in the contaminated area is similar to that in the uncontaminated area. In-situ respiration testing to determine remediation success is preferable economically to relying on soil sampling as the sole indicator of site remediation, because it eliminates the high cost of intermediate soil sampling. A 2007 respiration test will be performed to evaluate changes in the apparent oxygen utilization rate.
