FIRST QUARTER 2006 BIOVENTING STATUS REPORT

**REDWOOD REGIONAL PARK
SERVICE YARD
OAKLAND, CALIFORNIA**

**EAST BAY REGIONAL PARK DISTRICT
OAKLAND, CALIFORNIA**

Project No. 2005-66

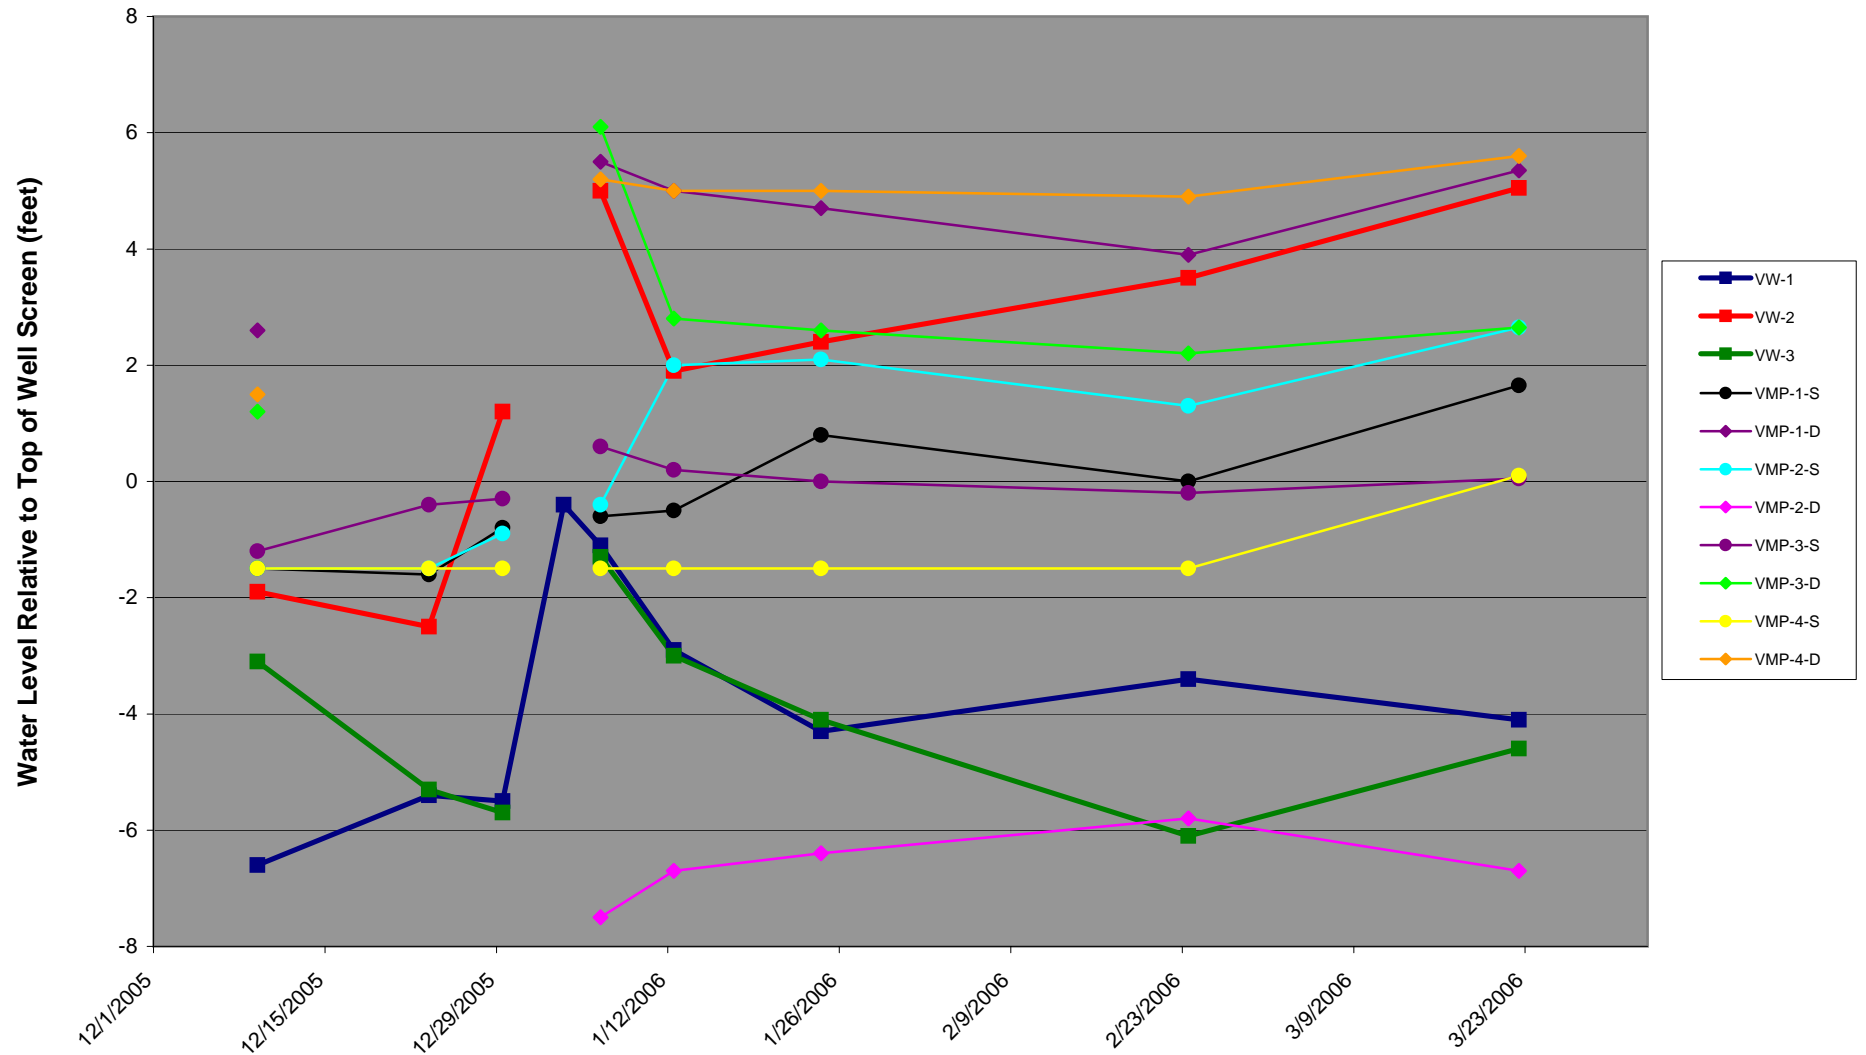
**Figure 6 - Historical Groundwater Levels Relative to Top of Bioventing Well Screened Intervals
Redwood Regional Park Service Yard - Oakland, California**

- Water levels have shown a general increase in most of the VMPs and VWs since the wells were installed, resulting in partially or fully flooded well screens in some wells. Figure 6 shows groundwater levels in VWs and VMPs relative to the top of the well screened interval. The screen in VW-2 has been fully flooded since installation. Wells VW-1 and VW-3 have had partially exposed screens since installation.

- No measurable air injection has occurred in VW-2 since system startup, due to the fully flooded screen.
- No measurable air injection has occurred in VW-3 since system startup, although that well's screen has been at least partially exposed (not flooded) since installation. SES confirmed (by physical probing) that the screened interval of that well is properly installed (from 8 to 18 feet). It is possible that the inability to inject air may be due to residual saturation in the well filter pack and/or surrounding soils, or that the borehole annulus may have been smeared during installation.

- No air flow is occurring through the VW-2 screened interval due to saturated well screen interval.
- No air flow is occurring through the VW-3 screened interval, although a portion of the well screen is unsaturated. The reason for no air flow in this VW is still under investigation, and several (previously discussed) possible causes have been eliminated. The problem may be due to either residual saturation in the filter pack and/or native soil, or possibly borehole smearing during well installation. An air injection test (conducted at 1 order of magnitude greater pressure than that delivered by the blower) indicated that air is leaking from the well, likely through fittings below grade and near the surface.

- Continue to report on bioventing system progress/activities in quarterly progress reports, and prepare an annual summary report (approximately 1 year after the system began operation).
- If future O&M events demonstrate continued absence of air flow through the VW-2 well screen, additional troubleshooting and/or corrective action will be evaluated. This might include redeveloping of the well (by surging and swabbing) to facilitate flushing of the annular pack. If the issue cannot be resolved, replacement of well VW-2 will be considered.
