ANNUAL 2009 BIOVENTING SYSTEM STATUS REPORT

**REDWOOD REGIONAL PARK
SERVICE YARD
OAKLAND, CALIFORNIA**

**EAST BAY REGIONAL PARK DISTRICT
OAKLAND, CALIFORNIA**

Subject: Annual 2009 Bioventing System Status Report,
Redwood Regional Park Service Yard Site, Oakland, California – RO #0000246

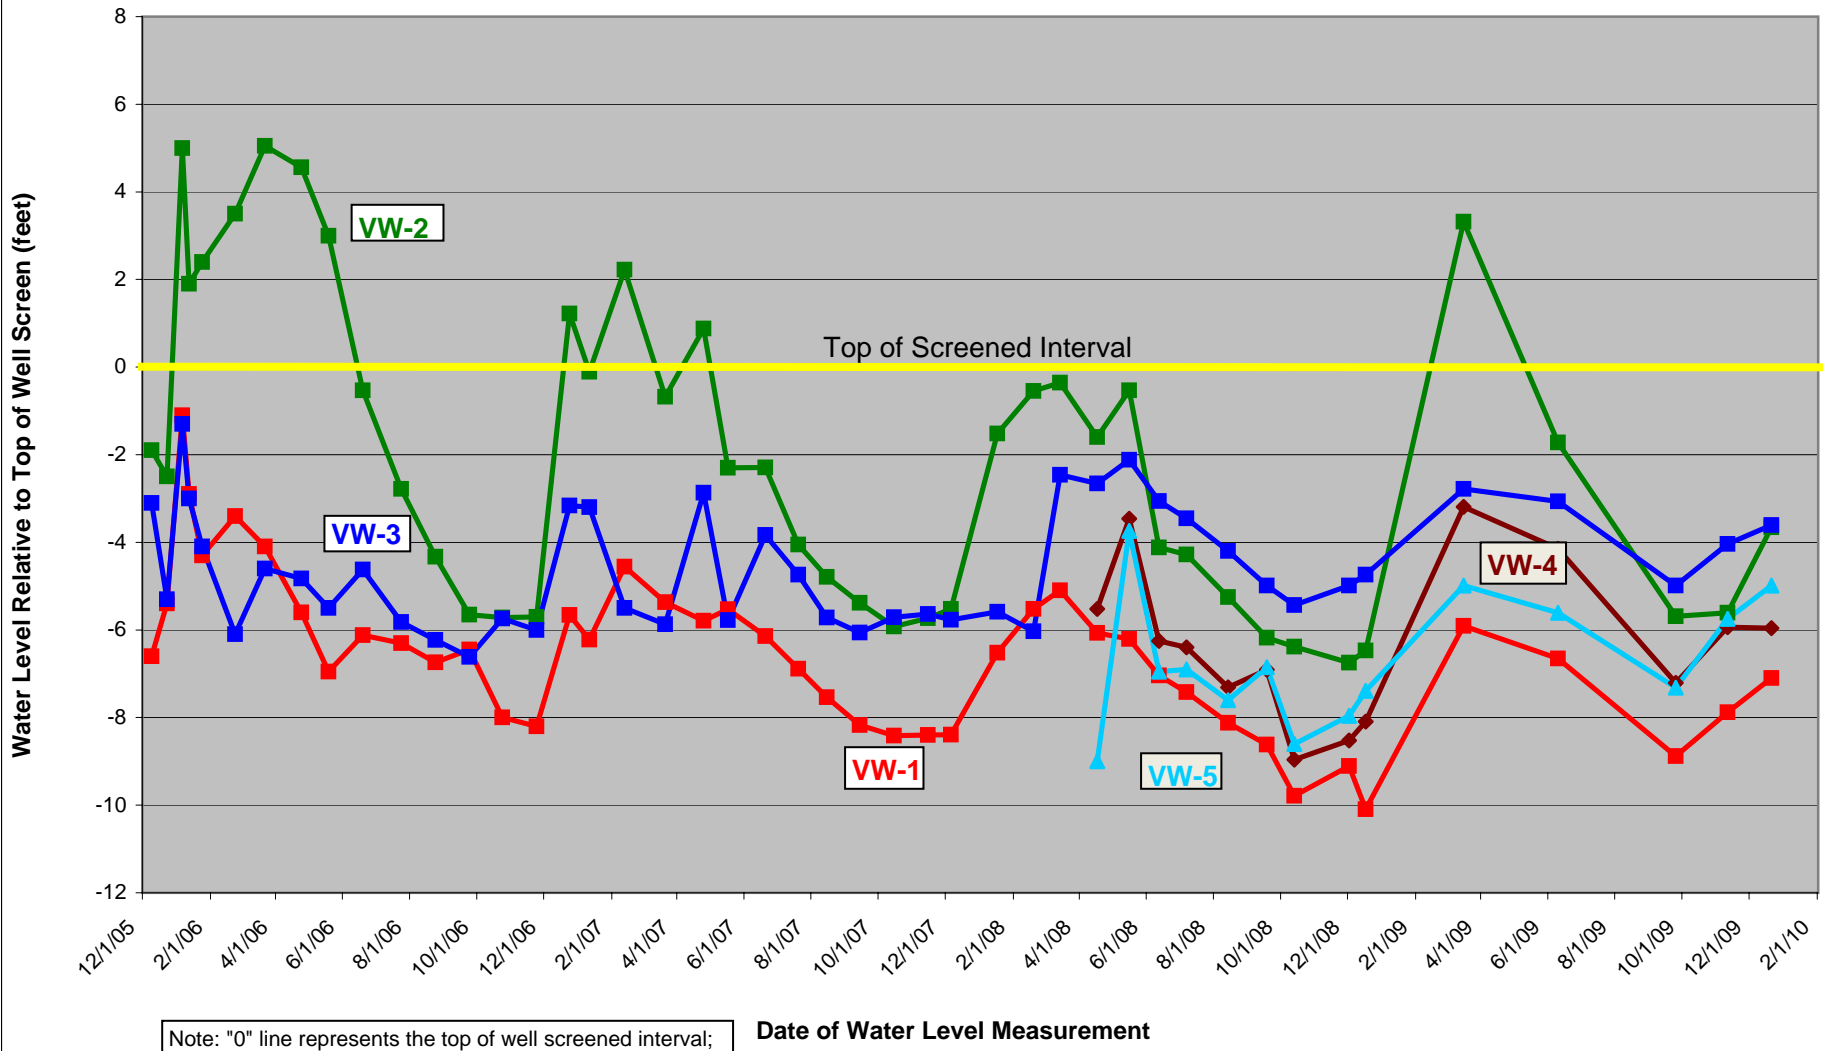
**Figure 6 - Historical Groundwater Levels Relative to Top of VW Screened Intervals
Redwood Regional Park Service Yard - Oakland, California**

- Figure 6 shows groundwater levels in VWs relative to the top of the screened interval. The screen in VW-2 was fully flooded as of May 2006, was lower than the screen interval until October 2006, and had fluctuated above and below the screen since then. In the 2009 year, the water level was above the screened interval in March, but was below the screened interval in the next quarterly monitoring event in June and has since remained below the interval. Water levels in VW-1, VW-4, and VW-5 have been below the screen intervals since installation in 2005 and 2008, respectively.

Note: "0" line represents the top of well screened interval; water levels above that line represent fully flooded screen.

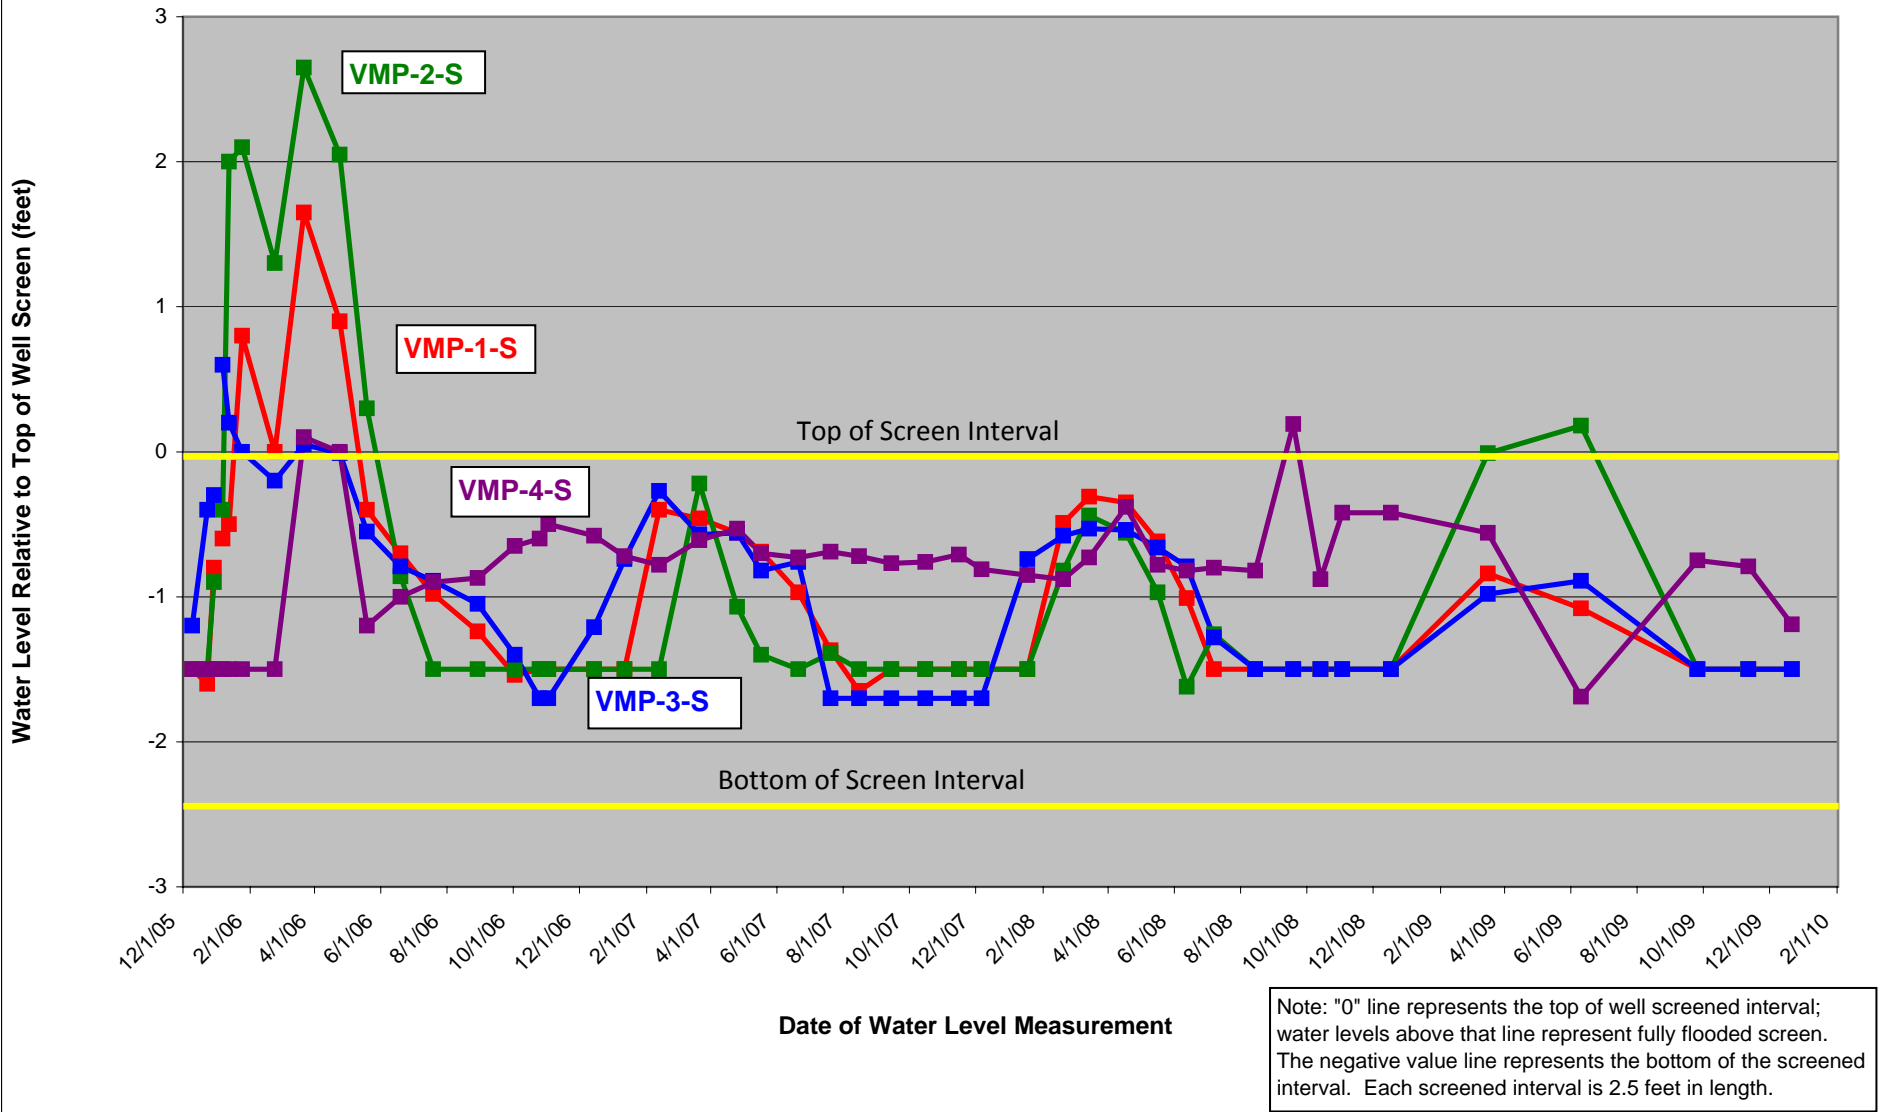
**Figure 7 - Historical Groundwater Levels Relative to Top of Shallow VMP Screened Intervals
Redwood Regional Park Service Yard - Oakland, California**

- As shown on Figure 7, groundwater levels in the shallow VMPs have fluctuated slightly since March 2006. VMPs 1 and 3 have remained below the interval since May 2006. VMP-2 was above the interval from March through June 2009, but has since fallen back below the interval. VMP-4 was above the interval in September 2008, but has been below the screened interval in subsequent events.

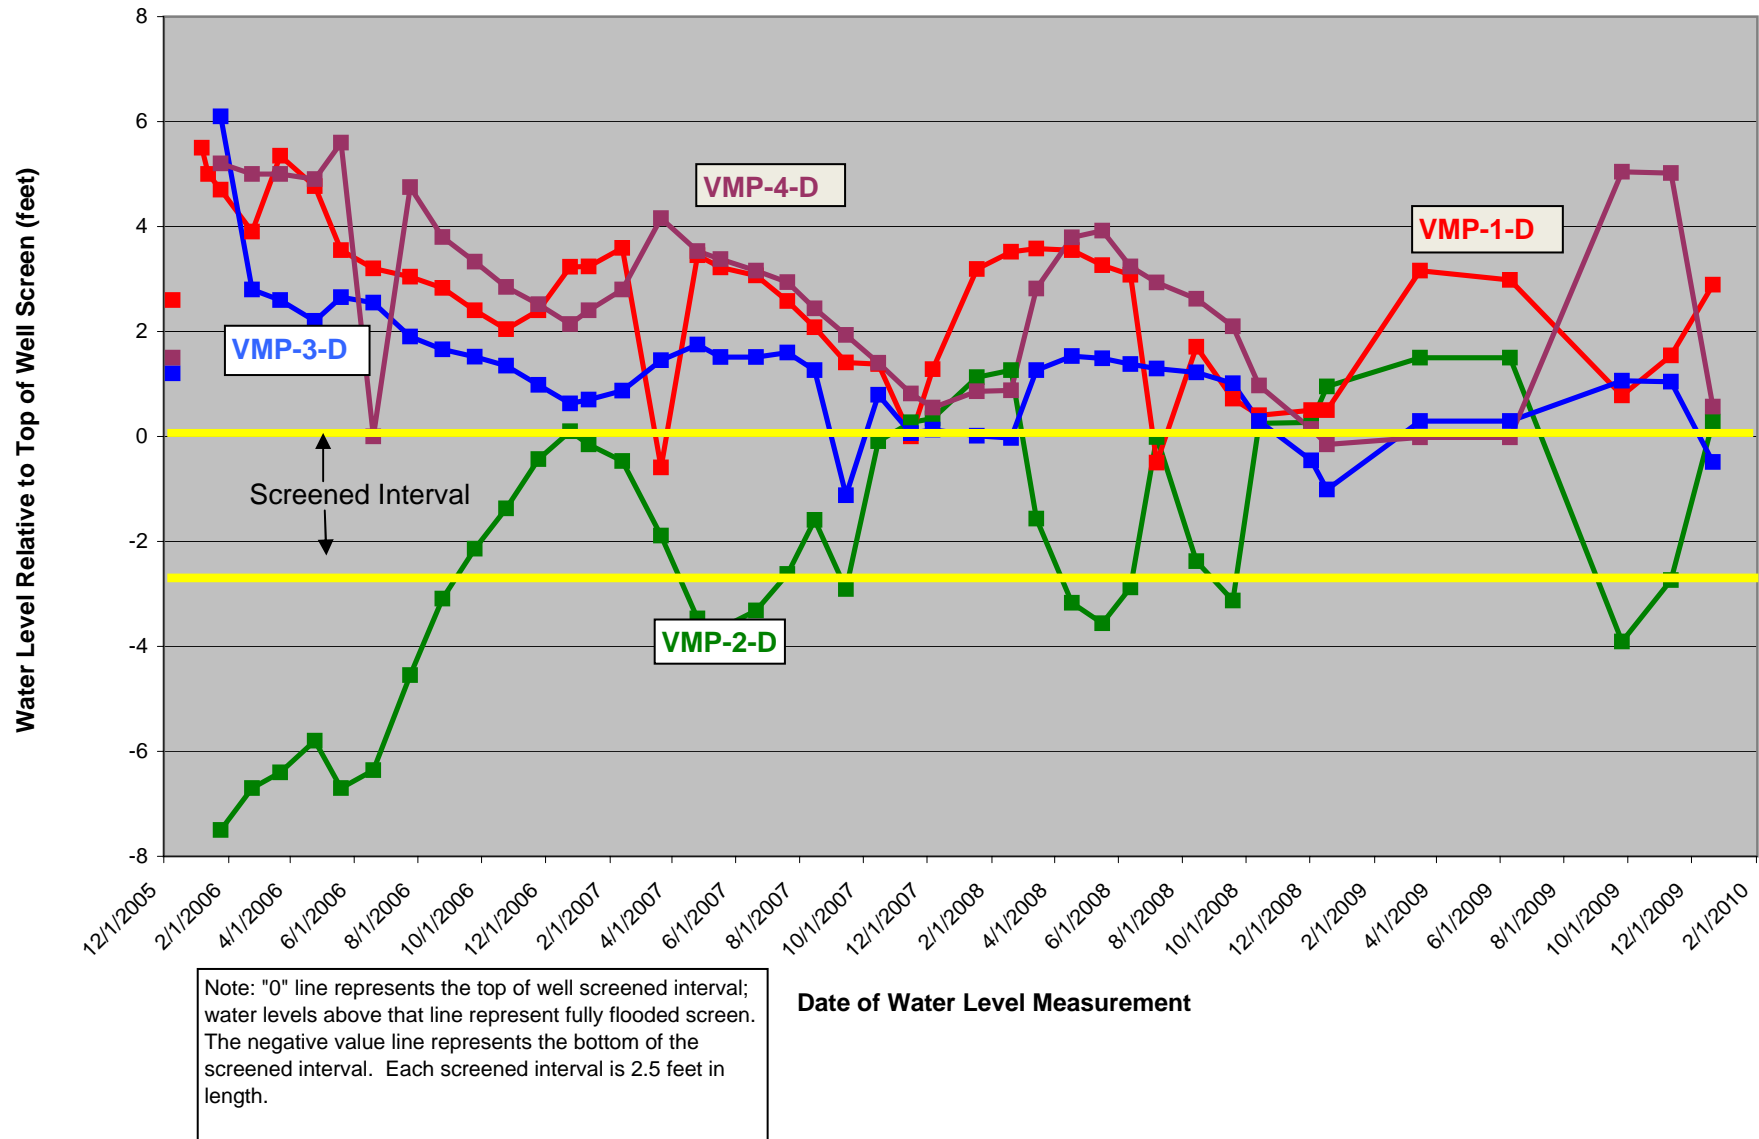
**Figure 8 - Historical Groundwater Levels Relative to Top of Deep VMP Screened Intervals
Redwood Regional Park Service Yard - Oakland, California**

- As shown on Figure 8, water levels in deep VMPs have been relatively stable since the VMPs were installed, with VMP wells 3, 4, and 5 remaining almost constantly saturated. The exception is VMP-2-D, which has fluctuated above and below the screened interval since September 2006. In 2009, the water level was below the screened interval from approximately June to the latest event in December.

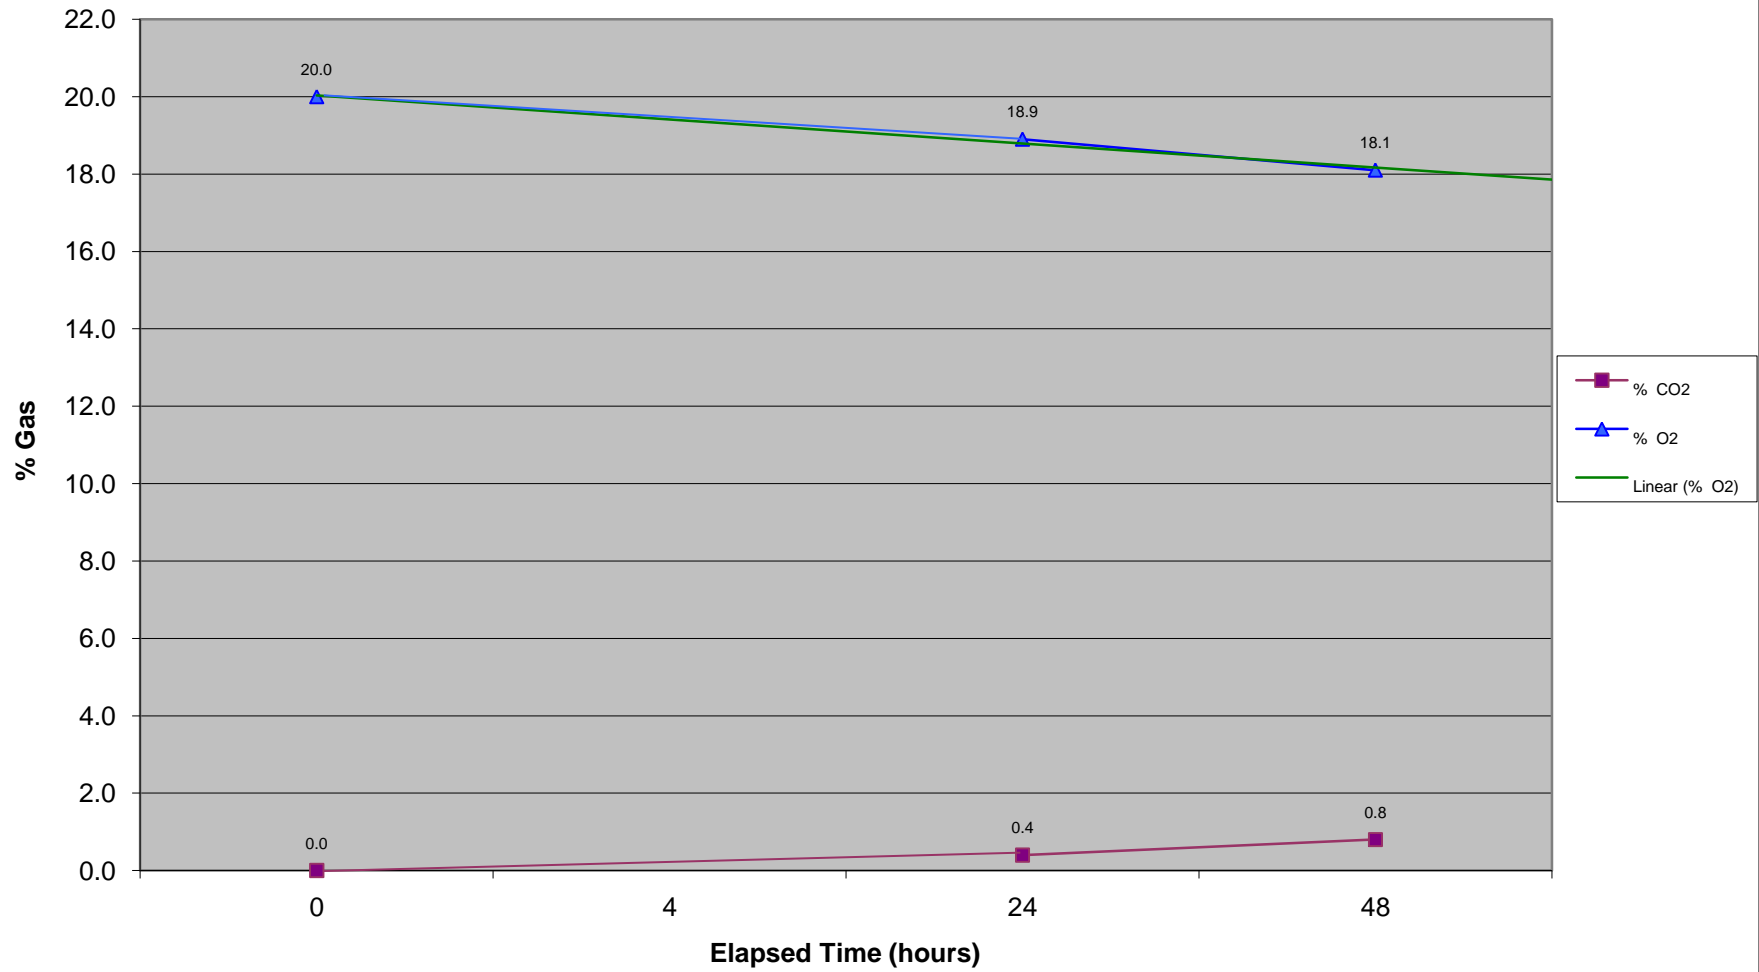
Figure 9: Respiration Test - November 11-13, 2009
VMP-2S O₂-CO₂ Trend Plot
Redwood Regional Park Service Yard, Oakland, CA

Figure 9 shows the respiration test results for 2009 with its marginal oxygen utilization, reflecting the drop in residual hydrocarbons and corroborated by the lower PID readings. The oxygen utilization within the first 24 hours in 2009 is just 1.9 percent. This value is lower than the 3.6, 5.8 and 6.1 percent oxygen utilization within the first 24 hours exhibited in the 2008, 2007, and 2006 respiration tests, respectively. The same decreasing utilizing trend occurred in the 48-hour measurement where the oxygen utilization was 2.1 percent in 2009, 6.5 percent in 2008, 11.0 percent in 2007, and 11.1 percent in 2006. Ideally, in the absence of additional hydrocarbon input from residual hydrocarbons entrained in the upgradient soil sources, the oxygen utilization rate decrease reflects a reduction in hydrocarbon mass over time. However, based on the 2009 data from MW-2, more source based contamination is still entering the system.

The 2009 year data, using the above assumptions, shows an oxygen utilization rate of 1.9 percent of oxygen per day would correspond to a biodegradation rate of approximately 0.4 milligrams per kilogram (mg/kg) per day, or 146 mg/kg per year. This compares with the significantly higher biodegradation rates observed in 2007 and 2006. During the initial respiration test in 2006, it was found that by using the initial average TPH concentration in soil of 6,000 mg/kg (based on the average of the soil samples from the source area), the oxygen utilization was 4.1 mg/kg per day, or 1,495 mg/kg per year, which was the basis for the estimate of 4-5 years of remediation.. In 2007, approximately 1.8 milligrams per kilogram (mg/kg) per day or 884 mg/kg per year hydrocarbon reduction was estimated with a drop to 494 mg/kg per year in 2008. However, the lesser utilization rate and the continued input from the source area negate the original estimate to an extent. These respiration test calculations suggest that in the area of VMP-2, the bioventing has been pretty effective in reducing the hydrocarbons in soil.
