# **ANNUAL 2010 BIOVENTING SYSTEM STATUS REPORT**

**REDWOOD REGIONAL PARK  
SERVICE YARD  
OAKLAND, CALIFORNIA**

**EAST BAY REGIONAL PARK DISTRICT  
OAKLAND, CALIFORNIA**

**January 28, 2011**

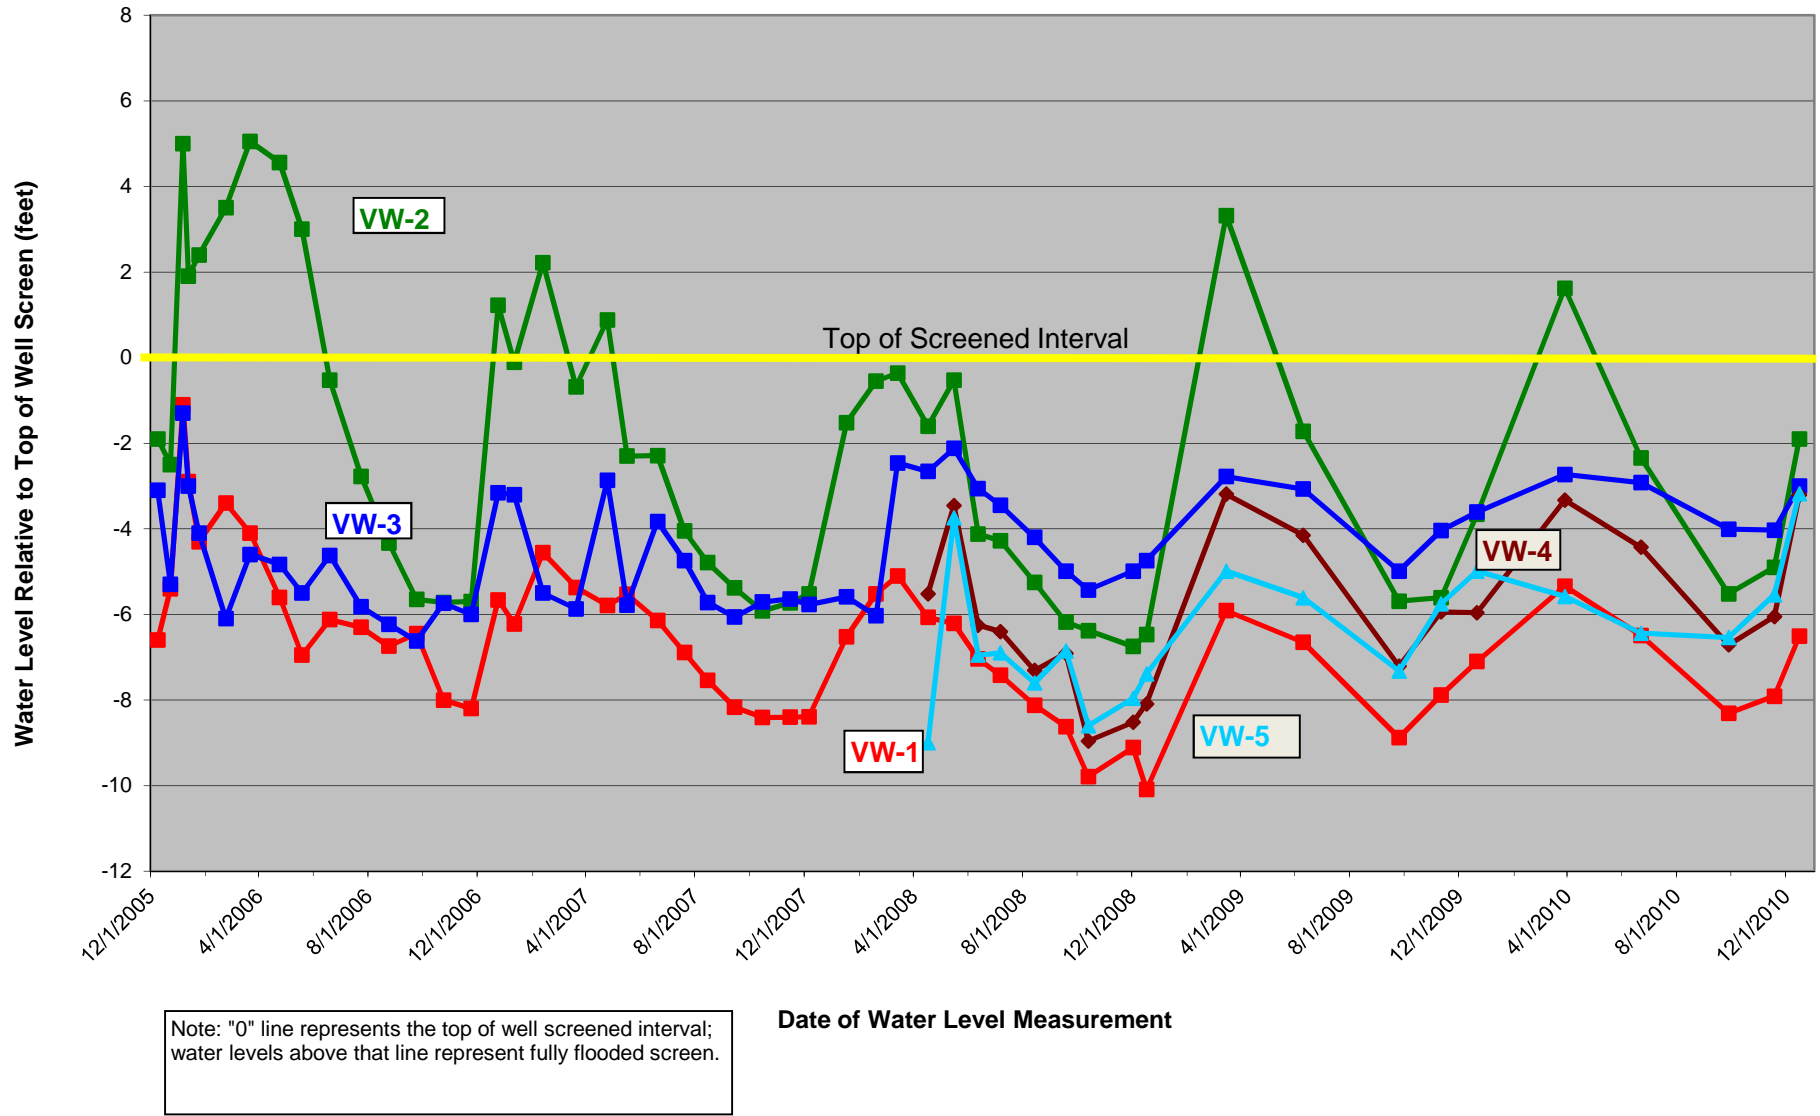
**Figure 6 - Historical Groundwater Levels Relative to Top of VW Screened Intervals  
Redwood Regional Park Service Yard - Oakland, California**

- Figure 6 shows groundwater levels in VWs relative to the top of the screened interval. In general, the screen in VW-2 has historically been fully flooded during the March monitoring event but is below the screen during the next monitoring event in June. Water levels in VW-1, VW-4, and VW-5 have been below the screen intervals since installation in 2005 and 2008, respectively.

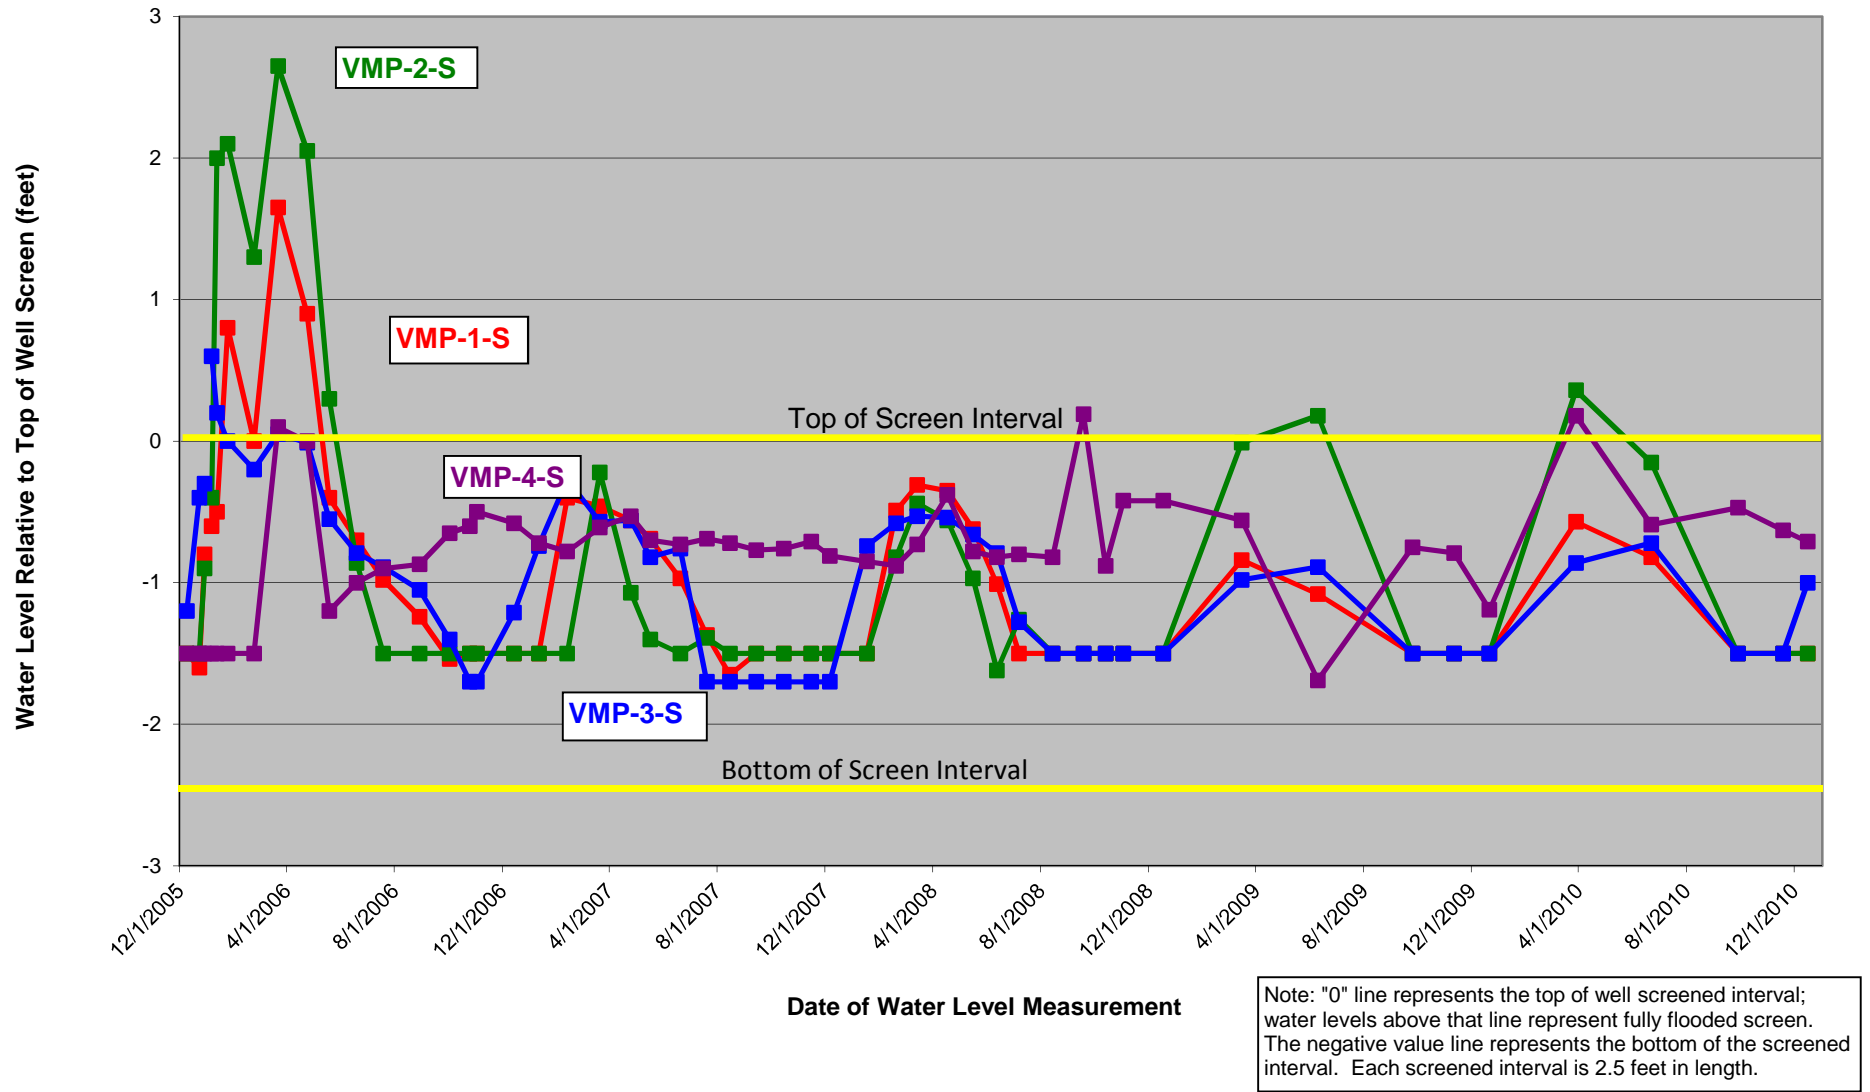
**Figure 7 - Historical Groundwater Levels Relative to Top of Shallow VMP Screened Intervals  
Redwood Regional Park Service Yard - Oakland, California**

- As shown on Figure 7, groundwater levels in the shallow VMPs have fluctuated slightly since March 2006. VMPs 1 and 3 have remained below the interval since May 2006. VMP-2 was above the interval from March through June 2010, fell back below the interval until March 2009 and has since been sporadic with levels above the interval in March 2009 and March 2010. VMP-4-S was above the interval in September 2008 and March 2010, but has been below the screened interval in subsequent events.

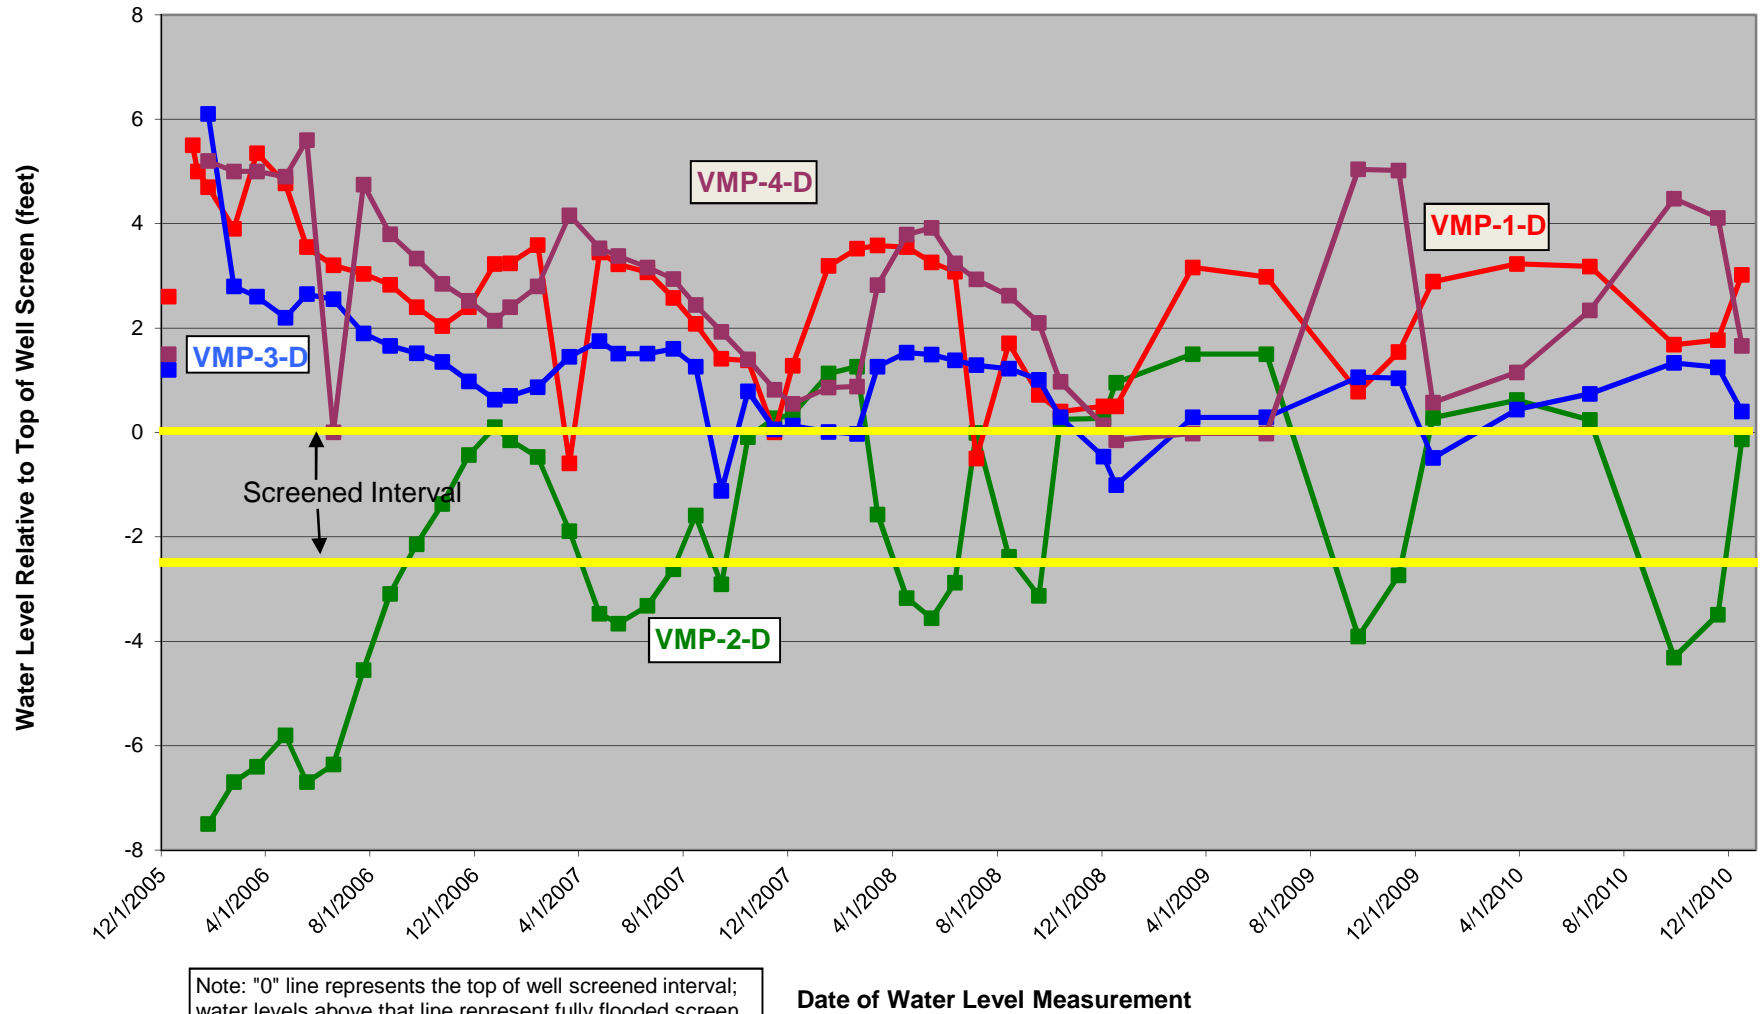
**Figure 8 - Historical Groundwater Levels Relative to Top of Deep VMP Screened Intervals  
Redwood Regional Park Service Yard - Oakland, California**

- As shown on Figure 8, water levels in deep VMPs have been relatively stable since the VMPs were installed, with VMP wells 1, 3, and 4 and 5 remaining almost constantly saturated. The exception is VMP-2-D, which has fluctuated above and below the screened interval since September 2006. In 2010, the water level was below the screened interval from approximately June to the latest event in December.

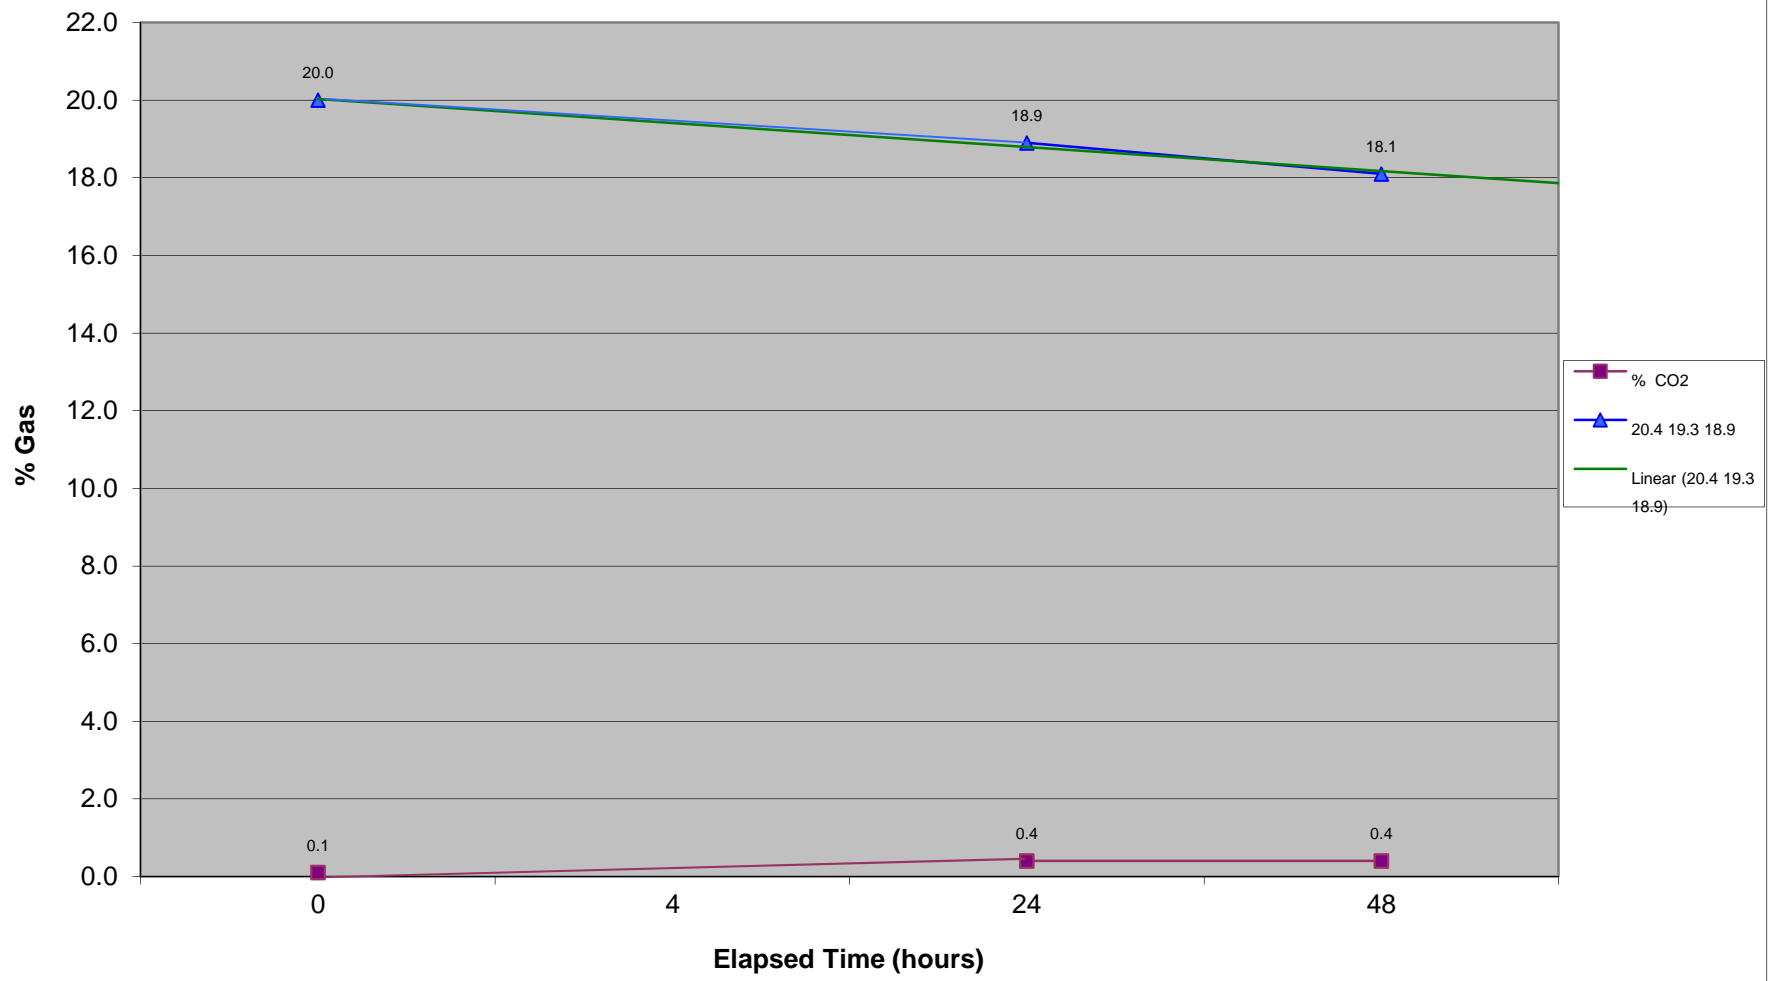
**Figure 9: Respiration Test - November 18-20, 2010**  
**VMP-2S O<sub>2</sub>-CO<sub>2</sub> Trend Plot**  
**Redwood Regional Park Service Yard, Oakland, CA**

VMP-2s and 2d and, to a lesser extent, VMP-1s and 1d showed a marginal decrease in oxygen that indicates some microbial activity (oxygen utilization) but basically the operation of the bioventing system has worked to reduce hydrocarbons in this contaminate zone area and there is less residual hydrocarbons for microbial activity. The position of VMP-2 (nearly midway between the two vent wells) and its relatively higher elevation likely resulted in increased aeration and microbial activity at this point. The VMP-2S respiration test results, as shown in Table 2 below, shows a significant reduction in oxygen utilization, CO2 respiration and PID maximum concentrations between 2006 and 2010, although the air delivery has remained constant, indicating a real reduction in hydrocarbons has been achieved. This reduction is supported with the PID readings at VMP-2, which have decreased between 2006 and 2010.

The respiration test results for 2010 with its marginal oxygen utilization, reflecting the drop in residual hydrocarbons and corroborated by the lower PID readings compared to previous years. The maximum oxygen utilization within the first 24 hours in the 2010 test—at well VMP-2S—is just 0.9 percent. This value is lower than the 1.9, 3.6, 5.8 and 6.1 percent oxygen utilization within the first 24 hours exhibited in the 2009, 2008, 2007, and 2006 respiration tests, respectively. The same decreasing utilizing trend occurred in the 48-hour measurement where the oxygen utilization was 2.1 percent in 2009, 6.5 percent in 2008, 11.0 percent in 2007, and 11.1 percent in 2006. Ideally, in the absence of additional hydrocarbon input from residual hydrocarbons entrained in the upgradient soil sources, the oxygen utilization rate decrease reflects a reduction in hydrocarbon mass over time.

The 2010 year data, using the above assumptions, shows an oxygen utilization rate of 0.9 percent of oxygen per day would correspond to a biodegradation rate of approximately 0.2 milligrams per kilogram (mg/kg) per day, or 73 mg/kg per year. This shows the trend of decreasing utilization rates since 2006. During the initial respiration test in 2006, it was found that by using the initial average TPH concentration in soil of 6,000 mg/kg (based on the average of the soil samples from the source area), the oxygen utilization was 6.1 mg/kg per day, or 1,496 mg/kg per year, which was the basis for the estimate of 4-5 years of remediation. These respiration test calculations suggest that in the area of VMP-2, the bioventing has been pretty effective in reducing the hydrocarbons in soil, but also that its operation has reached diminishing returns for contaminant mass reduction.

The recent test results at VW-2 suggest we have reached the limits of the bioventing system use; therefore, Stellar Environmental recommends the system should be shut down for six months. At that point a rebound test should be completed to see if pulsing the bioventing system would provide better efficiency. If no additional benefit is observed, the bioventing system should be decommissioned. The bioventing system is considered to have been as effective as it can be, given its effectiveness within a part of the hydrocarbon contaminated zone and lithologic constraints the limits its effectiveness in other parts of the contaminated zone. In 2011, we recommend it be turned on and monitored after the six month shut-down in June/July 2011 to see if any rebound has occurred.
