DATE: September 15, 1989  
PROJECT Plaza Car Wash  
SCI JOB NUMBER: 549.001

Surface Water Contamination Mitigation

September 15, 1989  
SCI 549.001

Consultation  
Surface Water Contamination Mitigation  
Plaza Car Wash  
400 San Pablo Avenue  
Albany, California

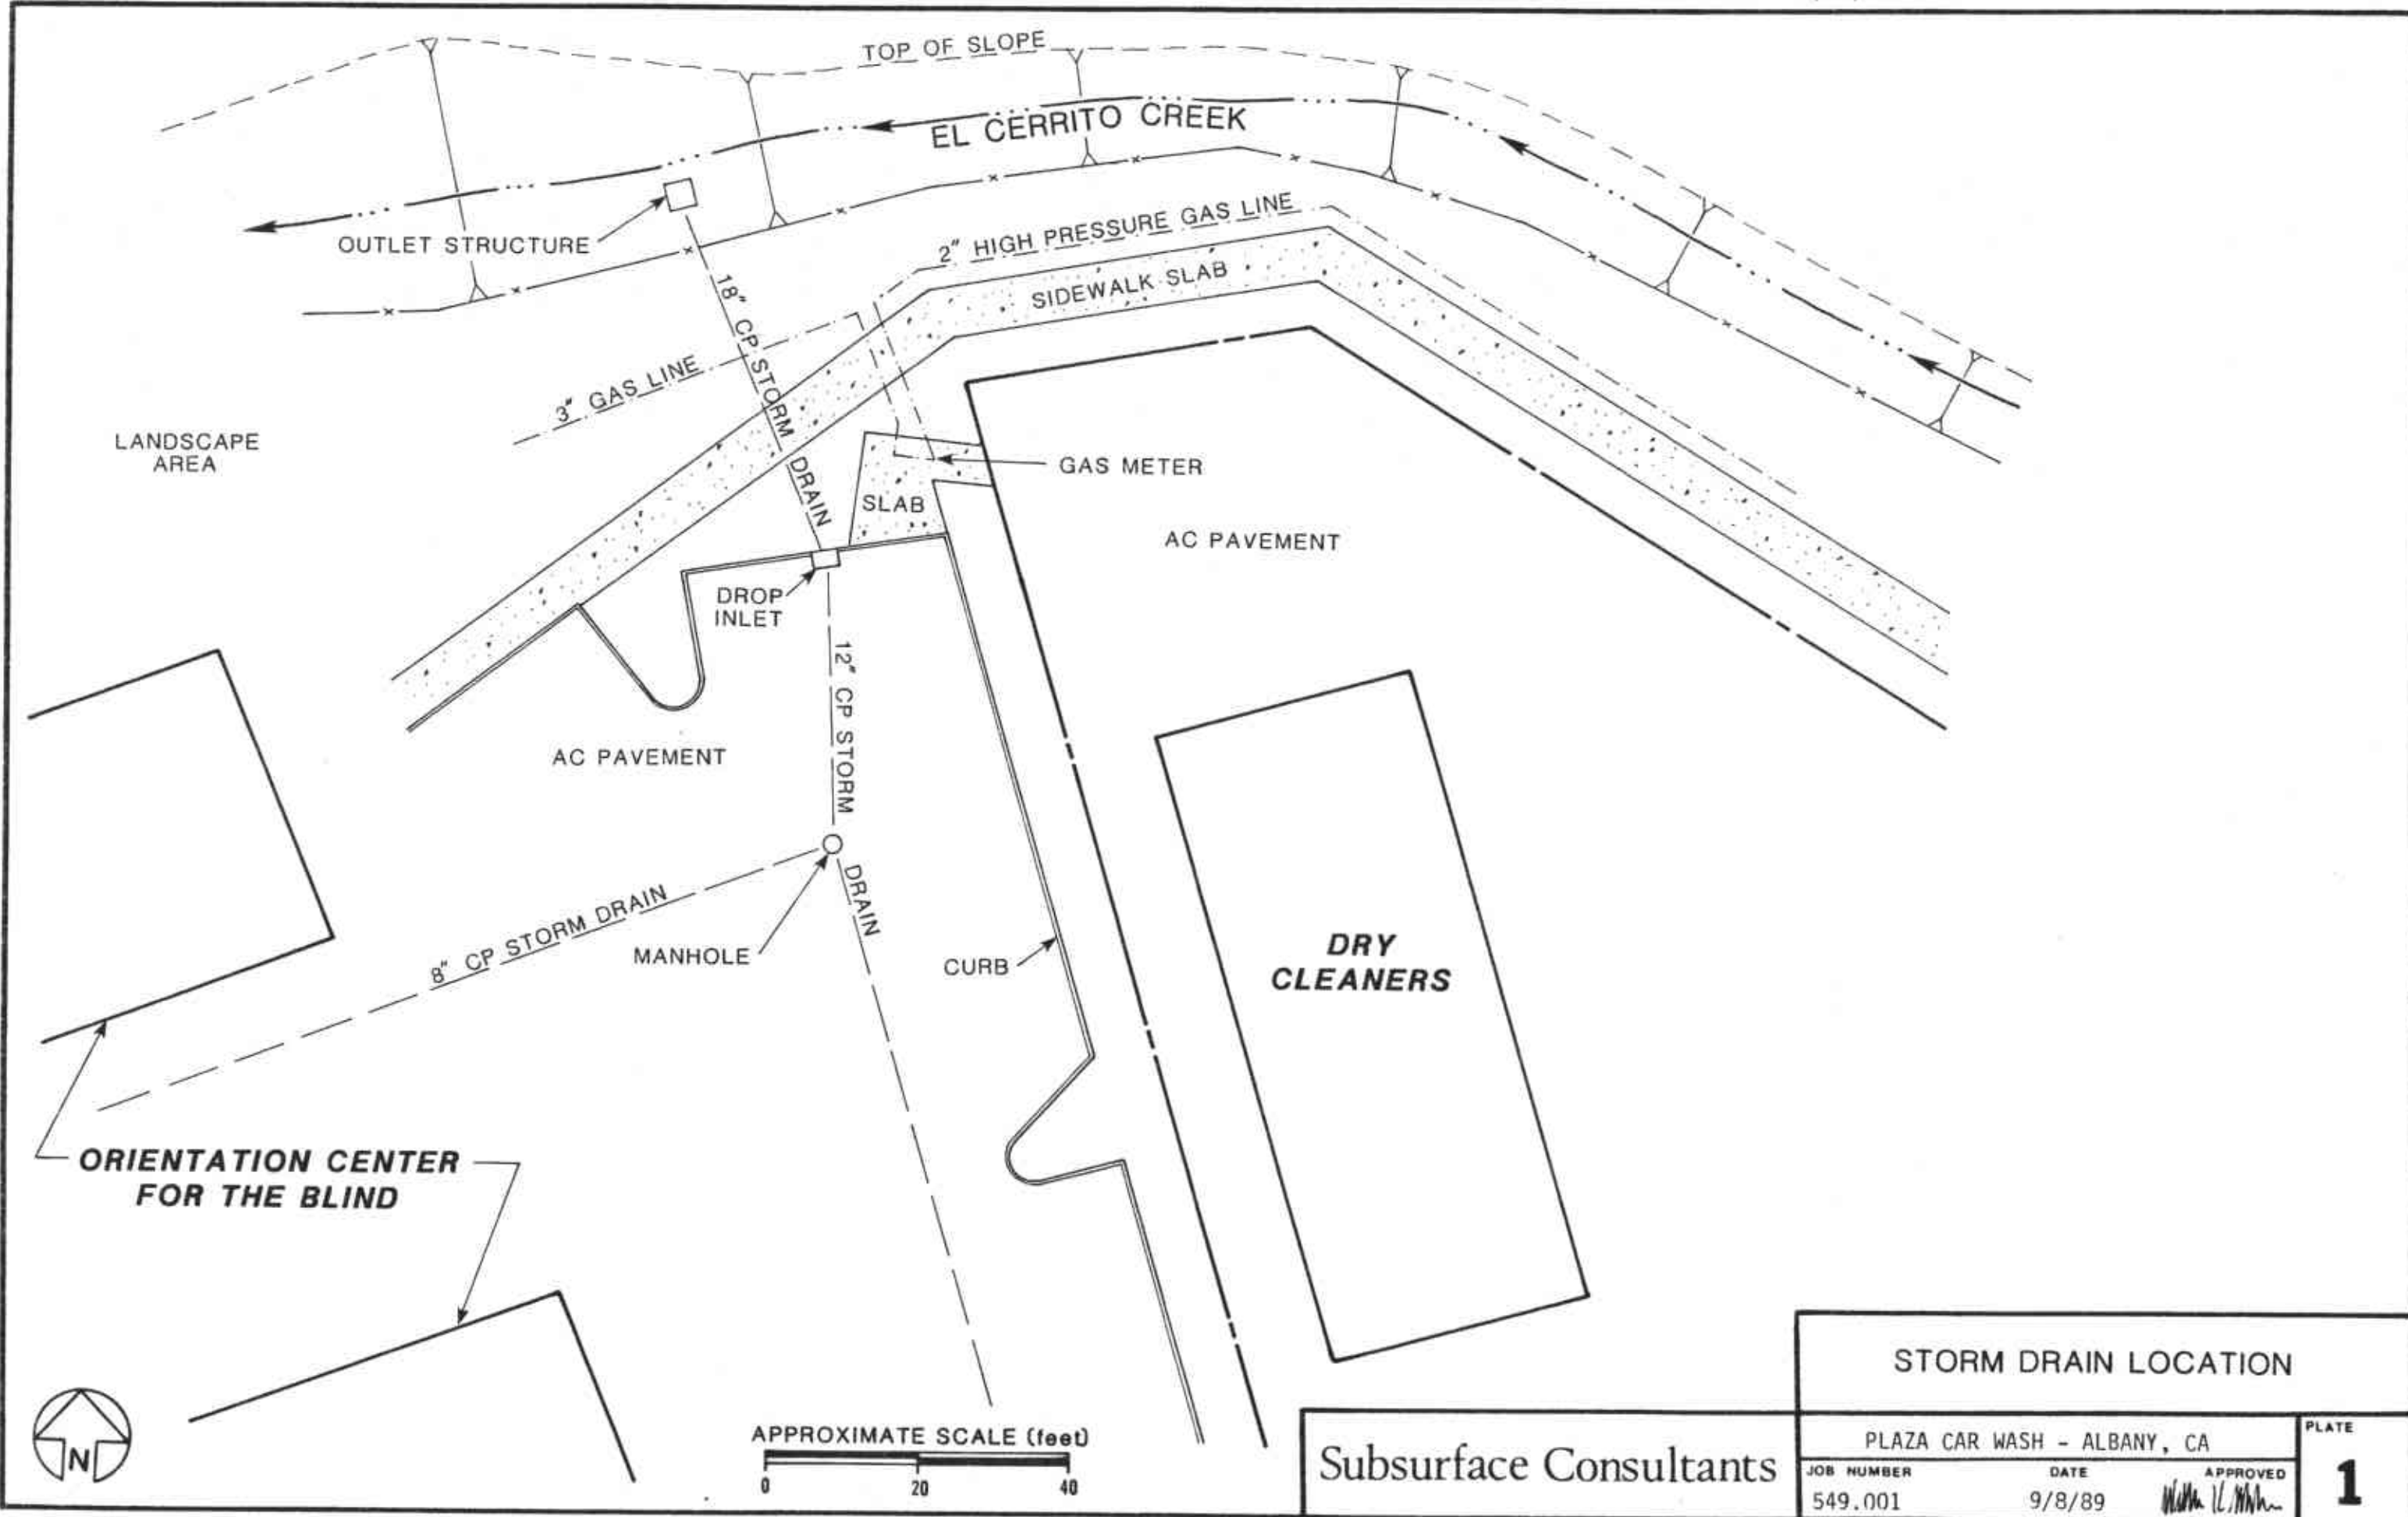
<b>STORM DRAIN LOCATION</b>		
PLAZA CAR WASH - ALBANY, CA		
JOB NUMBER	DATE	APPROVED
549.001	9/8/89	<i>[Signature]</i>
		<b>PLATE 1</b>

Based upon groundwater level measurements from monitoring wells that have been installed at the site, the direction of groundwater flow is about south 65 to 80 degrees west with about a 1 percent gradient. The approximate storm drain location is shown on Plate 1; it is about 2 feet below the groundwater level encountered in the monitoring wells. Storm drains are often constructed with relatively permeable backfill and with unsealed joints. It is likely that the storm drain is acting as a subsurface drain, lowering the groundwater level in the area. We judge that the contaminated groundwater is also flowing toward the stormdrain, entering through joints and exiting into El Cerrito Creek.

Based upon the results of a recently completed soil gas study, contaminated soil/water appears to be located along the north about 60 feet of the storm drain. We understand that the Albany Fire Department viewed the storm drain interior using a video camera. Product was only observed to enter the storm drain north of the manhole, which is located about 90 feet from the creek. Based upon the soil gas and video studies, we judge that contaminated water does not appear to be entering the storm drain south of the manhole.

In order to mitigate the discharge of free and dissolved product into El Cerrito Creek, we recommend that the storm drain joints be sealed so that subsurface water cannot enter. We judge that the Cues Joint Sealing System described in the attached brochure is an acceptable method for sealing the joints.

We understand that the joints will be sealed starting Tuesday, September 19, 1989, by Pacific Pipeline Survey. The pipe will first be swabbed, then cleaned using high-pressure water spray. If contaminated soil is removed from the pipe, it will be stockpiled for later proper disposal. The pipe rinse water will be allowed to flow into the creek after free product is removed. After cleaning, each pipeline joint north of the manhole will be injected with grout and tested for a tight seal. After construction, samples of water from the storm drain outlet should be analytically tested weekly for total volatile hydrocarbons (TVH). If no TVH is detected for at least 4 weeks, the sampling/testing intervals should be reduced to quarterly. If significant TVH is still detected, additional mitigations may be necessary.
