SITE CLOSURE REPORT

23rd Avenue Partners
1125 Miller Ave.
Oakland, California

October 3, 2002

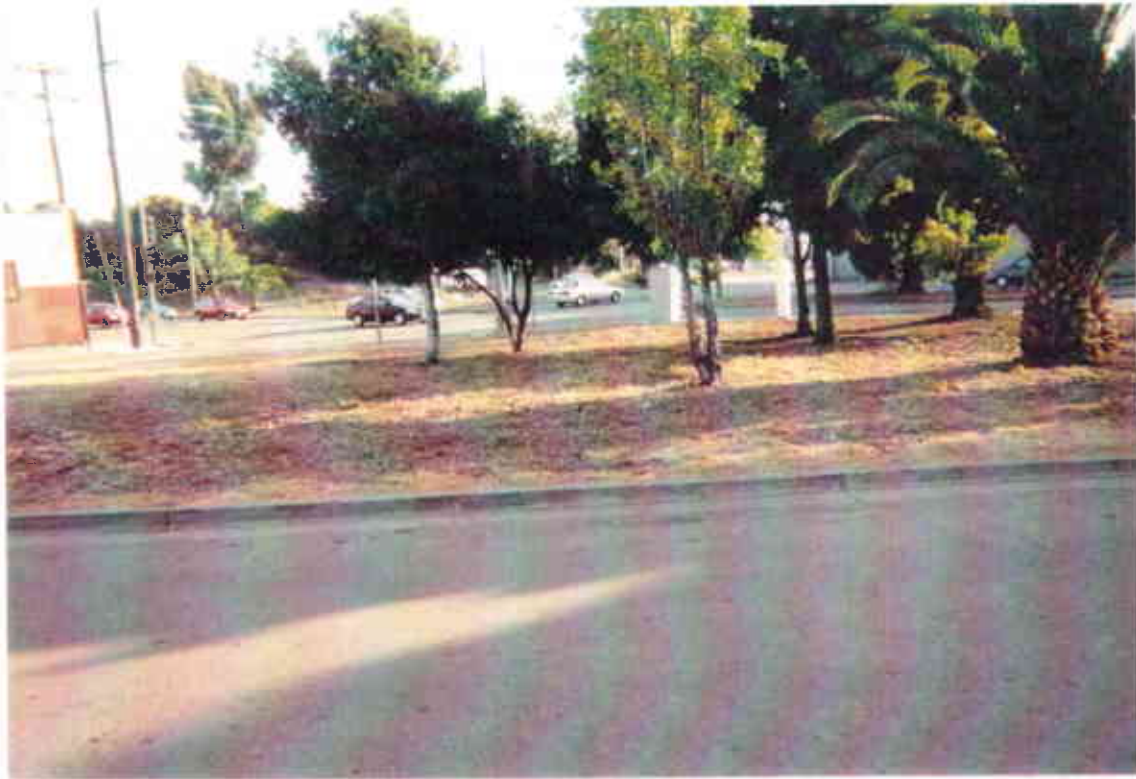
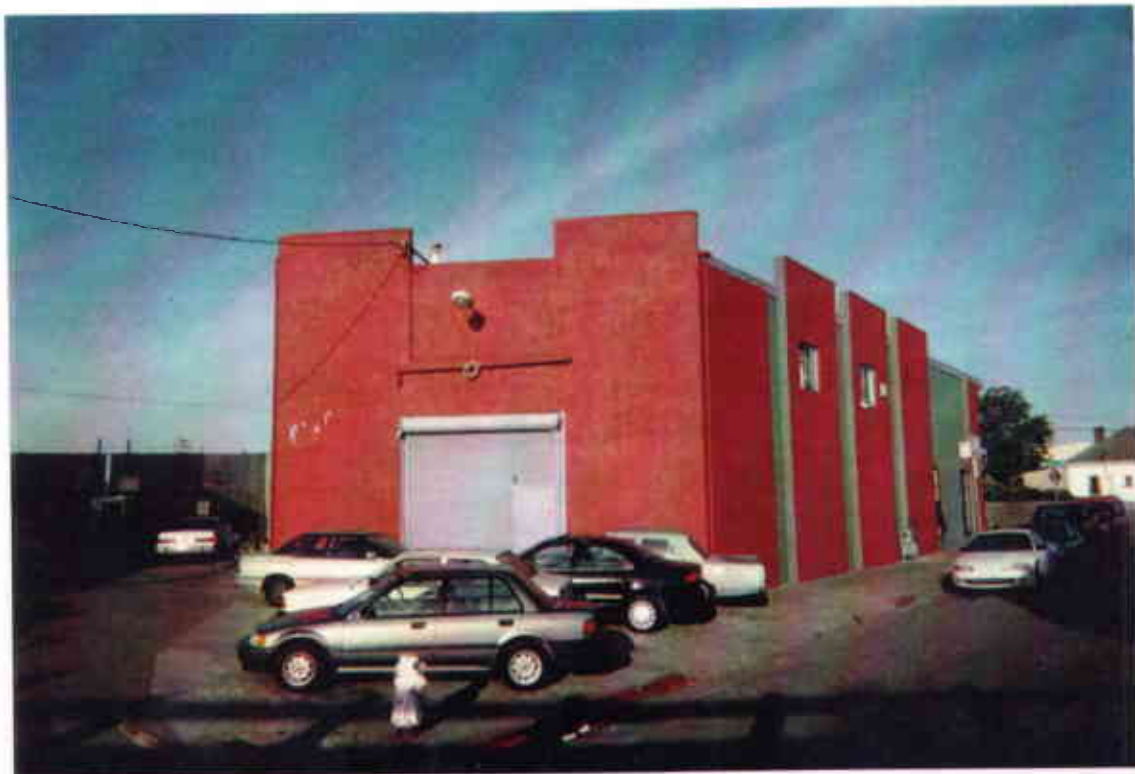
Top Photo: Looking southwest
Mini-park across East 11th Ave.
23rd Avenue in background (red cars)
Bottom Photo: Looking east
Hydrant and storm drain at bottom

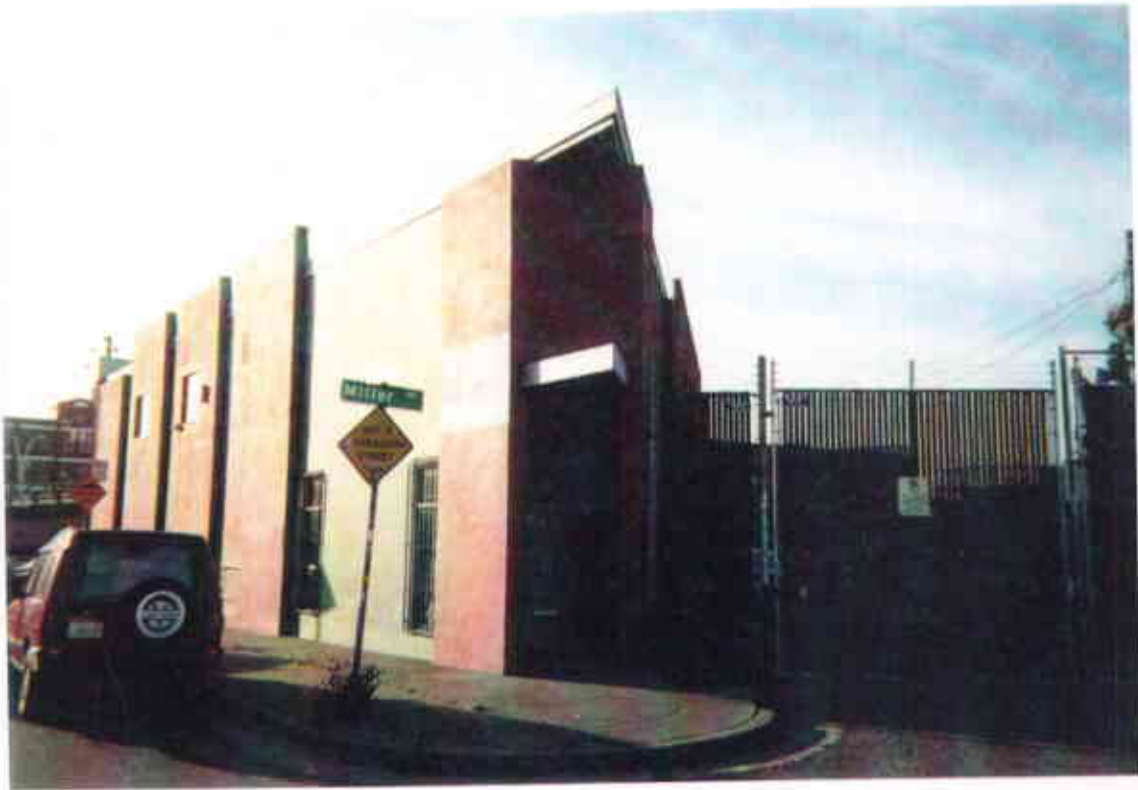
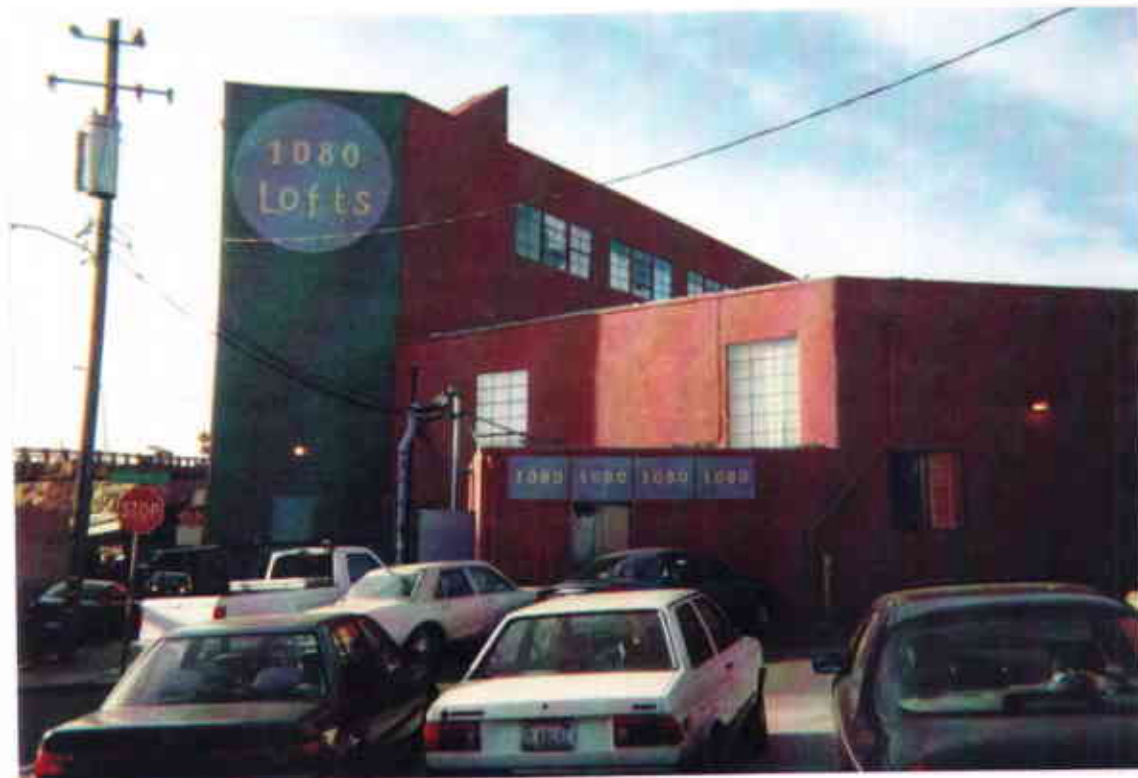
Top Photo: Left on E. 11th
right street: Miller Ave.
Building in center of photo.
Bottom Photo: Looking NE
across Miller Place to Lofts

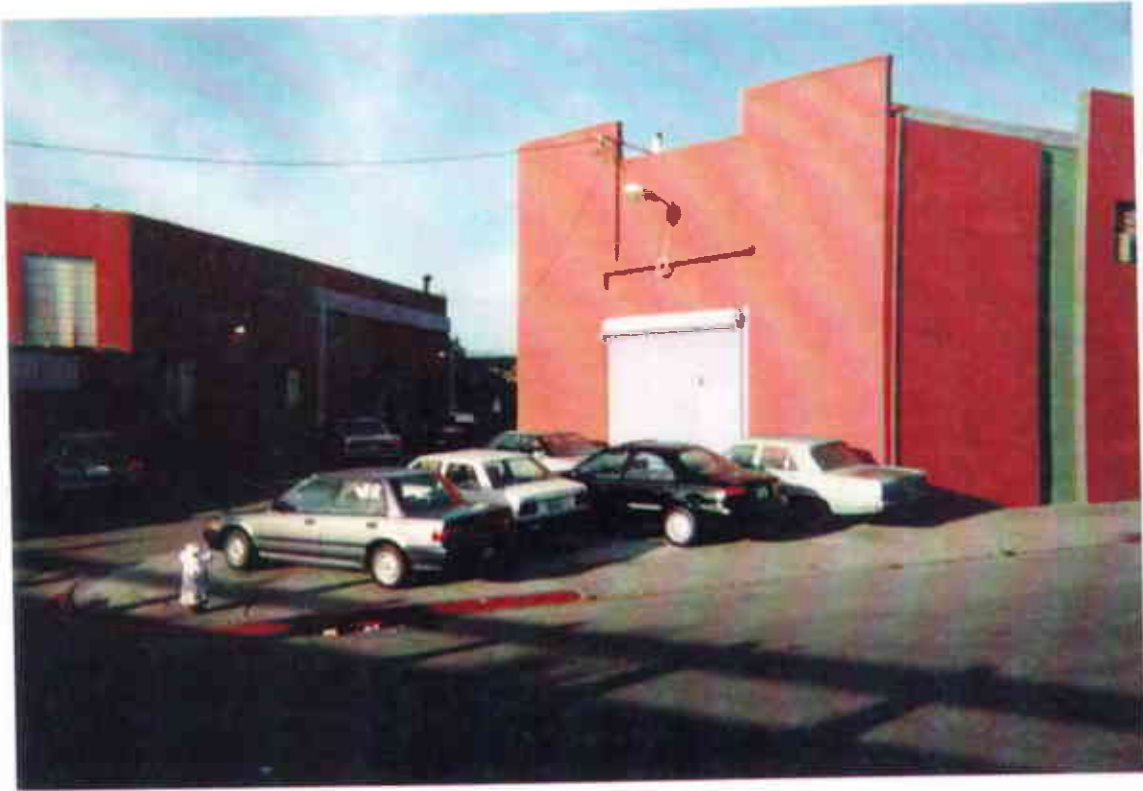
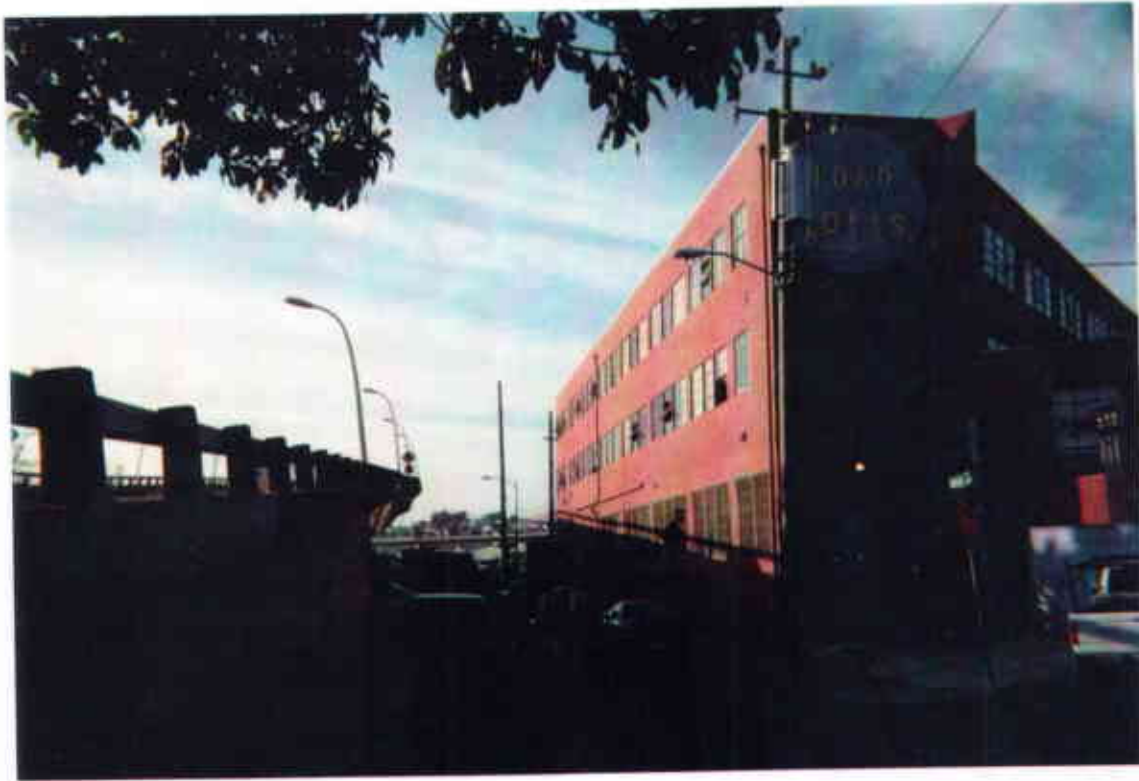
Top Photo: Looking southeast
Note white hydrant and storm drain.
Building in right of photo.
Bottom Photo: Looking north
23rd Ave. freeway ramp on left
