RE: Low Risk Fuel Site Evaluation
Former Chevron Service Station #9-2582
7240 Dublin Boulevard
Dublin, California
WA Job #4-1232-83

Figure 1. Ground Water Elevation Contour Map - June 27, 1996 - Former Chevron Service Station # 9-2582 - 7240 Dublin Blvd., Dublin, California

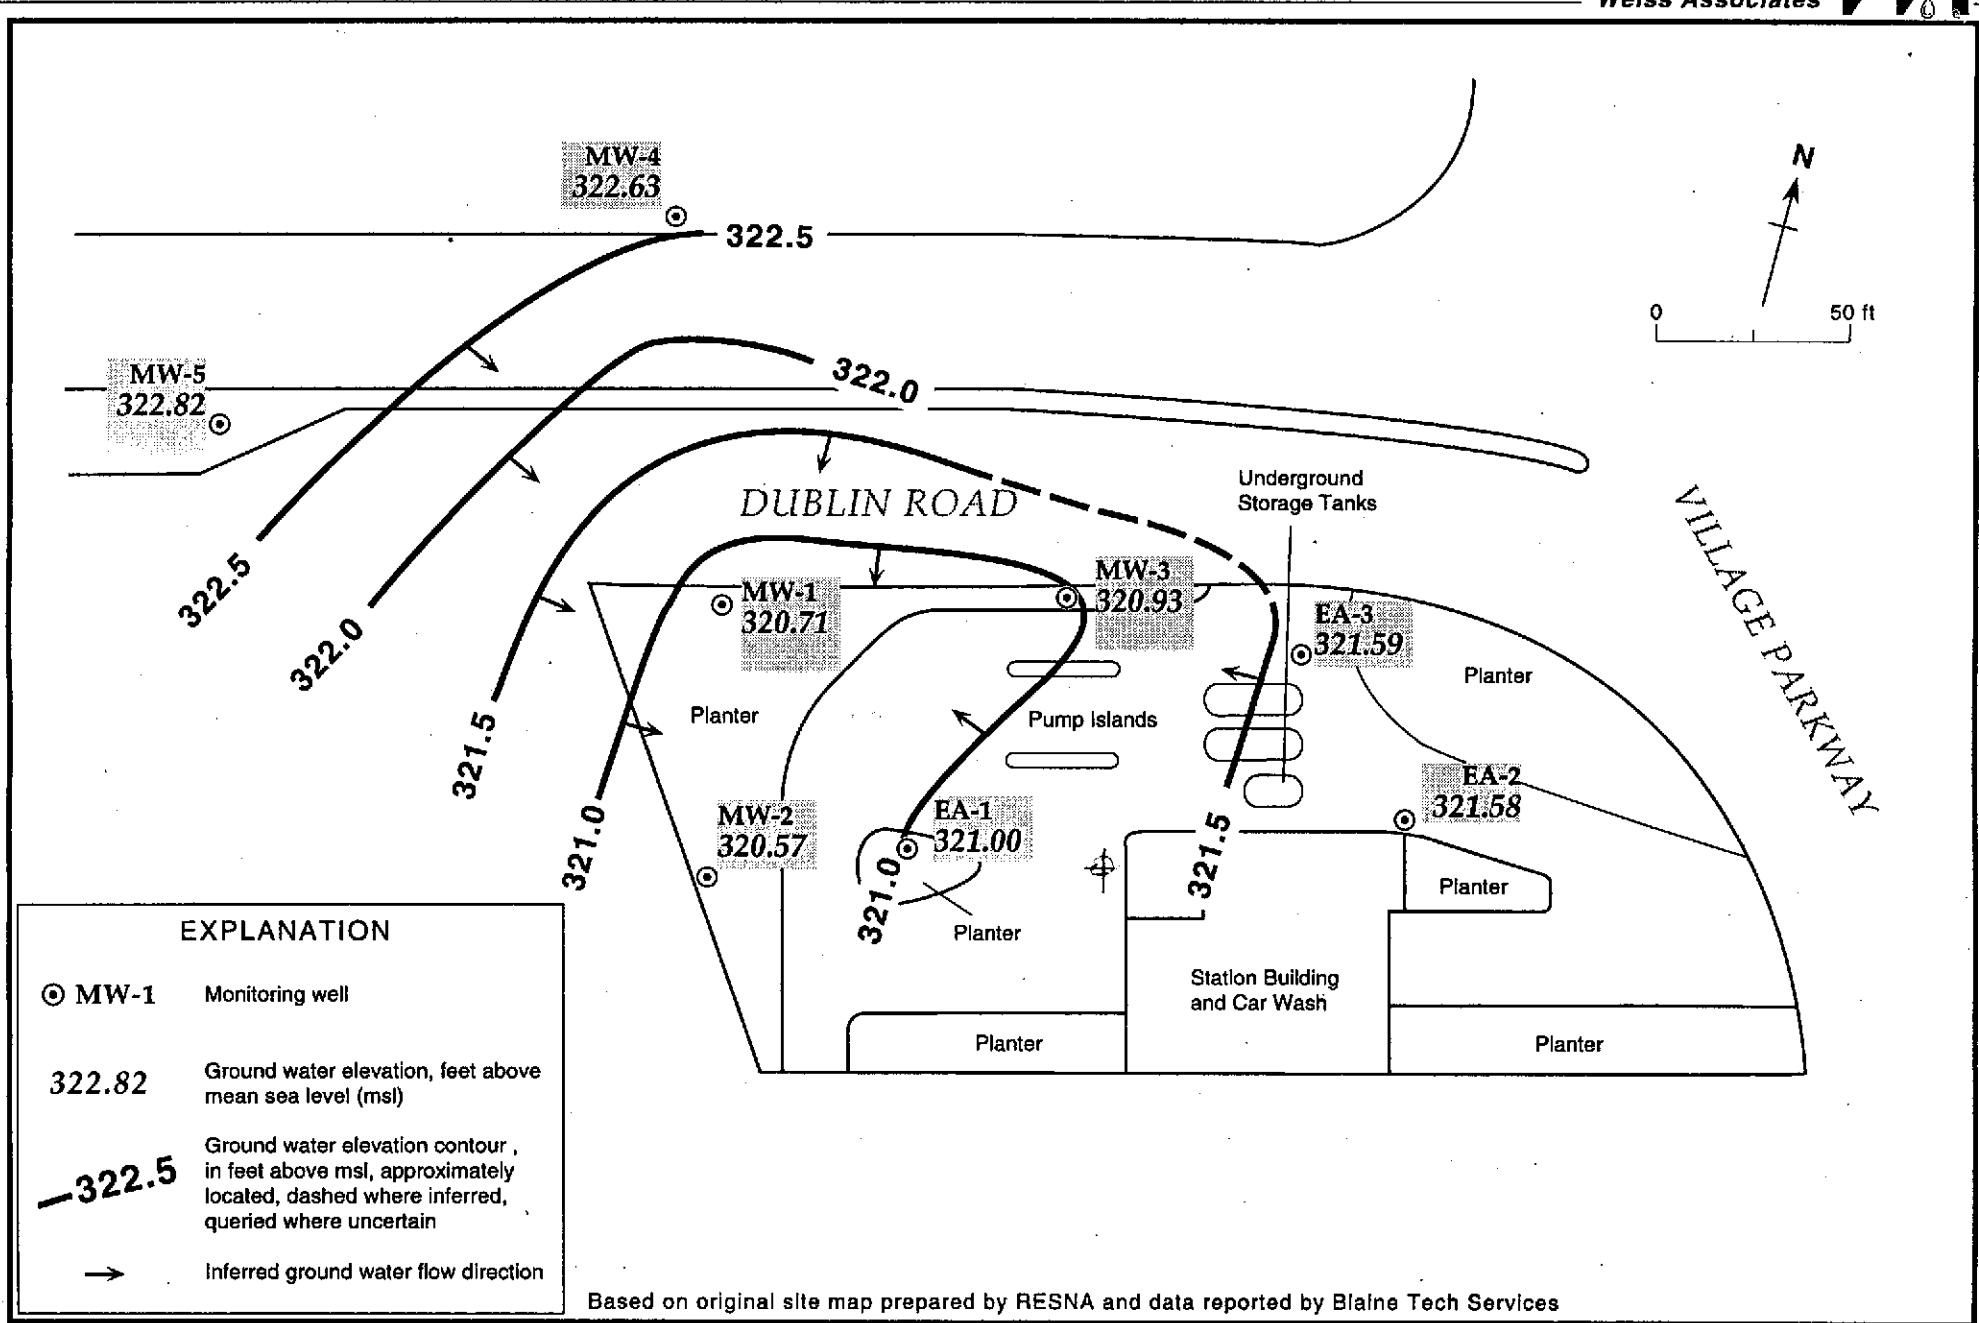
flows south to southeastward north of the property and west to northwestward on the property since February 1996 when two new monitoring wells were installed (Figure 1). *very flat gradient*

Prior to the installation of monitoring wells MW-4 and MW-5 in February, 1996, ground water elevation measurements indicated the plume gradient direction was towards the west and northwest and relatively flat. Inclusion of ground water elevation data from monitoring wells MW-4 and MW-5 indicates that the plume gradient direction is towards the southeast with a gradient of approximately 0.02 feet/foot upgradient of the site and approximately 0.007 feet/foot on the site. The southeast ground water flow direction is consistent with the regional ground water flow direction reported by the Zone 7 Water Agency.

- Install a monitoring well along the southern property line near the southwestern corner of the station building to better define the down gradient extent of the dissolved hydrocarbon plume.
- Continue ground water monitoring as summarized in the following table to evaluate the apparent increasing dissolved concentrations in well EA-1 and to confirm that dissolved concentrations in MW-2 are continuing to decrease.
