Preliminary Site Assessment

Phase I (Modified)

Cal Mac Transportation Co

June 7, 2006

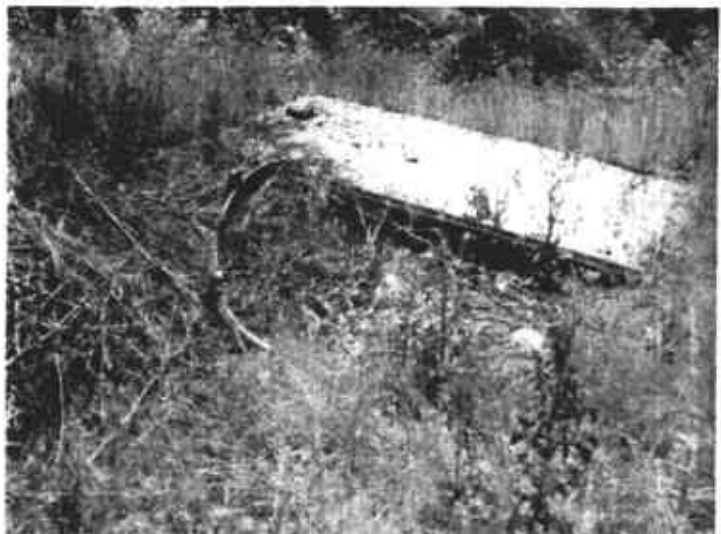
Picture 1.

Depression may have been caused by movement of T-3, the 40 foot long truck body that now lies to the east. There are no signs of petroleum contamination or other visible indicators of potential hazards. The 1995 report tested the soil reportedly at this location and found levels to be below action criteria.

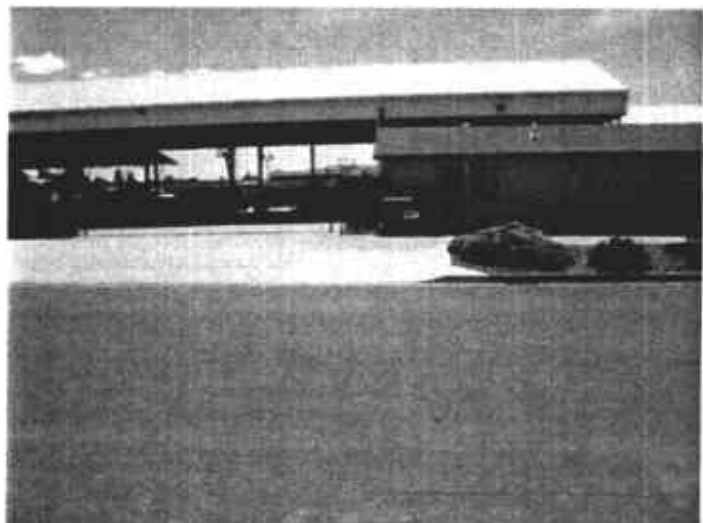
Picture 3. Across the street on McGraw (west end) is a metal fabrication company that builds re-bar structures for use in concrete forming. There is minimal employee exposure. There are no signs of any contamination due to wind blown or runoff that could affect this site.

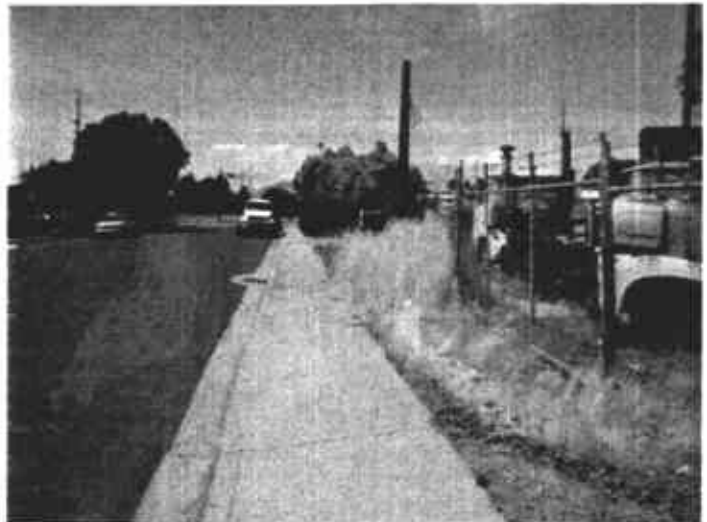
Picture 4. Entrance gate on right looking towards north with Olympic boat sales yard is located towards center right of trees. Interviews with Sales Manager and yard employees have indicated no odd odors or other noticeable work practices that have affected the boat yard. There are no signs of runoff or contamination along the north fence boundary.

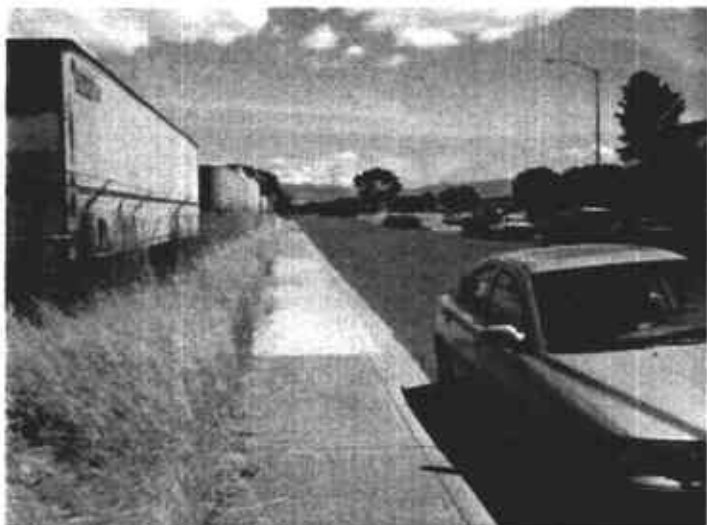
Picture 5. View towards south on McGraw. There is approximately 800' of frontage separated by a 4 foot grass strip. There are no signs of contamination or runoff staining along fence line on grass or in street.

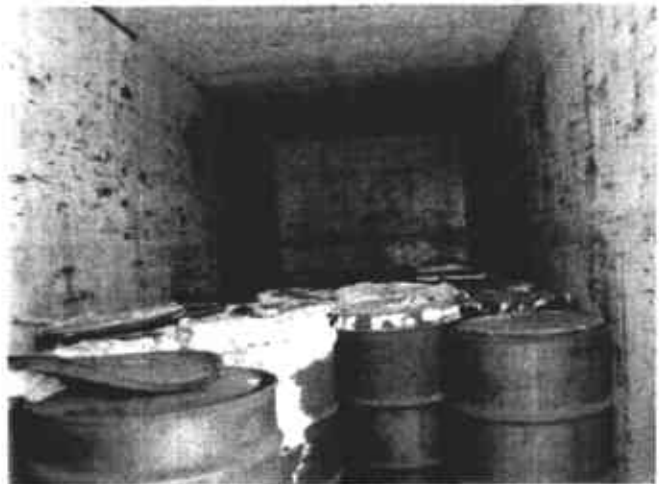
Picture 6. Thirty five drums that most likely contain spent caustic soda. This inorganic powder when used in solution can be used as a parts dipping compound. Remedy is testing for TTLC metals and VOC's that may have contaminated the now dried solution. It will be necessary to positively identify that this material is indeed caustic soda.

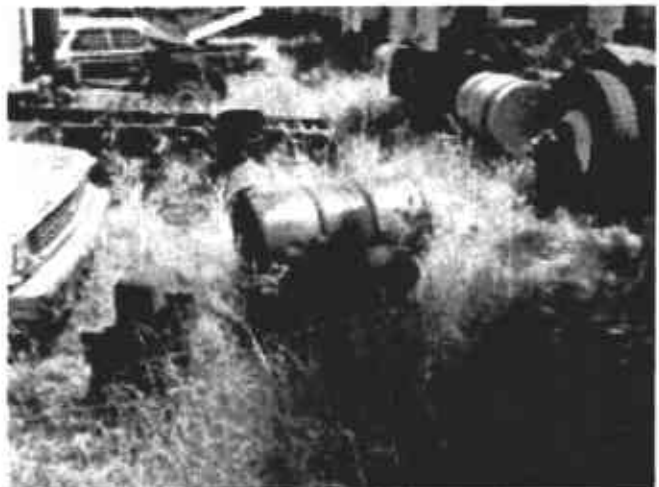
Picture 7. Miscellaneous metal 55-gallon drums are found in many areas throughout the yard. All seem to be free of hazardous materials as no liquid or solid residue could be seen. Many of the drums did contain trash and should be carefully emptied in case a hidden hazard may be present.

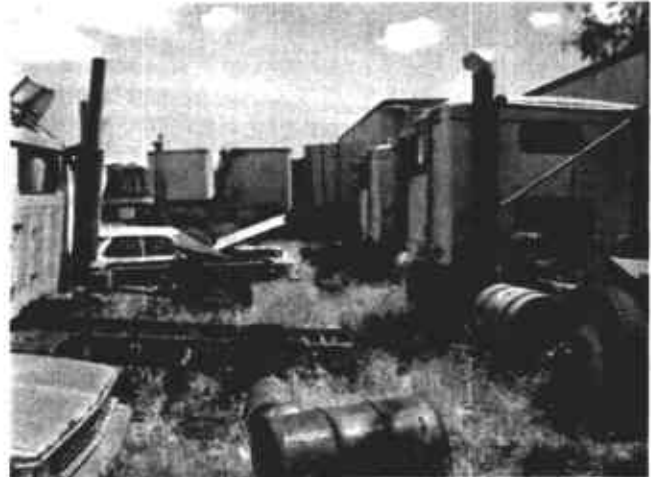
Picture 8. Photo demonstrates typical section of yard with tractor trucks, trailers, cars, and empty containers found in various states of disrepair.

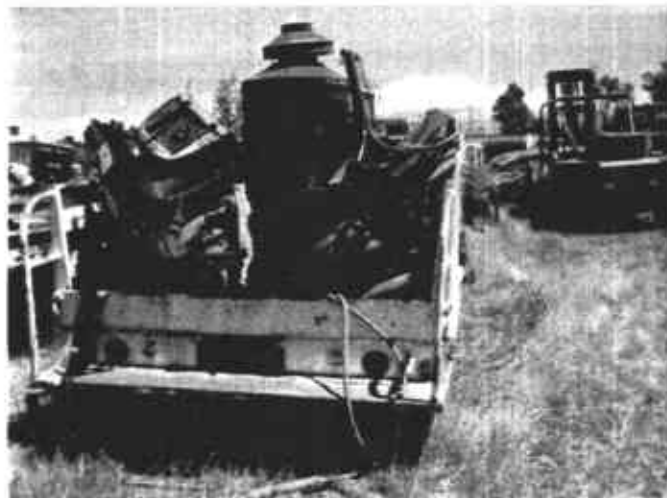
Picture 10. Vehicle filled with tires, old water heater, car seats, etc. This water heater/ boiler (?) may contain asbestos and should probably be sampled prior to removal as scrap metal. Tires are regulated and need to be handled by a registered tire transporter, etc.

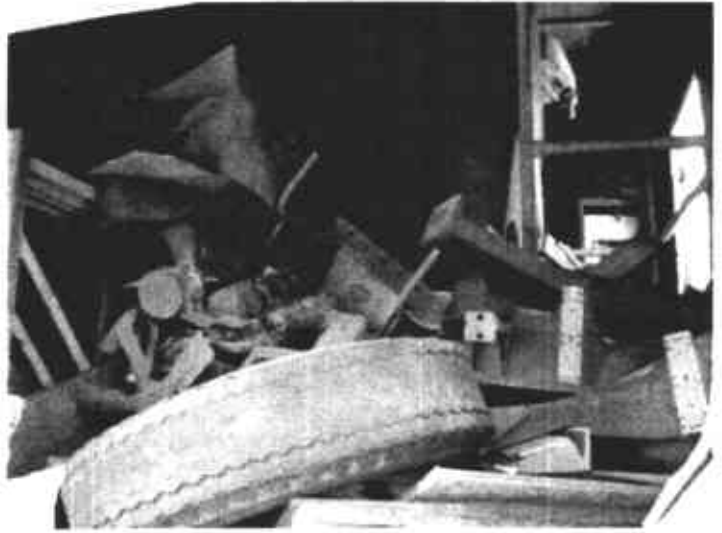
Picture 11. Trash is found in many of the containers. Some with mixed waste types such as tires, small gas cans, aerosols cans, and universal waste/ e-waste.

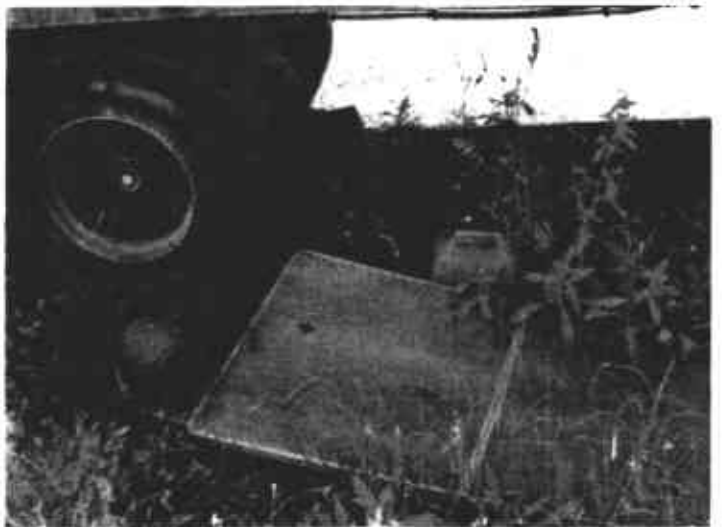
Picture 12. Small gas cans are found in trailers and on soil. They all seem to be empty and there does not appear to be any indication of spills to ground.

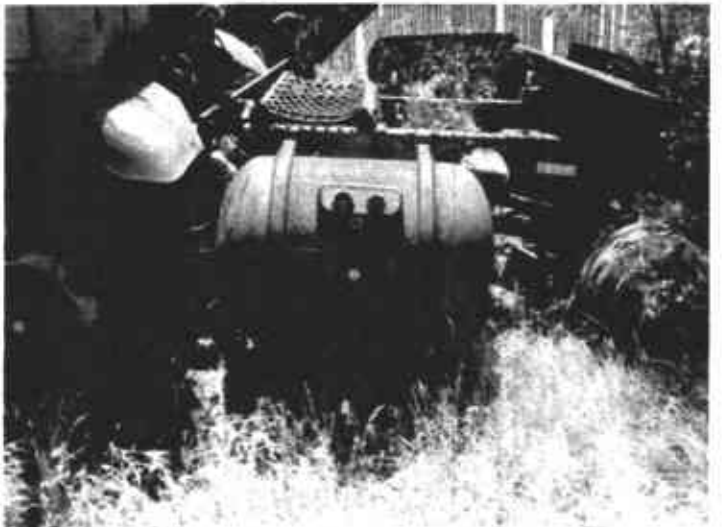
Picture 13. There appears to be about 10 tanks with propane on site. Some tanks have been removed from trucks, but all appear to be empty. Scrap metal companies such as Adams Steel, Anaheim, CA have contracts with cylinder companies to safely and economically remove contents and handle propane cylinders as scrap metal. Since the propane is re-used as propane, this cylinder and its contents are exempt from solid waste laws and are not regulated.

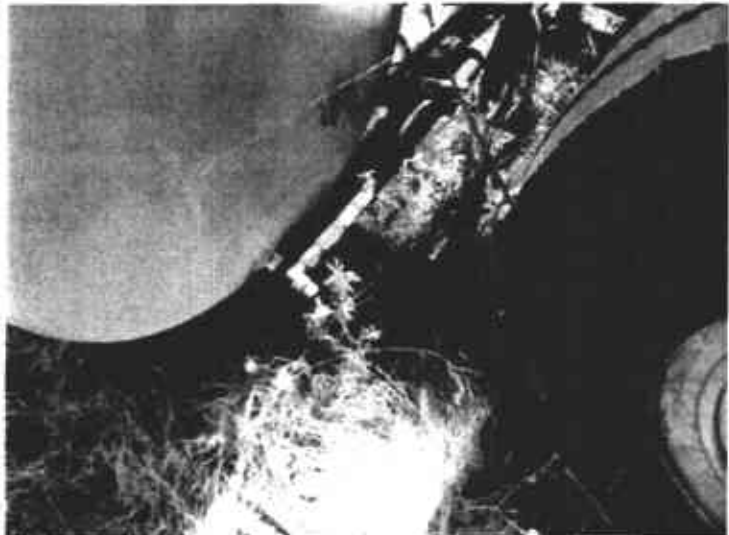
Although many trucks have had the fuel tanks removed or have plugs missing, there does appear to be significant fuel or oil spills underneath the vehicles. Many, if not all of the trucks, including ones with fuel tank holes have some trace residual fuel. Some trucks have full fuel tanks.

Picture 14. The tank holes appear to be due to missing tank connections that balance fuel levels between left and right tanks. Signs appear that spills are found under trucks with tank holes. These were obscured when trucks were in place, but now that they have been moved, it is apparent that many of the trucks have left spills.

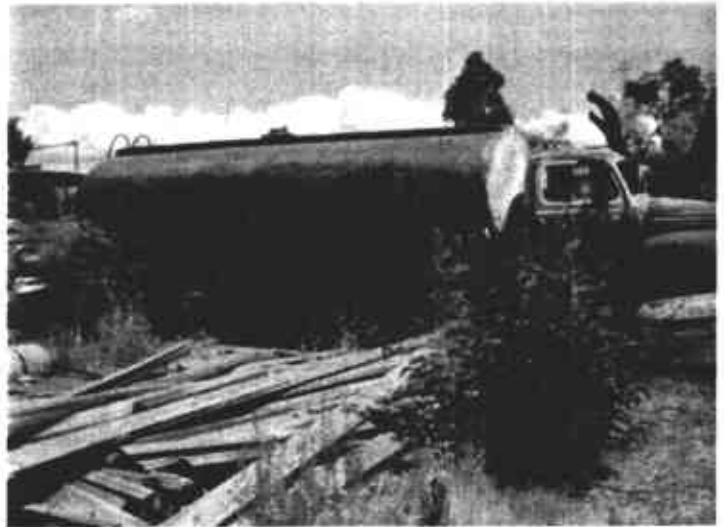
Picture 11. Fuel Tanker did not appear to have any free liquids inside. Inside tank walls were rusted and had dust coating. This tank and others may need hot pressure washing to remove residues if present. Water will need to be captured and tested prior to reclamation or disposal.

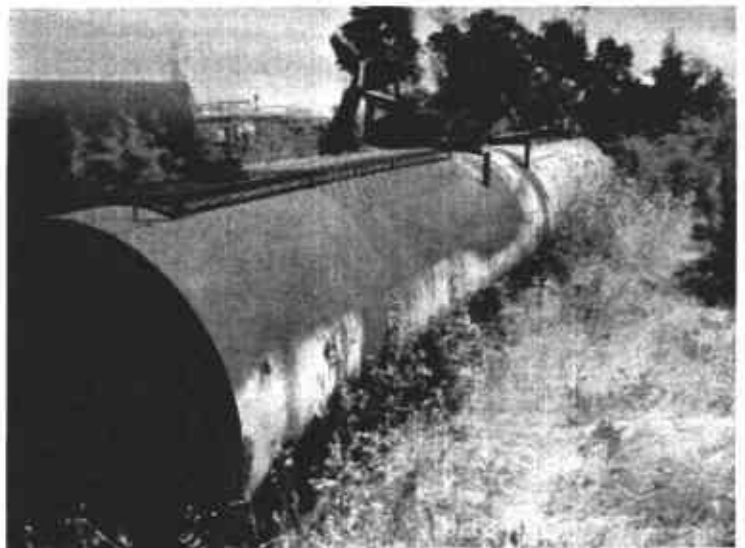
Picture 12. Tank T-3 was said to have been emptied as listed on the 1995 underground storage tank report. It is believed to have been moved since 2004 since its location does not match the aerial photo found on Google Earth.

Although difficult to see on copy, Picture 2 has tank on right center running parallel to property south side. Google photo is presumed to have been taken in circa 2004.

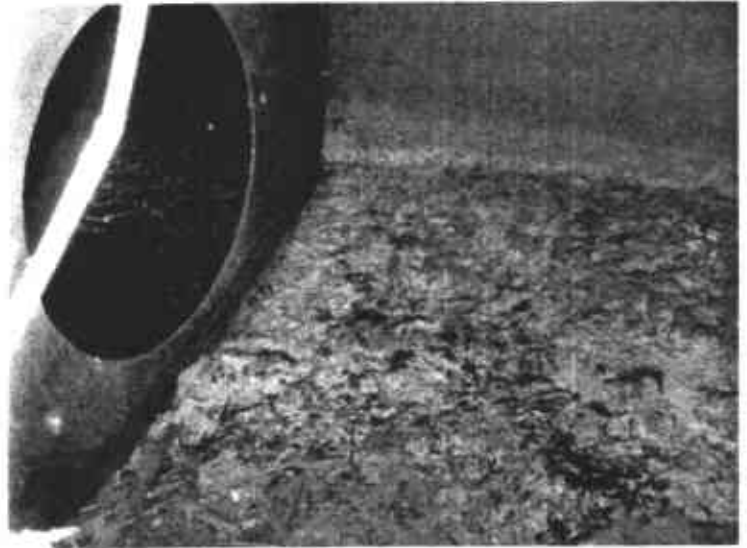
Picture 13. Contents of T-3. Open hole on top has presumably let rainwater mix with contents. Material has consistency of thick asphalt that separates when asphalt is pushed aside. Estimates of volume are 100 gallons of liquid with 300 gallons of solids. Decontamination of this tank would be very difficult and would most likely require permit confined space entry.

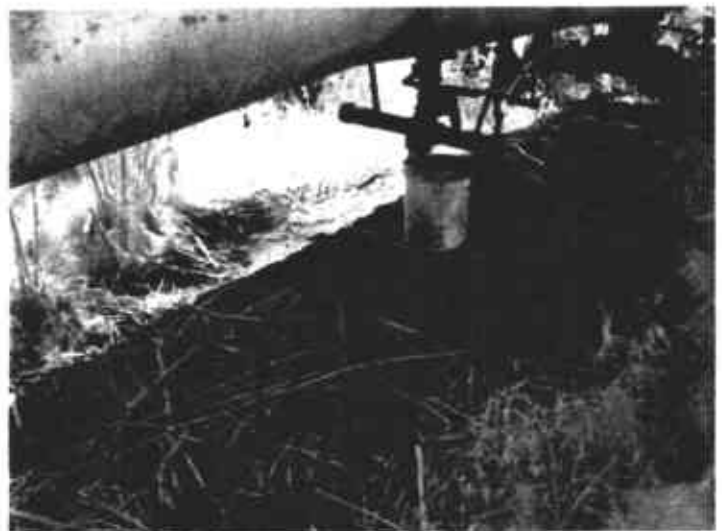
Picture 15. This asphalt tanker labeled as T-4 appears to be empty. There are obvious signs that the underlying soil has been contaminated by the asphalt (?).

Remedy sampled this site next to bucket. Soil is very discolored and dry. Ground has appearance of dried crushed asphalt.

This tank, unless it can be reused as an asphalt truck, will likely be classified as a portable tank but will still need decon if sampling indicates hazardous properties.

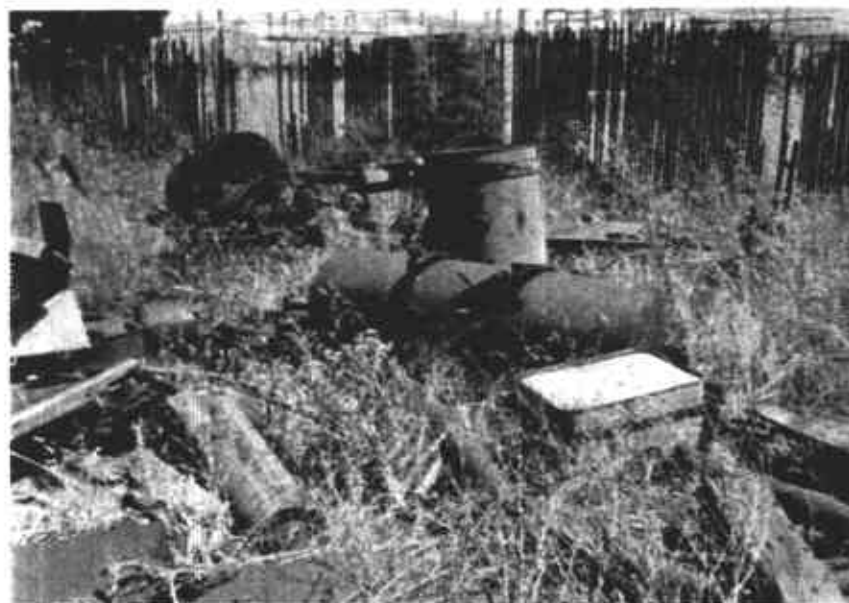
Picture 16. Drums with scrap metal and miscellaneous scrap items

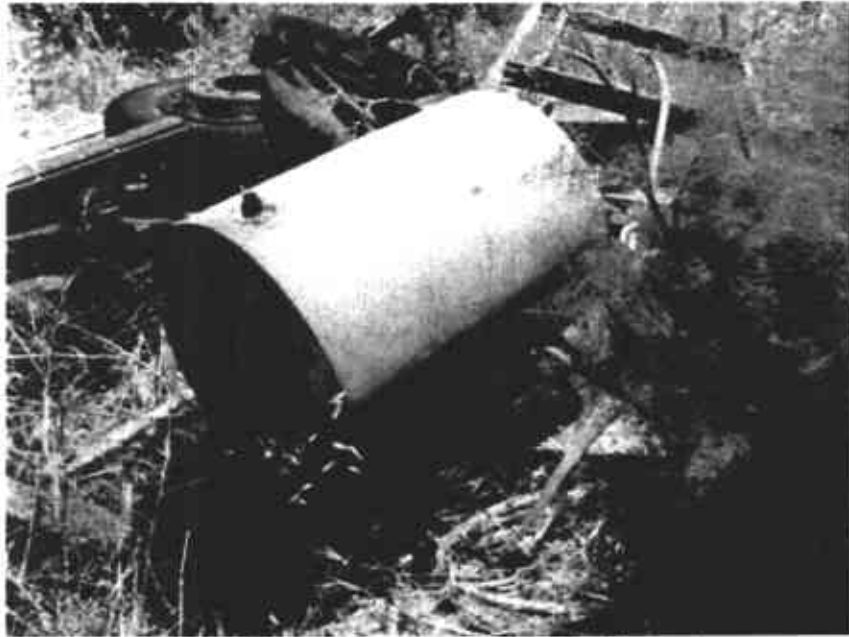
Picture 17. Miscellaneous scrap

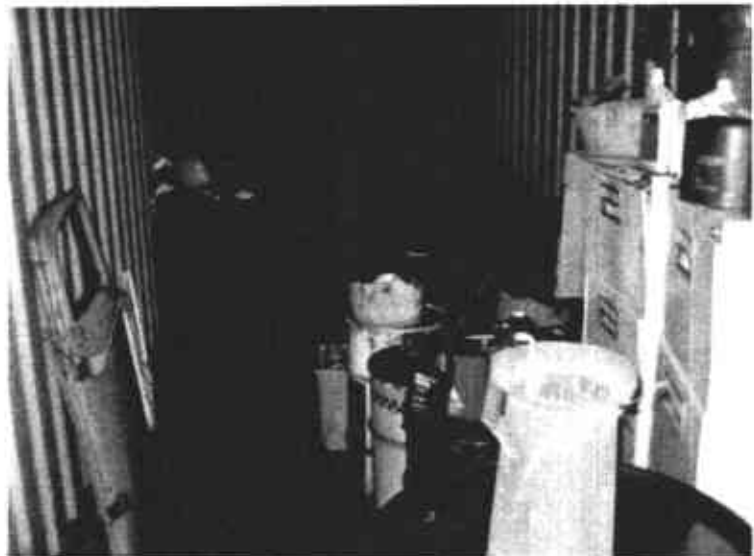
Picture 19. This is a photo of the 40-foot land sea container that was used for dispensing and storage of motor oil, fuels, soaps, filters and other automotive fluids. No spills to floor or surrounding soil outside of container. Drums vary as to levels of fluids.

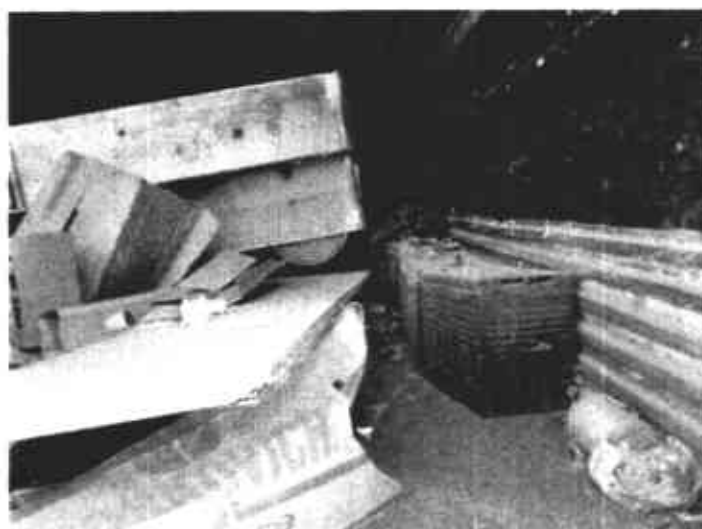
Picture 21. Numerous truck batteries are found in trailers and on ground throughout yard. These items can be handled on a bill of lading for reclamation if properly packaged and documented. There does not appear to be any cracked or leaking batteries anywhere on-site.

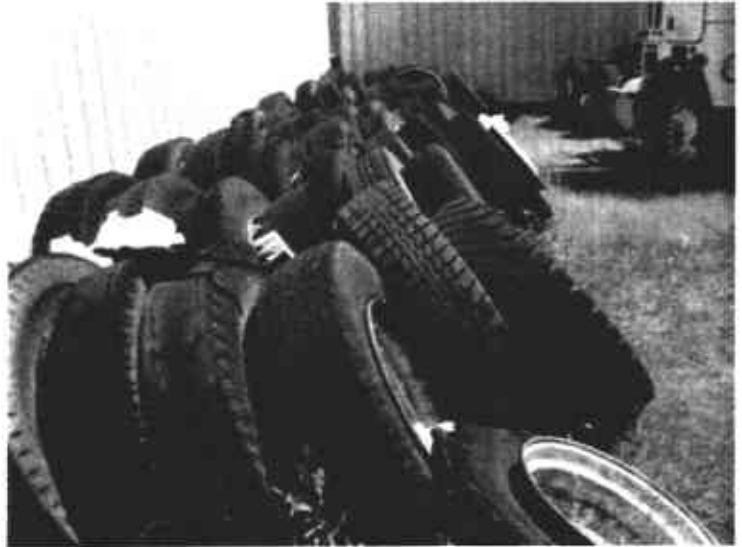
Picture 22. There are an estimated 400 truck tires found in various areas on site. These must be removed by a licensed transporter and taken to an authorized tire recycler. Tires with rims are especially difficult to dispose of.

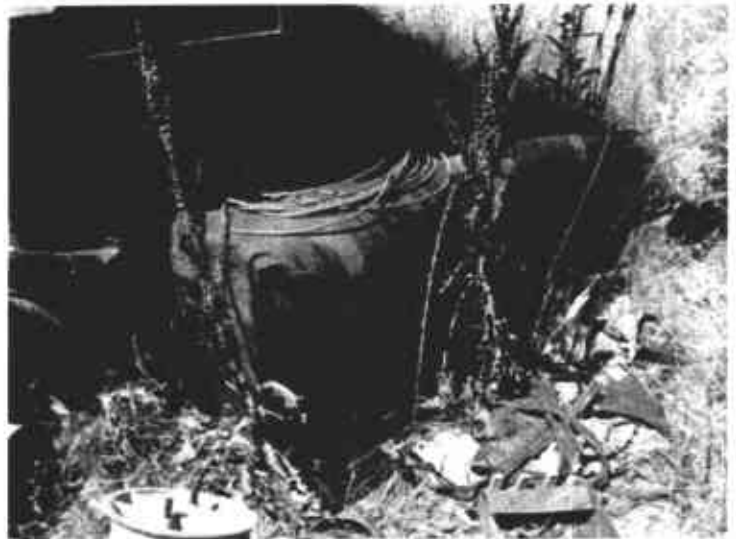
Picture 23. Various fuel tanks and small tanks, drums and bulk containers found onsite that may contain fuel residues and therefore pose a hazard if not dealt with properly. These must be handled carefully so as not to cause static charge and ignite vapors if present. Portable LEL meters must be used prior to movement to avoid flash issues. Fuel must be drained from all vehicles and tanks prior to movement. Grounding is required.
