ENVIRONMENTAL ASSESSMENT

Mariner Square
2415 Mariner Square Drive
Alameda, California

ALLWEST PROJECT NO. 91287.21

December 3, 1991

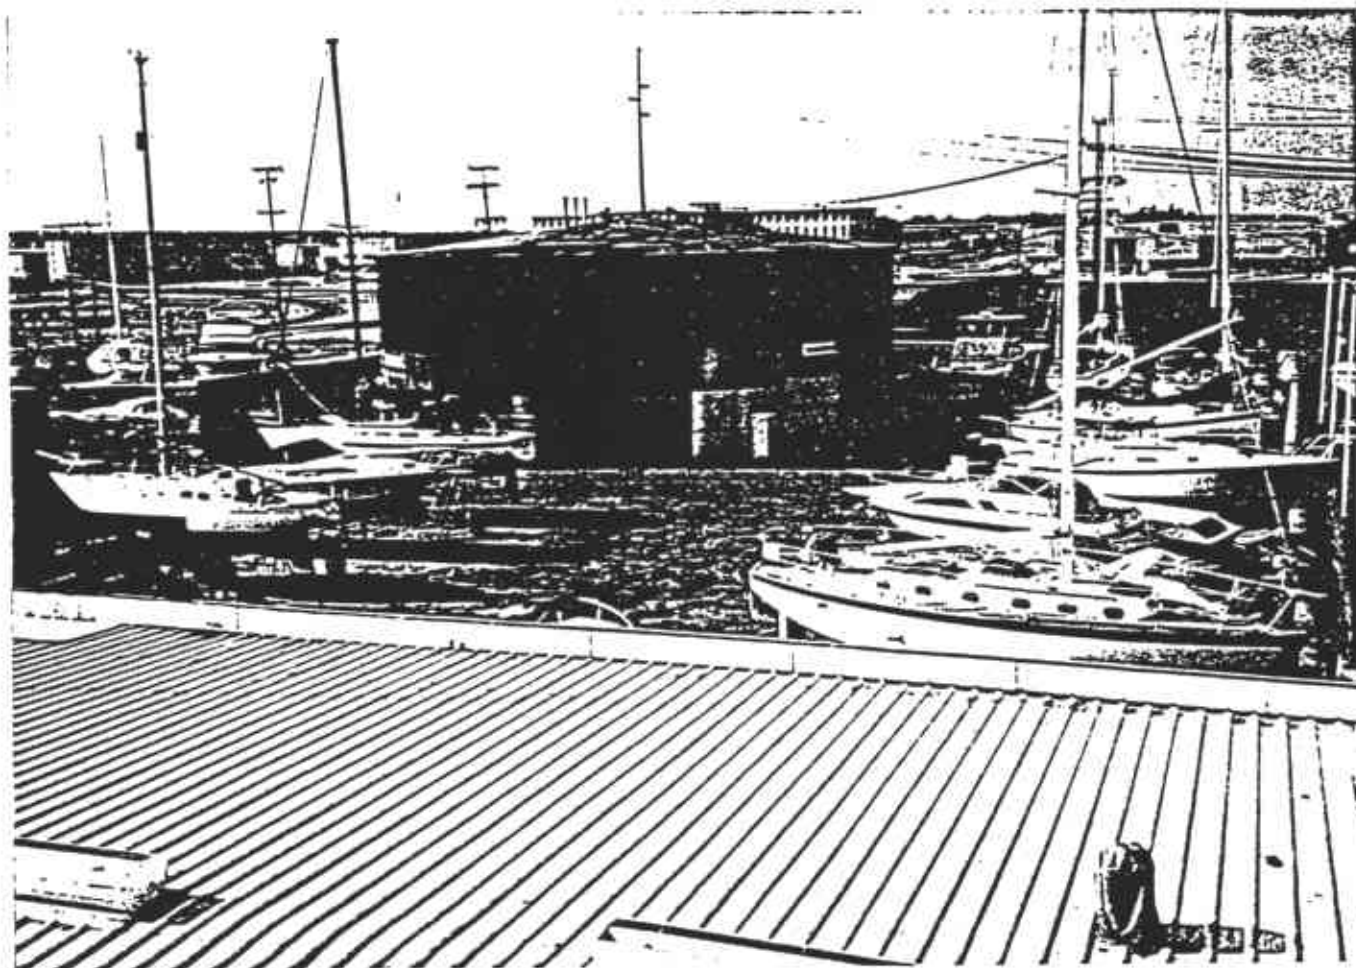
Converted Tank Building: The tank is constructed with welded steel panels. The tank was converted to warehouse and shop space approximately seventeen years ago. This tank had originally been used to store petroleum (crude oil) back when the subject site was a tank farm and distributing center for an oil company. No suspect asbestos-containing materials (ACM) were noted on structural members.

PHOTO 8: VIEW OF BOATYARD AREA AND FORMER PETROLEUM STORAGE TANK. TANK HAS BEEN CONVERTED TO A WAREHOUSE AND WORK SHOP.

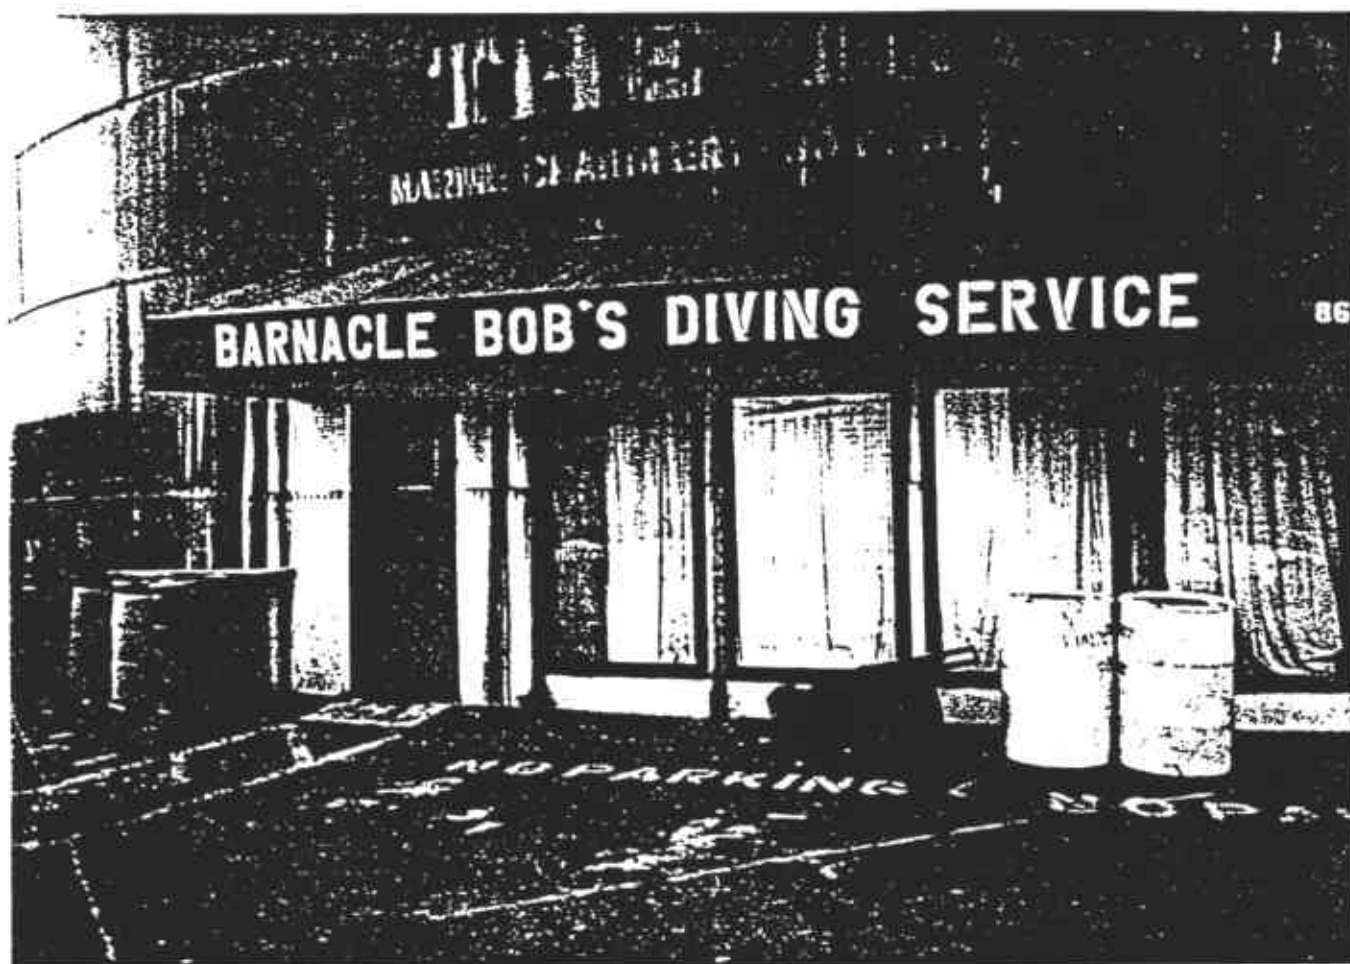
PHOTO 15: DIVING SERVICE OFFICE LOCATED IN
CONVERTED TANK BUILDING. DRUMS
CONTAIN WATER OR ARE EMPTY.

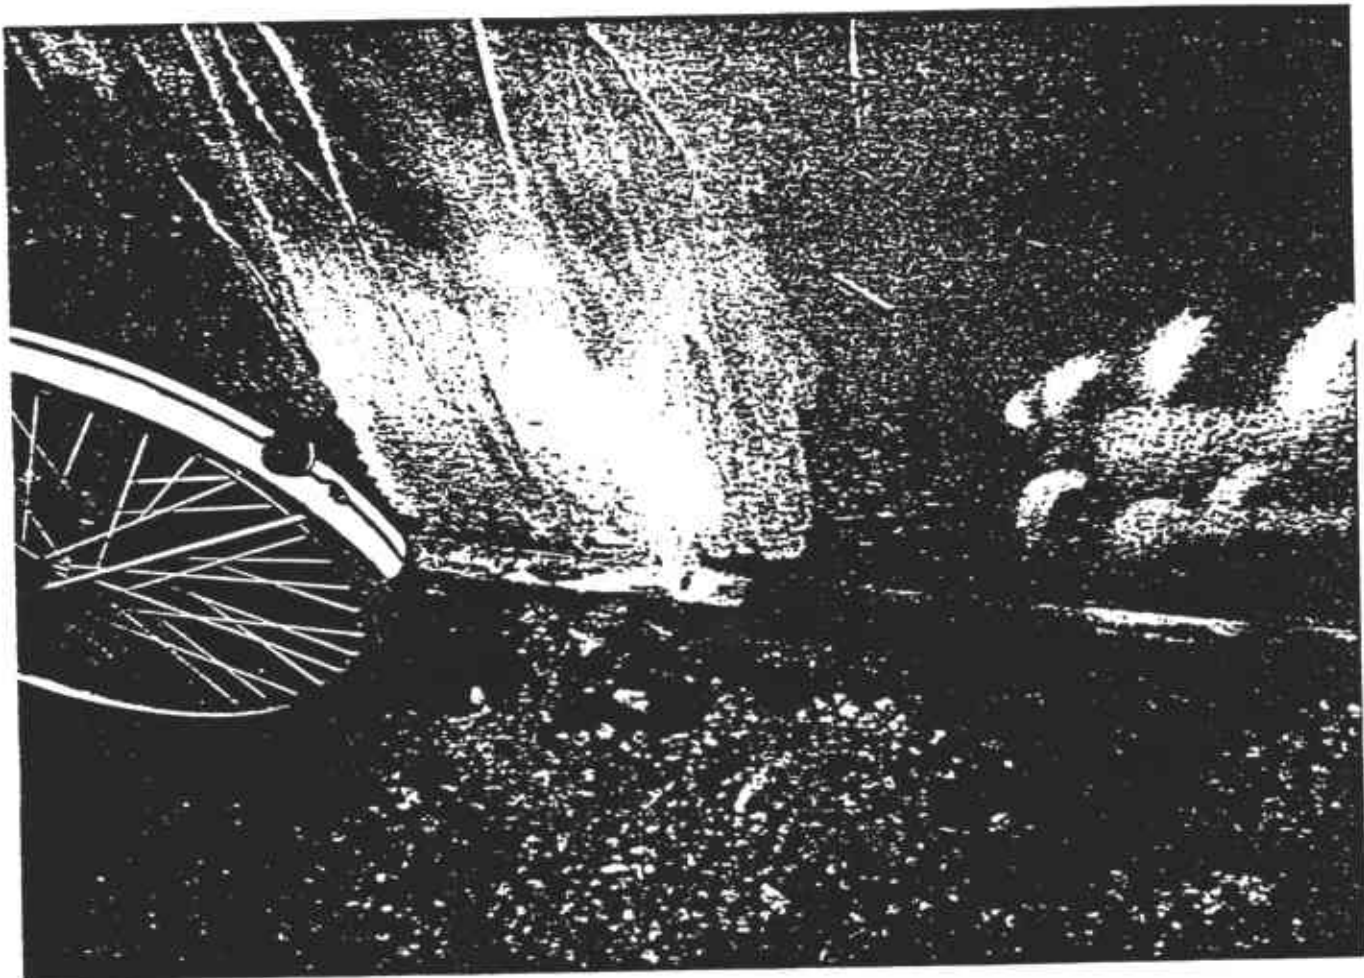
PHOTO 16: OILY LIQUID AT BASE OF CONVERTED TANK BUILDING.

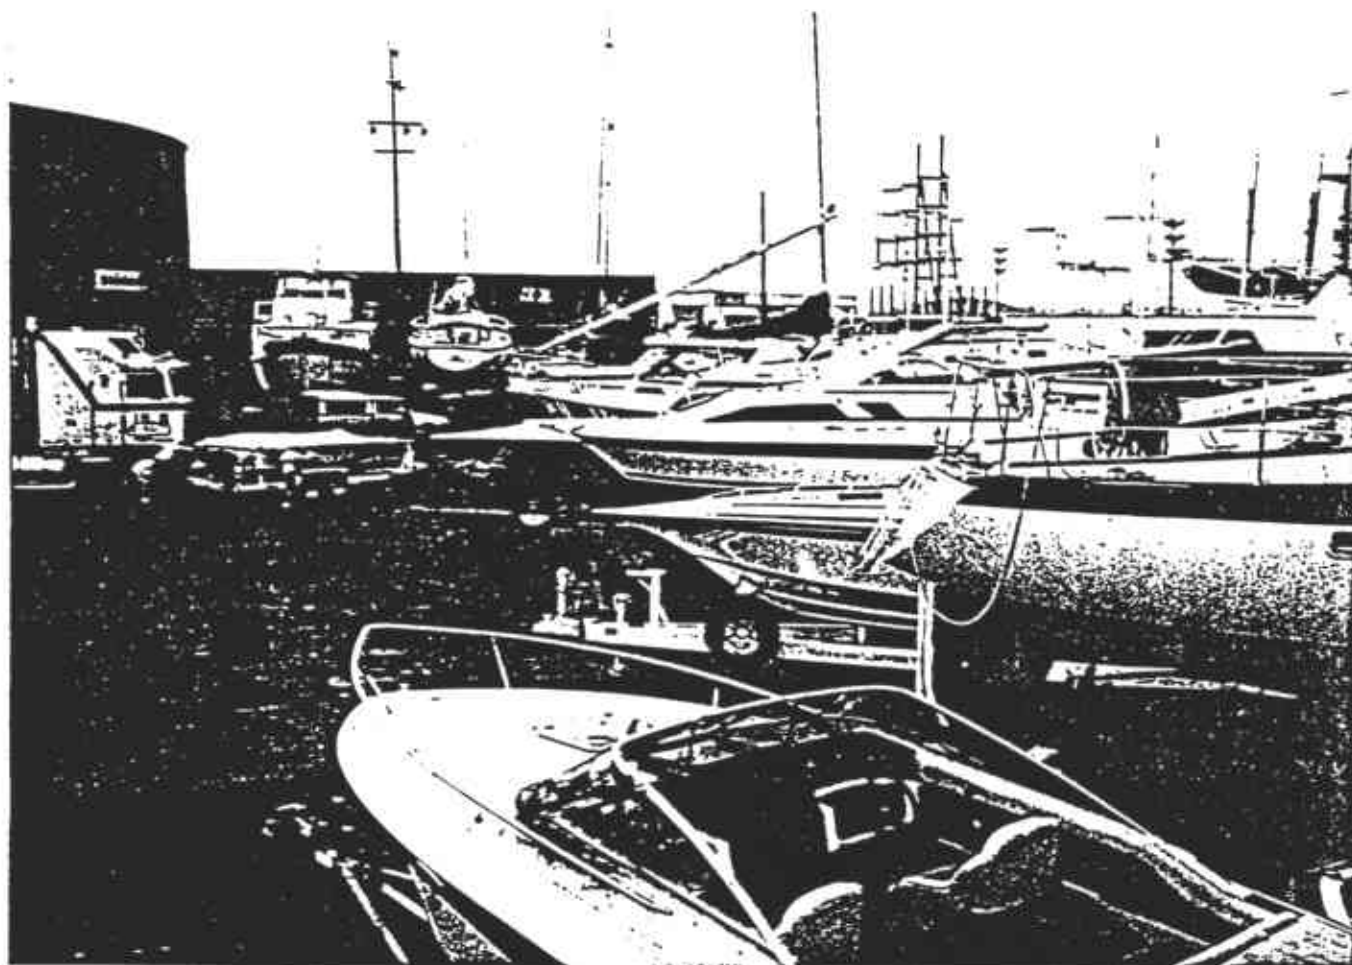
between the Converted Tank Building and the North Sails Industrial Building (Photo 8). A third yard of approximately 1,145 sq.ft. is located to the north of the Converted Tank Building. The second and third yards are used for boat maintenance and repair. Boat hauls destined for painting are sanded and repaired in these yards. The asphalt paving in these yards is in poor to fair with numerous small areas of subsidence and cracking (Photos 21, 22, & 23).

**PHOTO 21: BOAT REPAIR YARD. CONVERTED TANK
BUILDING IS VISIBLE TO LEFT.**

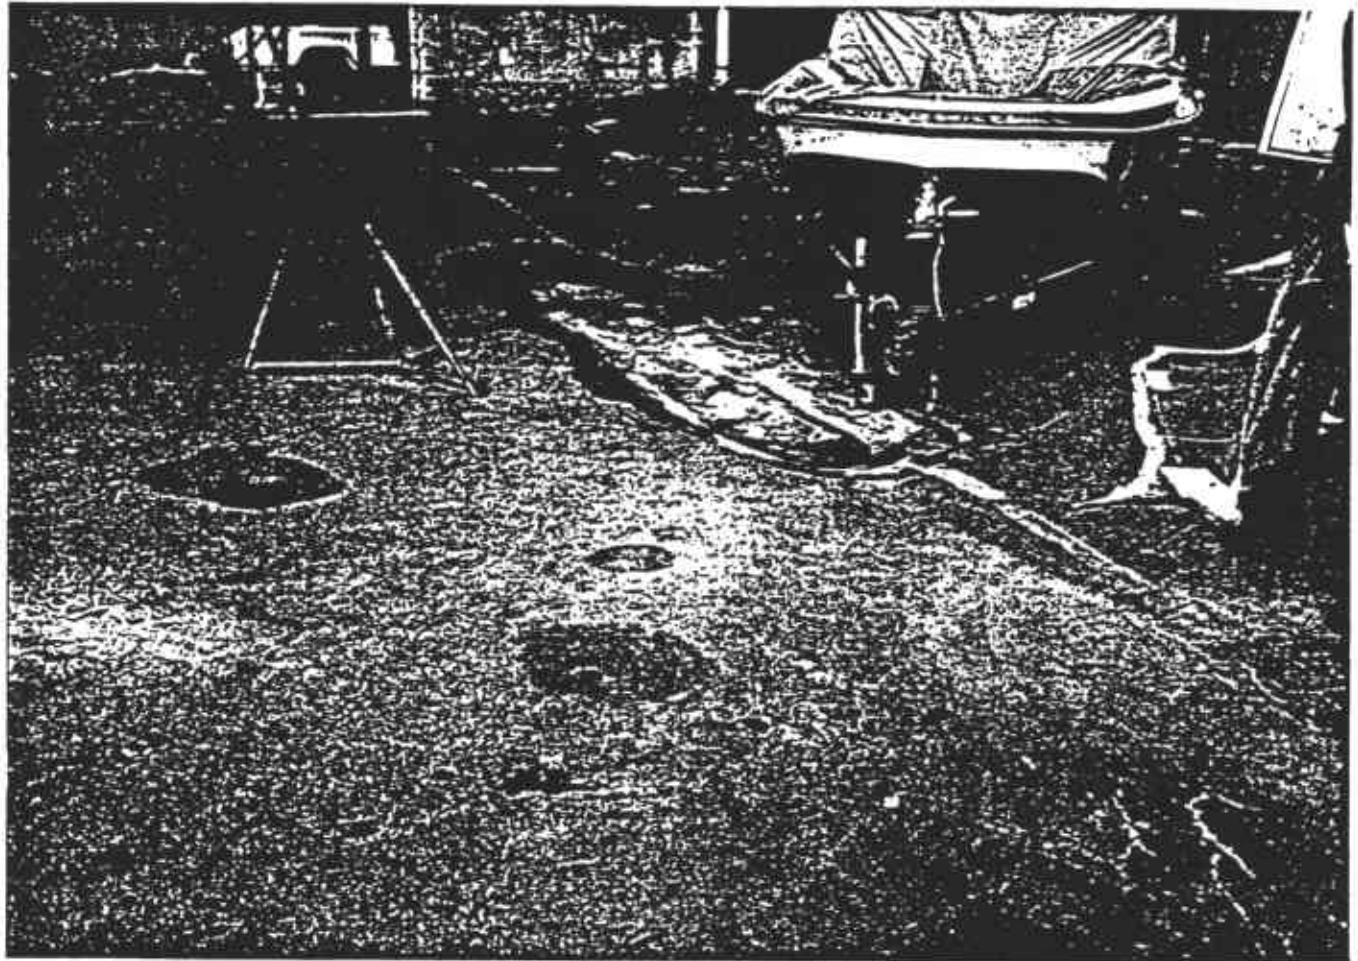
5. MASS WASTING: Small areas of subsidence were observed in the boat yard located between the Converted Tank Building and the North Sails Industrial Building (Photo 22 & 23).

**PHOTO 23: SUBSIDENCE OF ASPHALT SURFACE IN
BOAT YARD.**

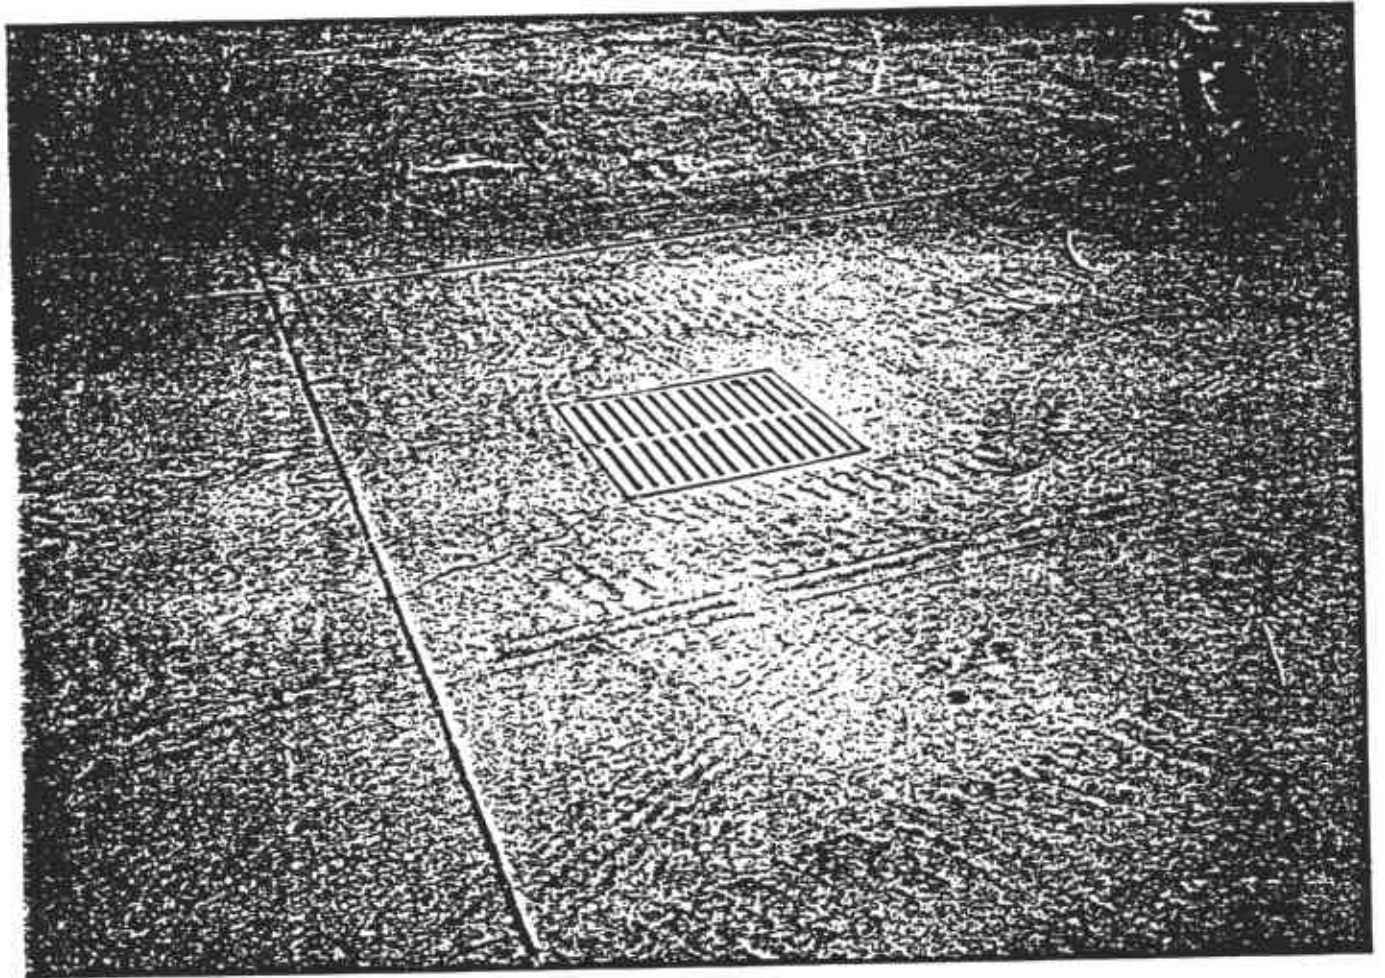
PHOTO 27: STORM DRAIN LOCATED NEAR BOAT
PAINTING AREA.
