September 29, 1998

Re: Former Chevron Service Station #9-1153 3126 Fernside Boulevard, Alameda, California

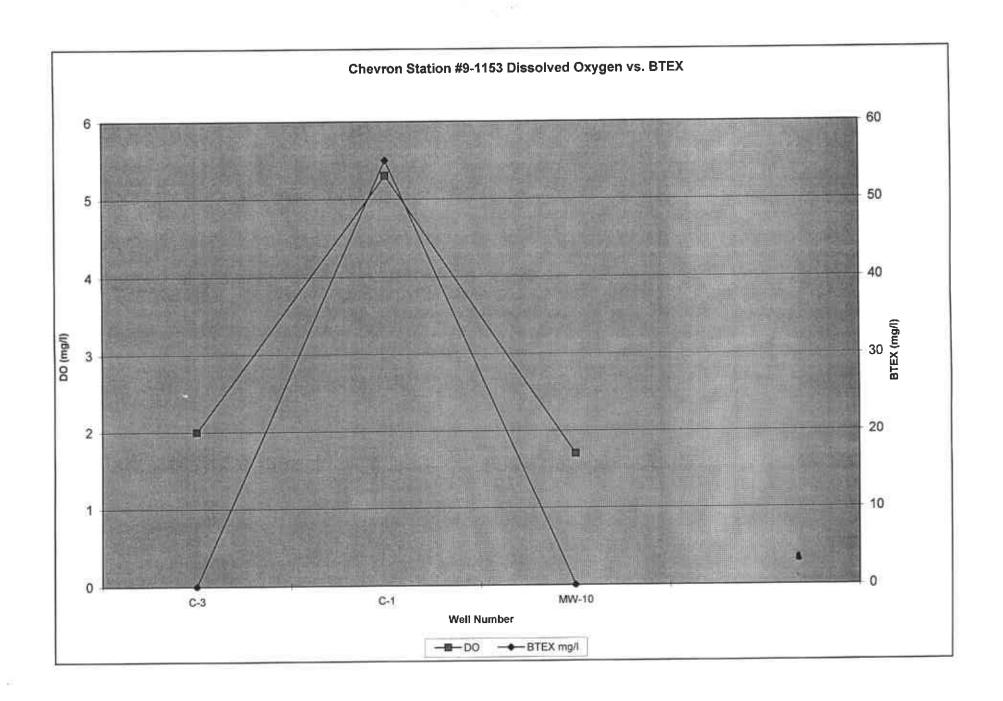
The dissolved oxygen vs. BTEX plot shows that as the BTEX concentrations are increasing the dissolved oxygen concentrations are increasing. The expected trend would be a decrease in dissolved oxygen values with increasing BTEX values. Therefore, this trend would not be a good indicator of the presence of intrinsic bioremediation at this site.

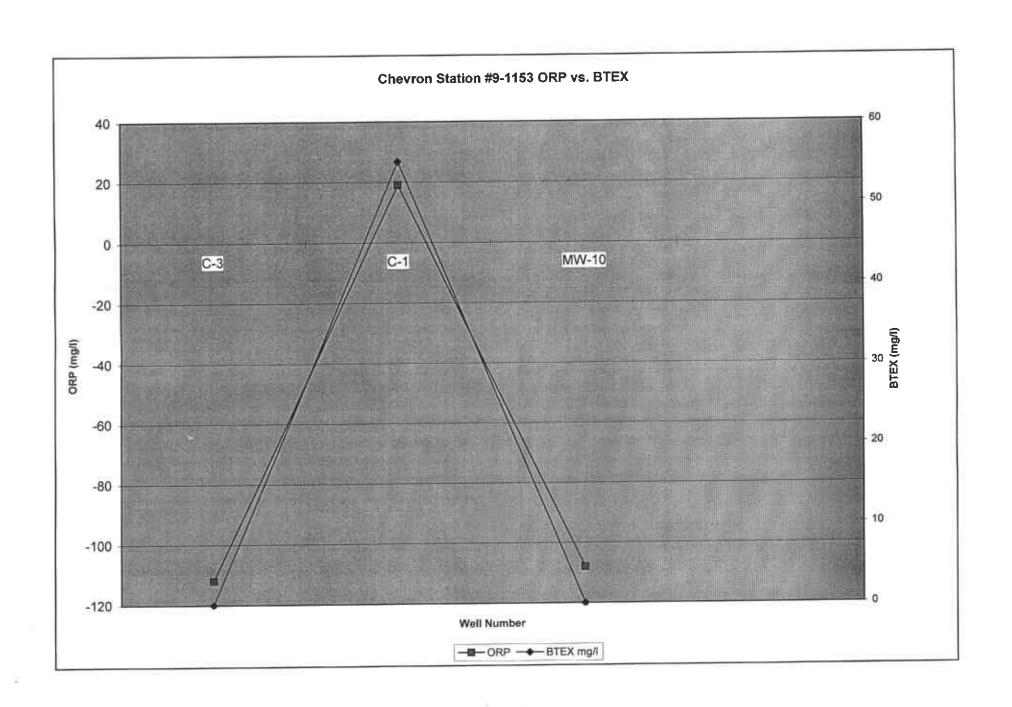
The ORP vs. BTEX plot indicates that ORP is increasing with increasing BTEX values. The expected trend would be a decrease in ORP values with increasing BTEX values. Therefore, this trend would not be a good indicator of the presence of intrinsic bioremediation at this site.

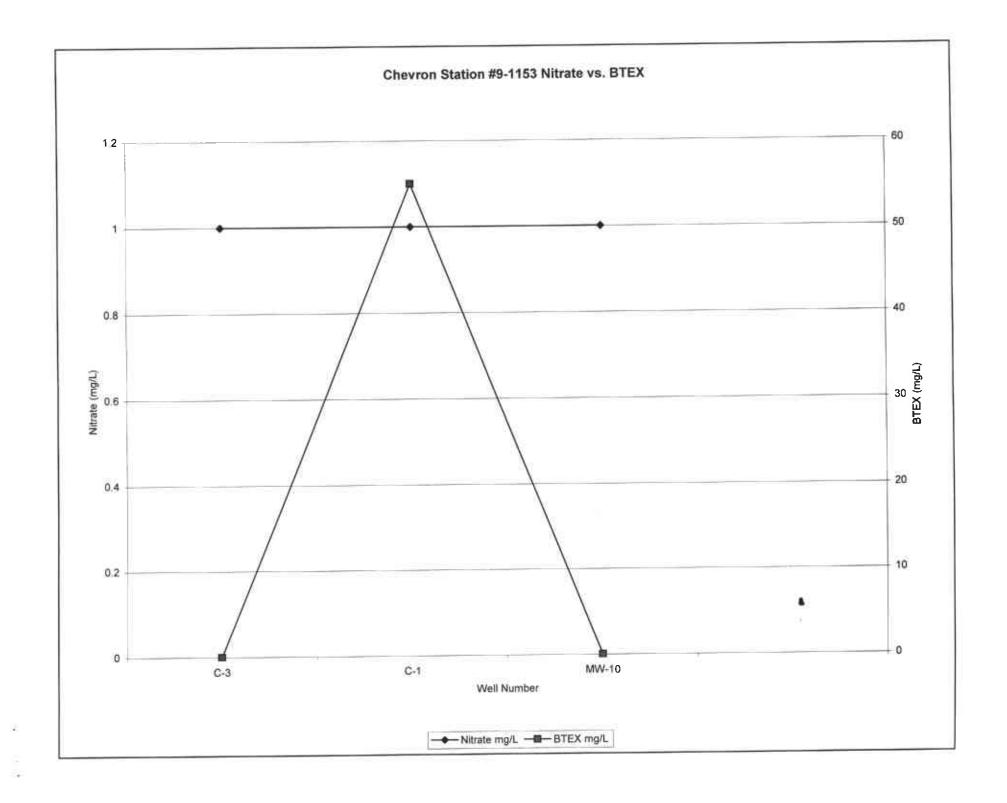
The nitrate vs. BTEX plot indicates that nitrate is not present where BTEX concentrations are high. The expected trend would be a decrease in nitrate values with increasing BTEX values. With no nitrate detected, no statement can be made as to whether intrinsic bioremediation is occurring at this site.

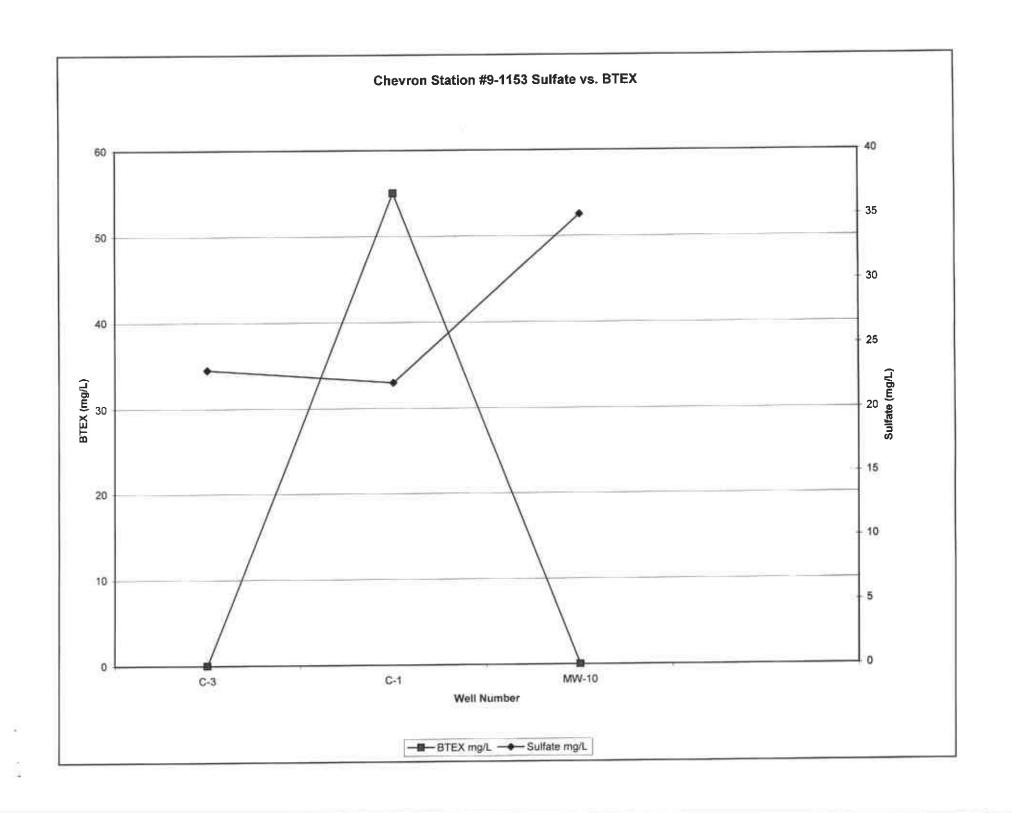
The sulfate vs. BTEX plot shows that as the BTEX concentrations are increasing from wells C-3 to C-1, the sulfate concentrations are slightly decreasing, which indicates some biological activity is occurring within this range of the contaminant plume. From wells C-1 to MW-10 the BTEX concentrations decrease as the sulfate concentration increases, which indicates that some biological activity is occurring within this range of the contaminant plume. Therefore, this trend would indicate that partial intrinsic bioremediation is occurring at this site.

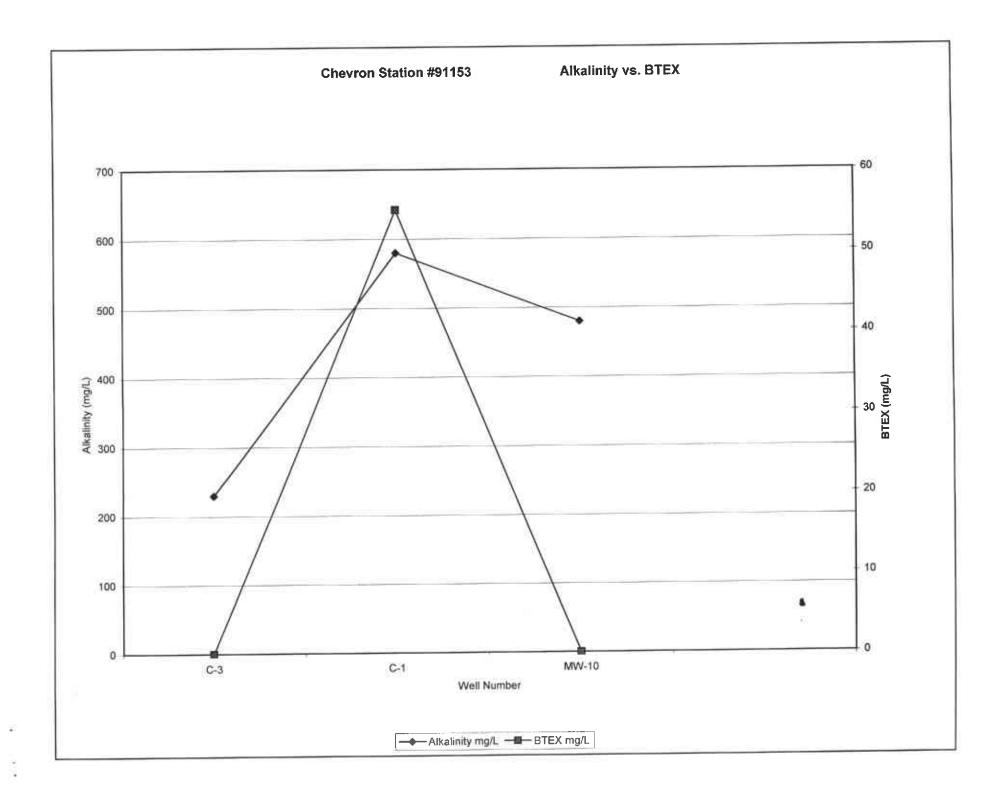
The alkalinity vs. BTEX plot indicates that the upgradient waters at this site are low in alkalinity and the interior plume waters are higher in alkalinity. An increase in alkalinity across a contaminant plume is a potential indicator of biologic activity. Therefore, the observed trend for alkalinity is consistent with the occurrence of intrinsic bioremediation in the groundwater at this site.

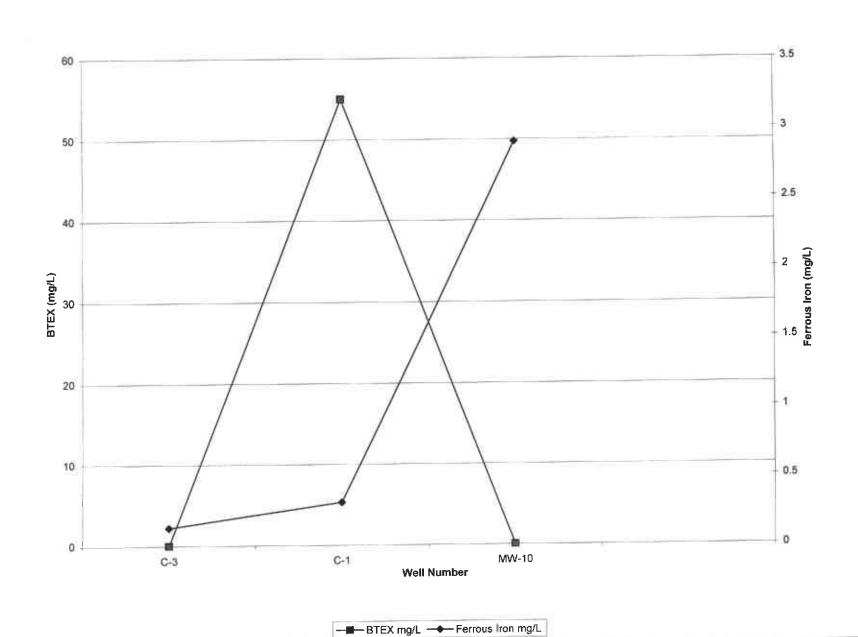
Ferrous Iron vs. BTEX

The dissolved iron (ferrous) vs. BTEX plot indicates that as the BTEX concentrations are increasing from wells C-3 to C-1, the dissolved iron concentrations are slightly increasing, which indicates some biological activity is occurring within this range of the contaminant plume. From wells C-1 to MW-10 the BTEX concentrations decrease as the dissolved iron increases, which indicates that some biological activity is occurring within this range of the contaminant plume. Therefore, this trend would indicate that partial intrinsic bioremediation is occurring at this site.
