September 12, 2005 Report 0298.R3

PREFERENTIAL PATHWAY/CONDUIT STUDY

Fuel Leak Site RO0000357

Snow Cleaners, Inc. 2678 Coolidge Avenue Oakland, California

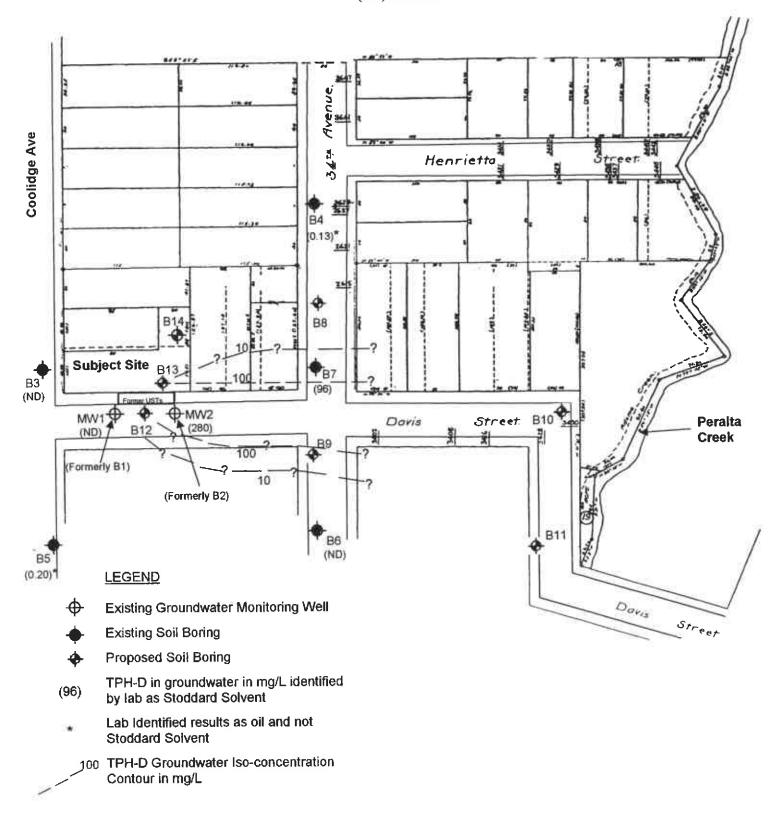
Figure 2 SITE VICINITY MAP TPH-D Concentrations 2678 Coolidge Ave Oakland, CA

In January, 1994 two groundwater monitoring wells were installed in Davis Street approximately five feet south of the former UST pit. Figure 2 shows the approximate former location of the USTs beneath the sidewalk. Well B1 (the well closest to Coolidge Avenue, and subsequently renamed as well MW1) was drilled to a total depth of 46.1 feet, and was constructed using 2-inch diameter PVC pipe. The screened interval is from 25 to 45 feet below the ground surface. Groundwater was initially encountered at a depth of 42.1 feet and subsequently stabilized at a depth of approximately 29 feet below the ground surface. The subsurface materials encountered in the borehole consisted predominantly of clay and silty clay. No evidence of petroleum hydrocarbons was detected in the borehole at the time of drilling, and no petroleum hydrocarbons were detected in soil samples from the borehole or water samples from the well.

In the event that the sanitary sewer lateral or the associated trench for the lateral were a conduit for Stoddard Solvent from the former UST pit, Stoddard Solvent would have been transported to the sanitary sewer main or the sanitary sewer main trench located in the center of Davis Street. This condition would be consistent with the observed distribution of Stoddard Solvent from soil and groundwater samples collected to date. A subsurface investigation work plan dated September 12, 2005 proposes additional investigation of the extent of Stoddard Solvent in the vicinity of the sanitary sewer trench in Davis Street with soil borings B8 through B11 (see Figure 2).

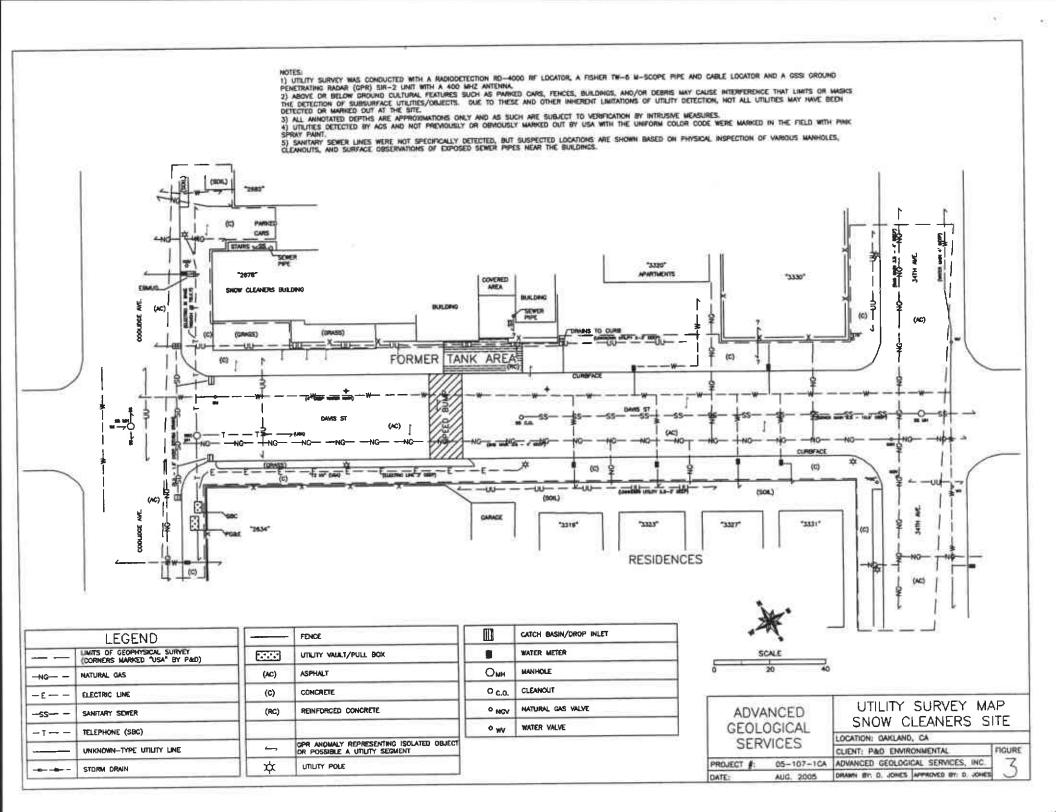
Review of the AGS Utility Survey Map (Figure 3) shows that a telephone wire is located 5 feet southeast of the curb. This is corroborated by the map provided by SBC (see Appendix E). A comment on the AGS map, Figure 3, suggests that the electric and telephone service may be in the same trench directly in front of the Snow Cleaners building. The map provided by PG&E electric (see Appendix D) shows electrical wires as being overhead in this location.

Underground utilities were identified in the site vicinity by USA and a private utility locator. In addition, utility service providers were contacted to obtain maps of buried utility locations and to identify utility burial practices, including utility burial depth. Review of Figure 3 shows that an unknown utility that is oriented parallel to Davis Street appears to be coincident with the former UST pit. However, the utility is identified as being buried at a depth of two to three feet, and is presently not considered as a potential conduit for Stoddard Solvent from the former UST pit. Similarly, a water pipe located in Davis Street in the vicinity of the former UST pit is also considered to have a burial depth of four feet that is presently not considered a potential conduit for Stoddard Solvent from the former UST pit.
