Subject Letter-Report of Air Monitoring at the Towata Flowers building, 2305 Santa Clara, Alameda CA

October 8, 1997
Project No. 8700-752-100

Subject: Results of Air Monitoring
Towata Flowers Building
2305 Santa Clara Avenue, Alameda, CA

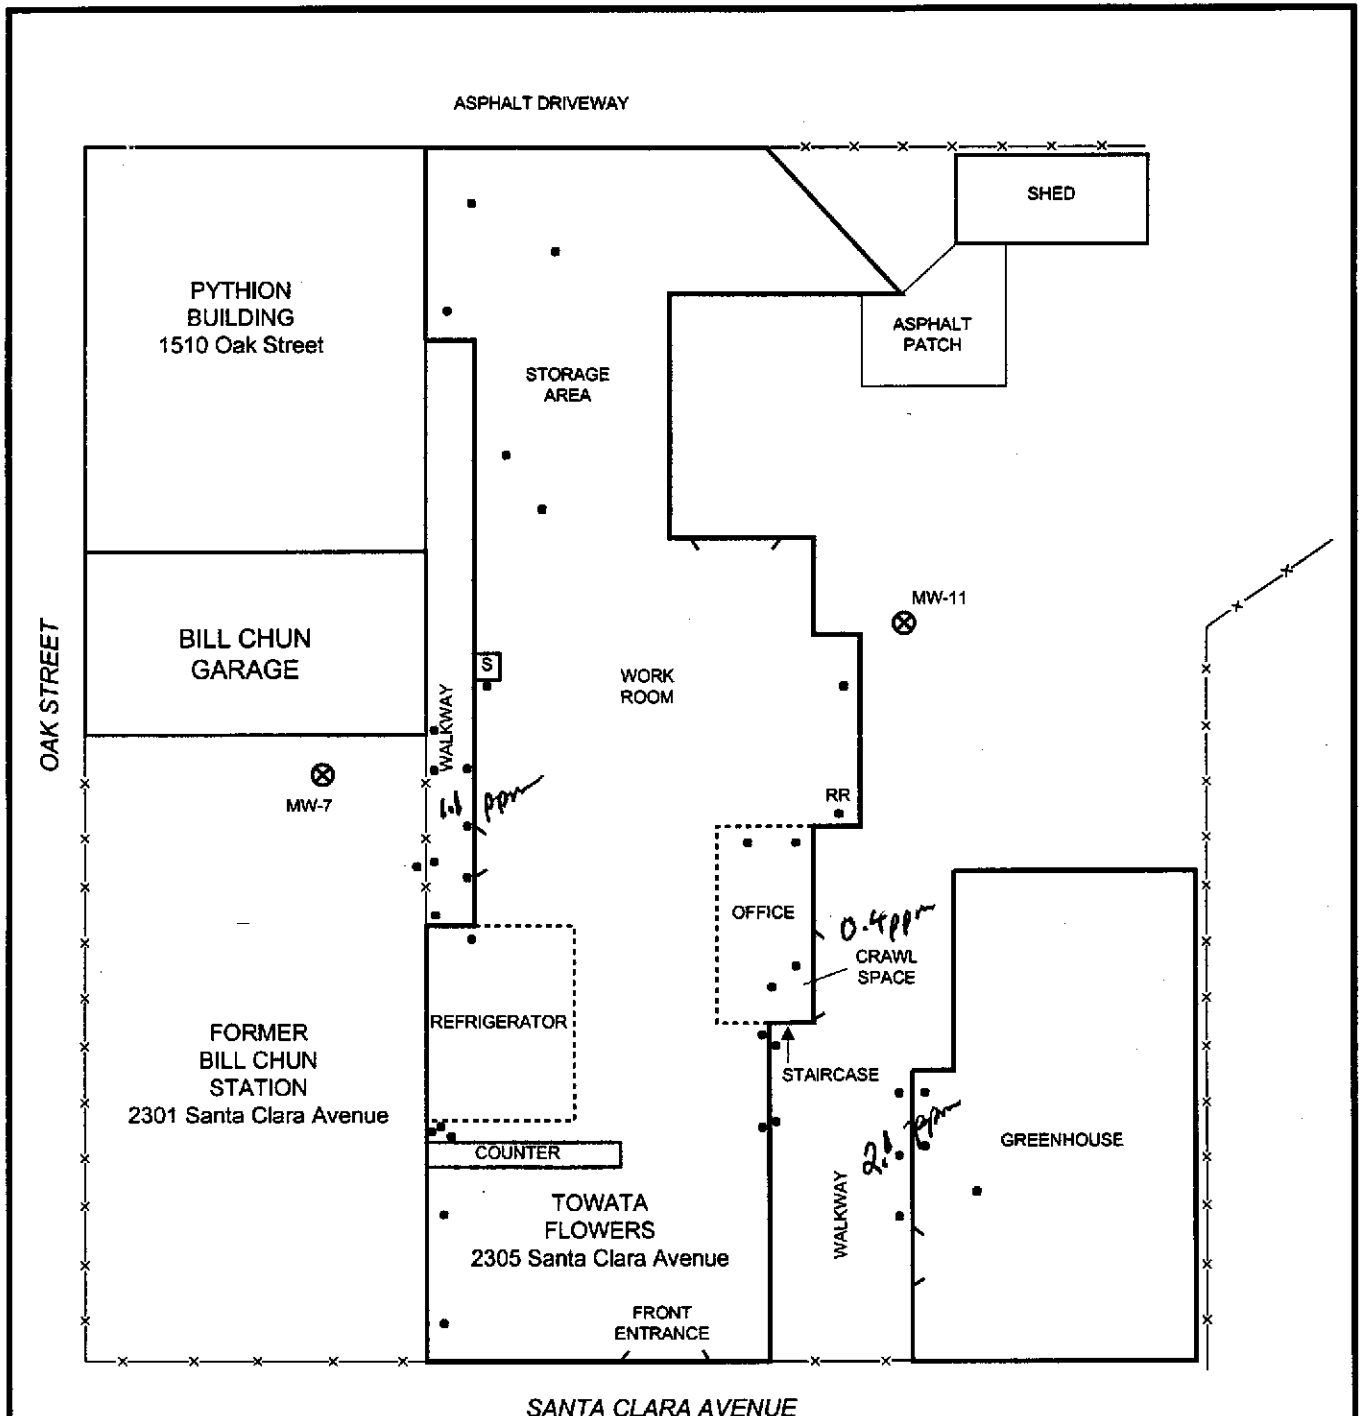
**FIGURE 1
SITE PLAN**

Vapor concentrations recorded at the monitoring locations within the building interior were nondetectable (< 0.1 ppm) with exception of one reading (0.5 ppm), detected beneath the floor boards in the rear storage area. The PGM did not indicate explosive conditions in the enclosed areas monitored within the building (closets and beneath the floor boards).

A maximum reading of 0.4 ppm was recorded in the crawl space underneath the outside stairway. Vapor concentration recorded in the other outside monitoring locations were nondetectable (< 0.1 ppm).

The vapor concentration detected within the first 6 inches of soil in the landscaped and exposed soil areas ranged from 0.5 ppm to 2.1 ppm. The maximum concentration (2.1 ppm) was detected in the flower strips between the building and the greenhouse. The maximum concentrations of 1.1 ppm was detected in the first 6-inches of soil located in the side-yard (walkway) area between the in the Towata Building and the former Bill Chun property.

Concentrations of vapors detected (maximum detected at 6-inch depth was 2.1 ppm) in the soils from exterior portions of the Towata Flowers property on July 9, 1997, indicate that hydrocarbon vapors may be present in the near surface soils beneath the building. However, evidence that vapors were migrating upward into the building was not identified.
