**BIANNUAL  
GROUNDWATER  
MONITORING REPORT**

November 8, 1996

Peralta Maintenance Yard  
501 5th Avenue  
Oakland, California

ACC Project No. 6045-14

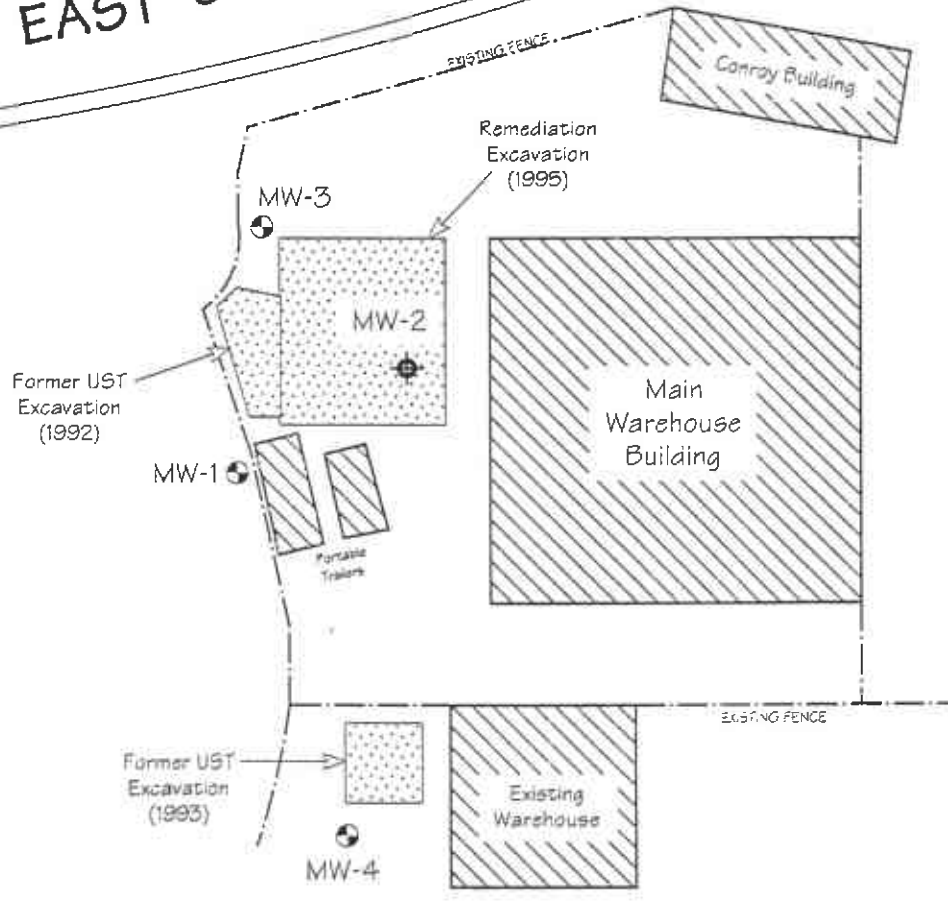
In February 1994, four additional borings were drilled on site and converted into 2-inch-diameter monitoring wells (MW-1, MW-2, MW-3, and MW-4). The monitoring wells were used to evaluate the extent of groundwater impact from the two former excavations (Figure 2). Laboratory analysis of the groundwater samples collected in February 1994 from monitoring wells MW-1 and MW-4 (downgradient from the tank excavations) indicated below detectable levels of the constituents evaluated. Analytical results of groundwater samples collected from monitoring well MW-1 indicated a downgradient extent of groundwater impact. Laboratory analysis of groundwater samples collected from monitoring wells MW-2 and MW-3 (upgradient of the former tank excavations) indicated detectable levels of constituents. Groundwater samples collected from well MW-2 and MW-3 indicated detectable levels of TPHd, TPHg, and benzene, toluene, ethylbenzene, and total xylenes (BTEX). Motor oil was detected in the soil collected from well MW-2. However, motor oil was not detected in the groundwater sample collected from monitoring well MW-2. A concentration of TPHd was only detected in the soil sample collected from well MW-2.

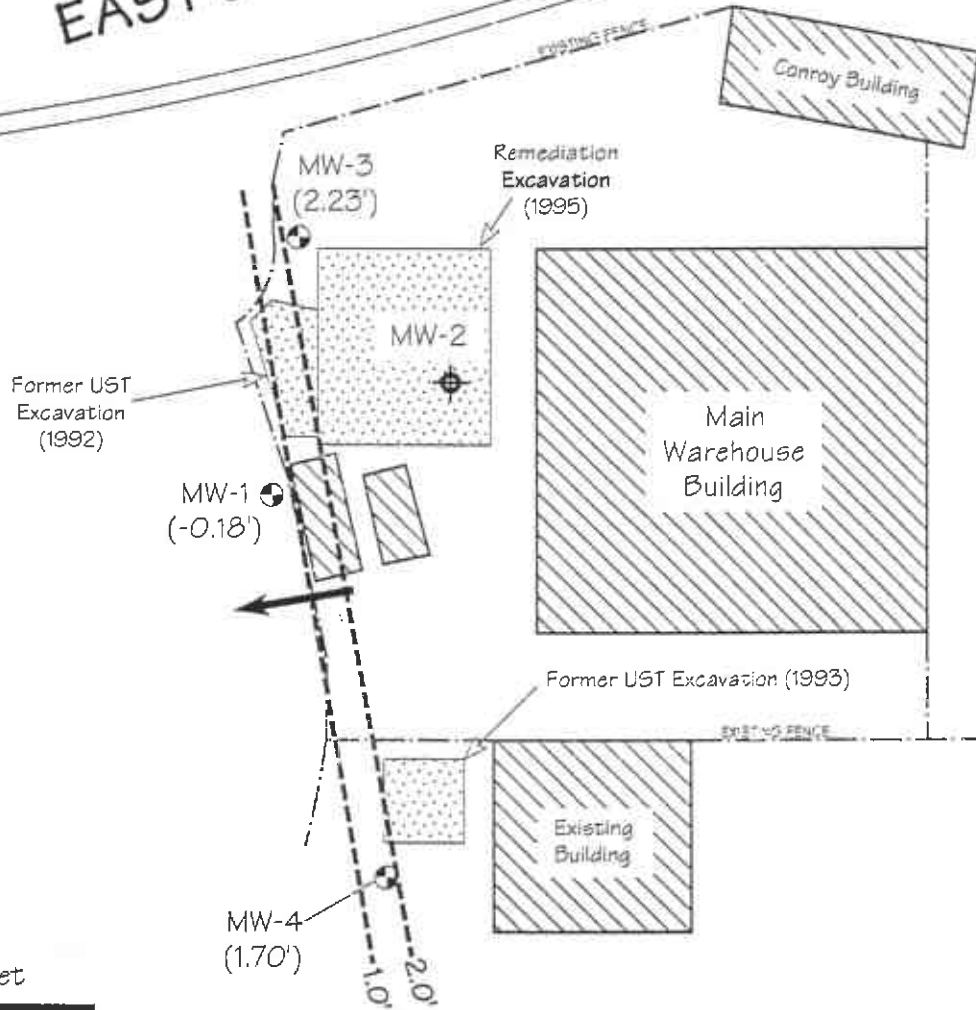
Groundwater Gradient Map  
 Peralta Community College District  
 Maintenance Yard  
 501 5th Avenue, Oakland, California

Groundwater elevations were calculated from water level measurements collected on October 8, 1996. Groundwater gradient was calculated using this data. The gradient was evaluated by triangulation using the elevation of the potentiometric surface measured with respect to MSL datum. As shown in Figure 3, general direction of groundwater flow is west at a gradient of 0.05 foot/foot. The groundwater gradient has become slightly steeper and flow direction is toward the west. Historic groundwater flow direction on site is summarized in Table 2.

Groundwater flow direction is consistent with previous sampling events (west) and the groundwater gradient has become slightly steeper compared with previous sampling events. The concentrations of petroleum hydrocarbons as diesel and motor oil have increased since the previous sampling event. Recent remedial action in the summer 1995 included removing impacted soil in the vicinity of and upgradient of wells MW-1 and MW-3. During the remedial action, four previously unknown USTs were discovered adjacent to destroyed well MW-2. To maintain the integrity of an adjacent building, one UST was left in place, upgradient of well MW-1. Soil around the previously unknown UST consisted of stiff clay below alternating layers of fill material, including buried asphalt and oil-coated baserock. These materials may have caused preferential pathways for groundwater flow in the subsurface. Removal of these materials and replacement with fill material of consistent porosity and grade may have aided the groundwater flow to a more regional pattern. As a result of excavation activity and subsequent regional groundwater flow direction, petroleum hydrocarbons were observed in wells MW-1 and MW-4.
