**Quarterly Progress Report**

December 1999 through February 2000 Safety-Kleen Systems, Inc., Service Center 400 Market Street Oakland, California

QUARTERLY PROGRESS REPORT
DECEMBER 1999 - FEBRUARY 2000
SAFETY-KLEEN SYSTEMS, INC. SERVICE CENTER
400 MARKET STREET
OAKLAND, CALIFORNIA
EPA ID NO. CAD053044053

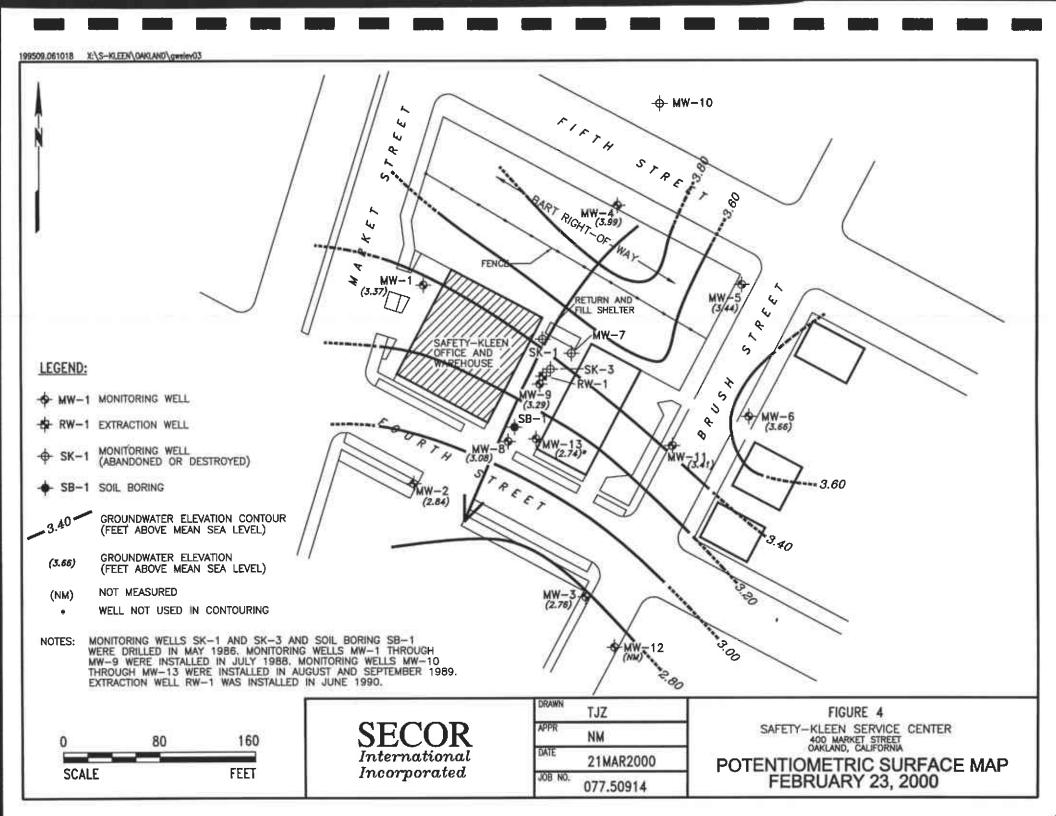
Groundwater elevations and depth-to-water measurements for the February 23, 2000, event are presented in Table 1. The average water-table elevation on February 23, 2000 was 3.26 feet above mean sea level (amsl), an increase of 1.55 feet since the October 1999 event. A groundwater potentiometric surface map prepared with this data is presented as Figure 4.

As shown in Figure 4, the on- and off-site groundwater flow direction remains to the south-southwest, consistent with historic site data. The hydraulic gradient was 0.0044 feet/foot (ft/ft) across the site as measured between monitoring wells MW-4 and MW-3. The hydraulic gradient is consistent with previous data for the site. A summary of groundwater elevations since January 1993 is provided as Table 2.
