SUBJECT: UNDERGROUND STORAGE TANK SUBSURFACE
INVESTIGATION AT THE SAFETY-KLEEN
404 MARKET STREET, OAKLAND, CA

SUBSURFACE INVESTIGATION AND
LEAK MONITORING INSTALLATION

SAFETY-KLEEN CORPORATION
OAKLAND SERVICE FACILITY
404 Market Street
Oakland, California

December 1986

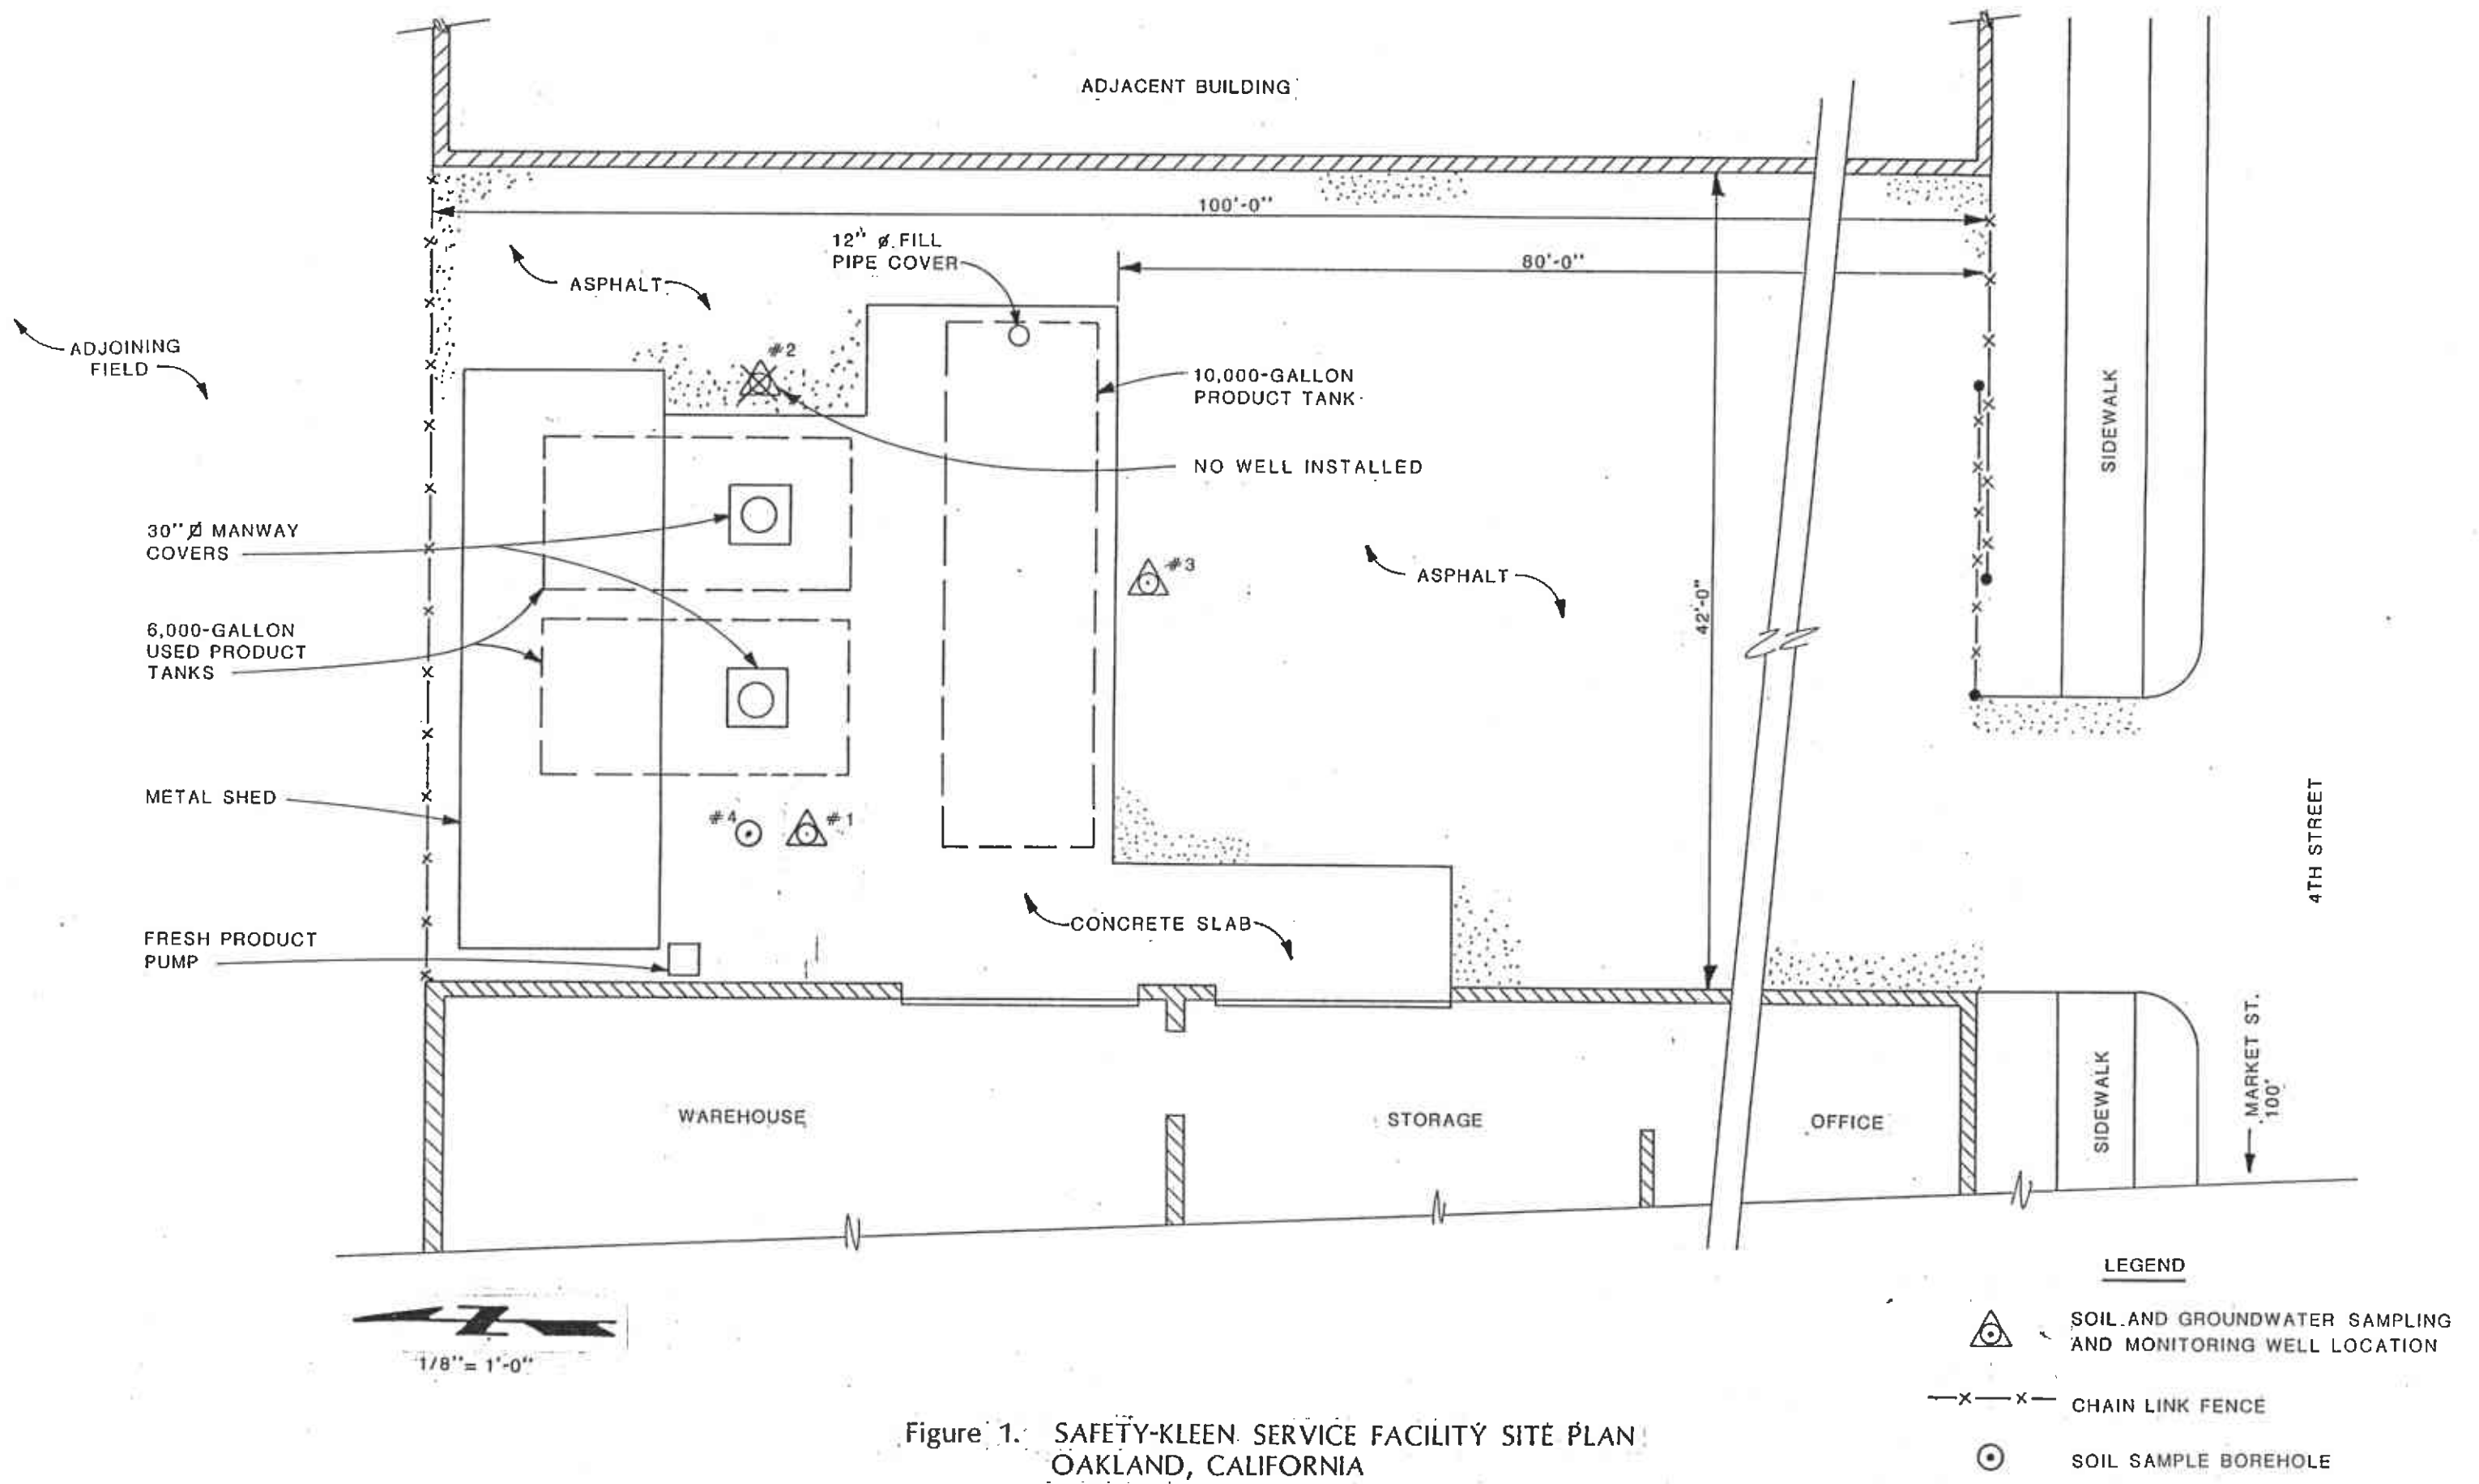
Figure 1. SAFETY-KLEEN SERVICE FACILITY SITE PLAN
OAKLAND, CALIFORNIA

At the location of Monitoring Well No. 1, concentrations of mineral spirits in the soil were at 2,300 ppm just beneath the concrete. The concentration of a grab sample collected at the ground surface of Hole No. 4, located 3 feet north of Monitoring Well No. 1, has 5,100 ppm. The concentration of contamination at Monitoring Well No. 1 increased with depth to 10,000 ppm at 10 feet of depth.

Mineral spirits contamination has been confirmed at the facility. It is unknown if the contamination has resulted from leaking tanks or from spillage that occurred at the site prior to the construction of the spill containment structure. We recommend that a tank precision leak test be completed to assess tank competency. Second, we recommend that a system be installed to recover the floating mineral spirits from the monitoring wells. This would help to stop the spread of the product. Finally, we recommend that additional soil and groundwater exploratory work be completed at the property limits to assess if contamination has migrated off-site.

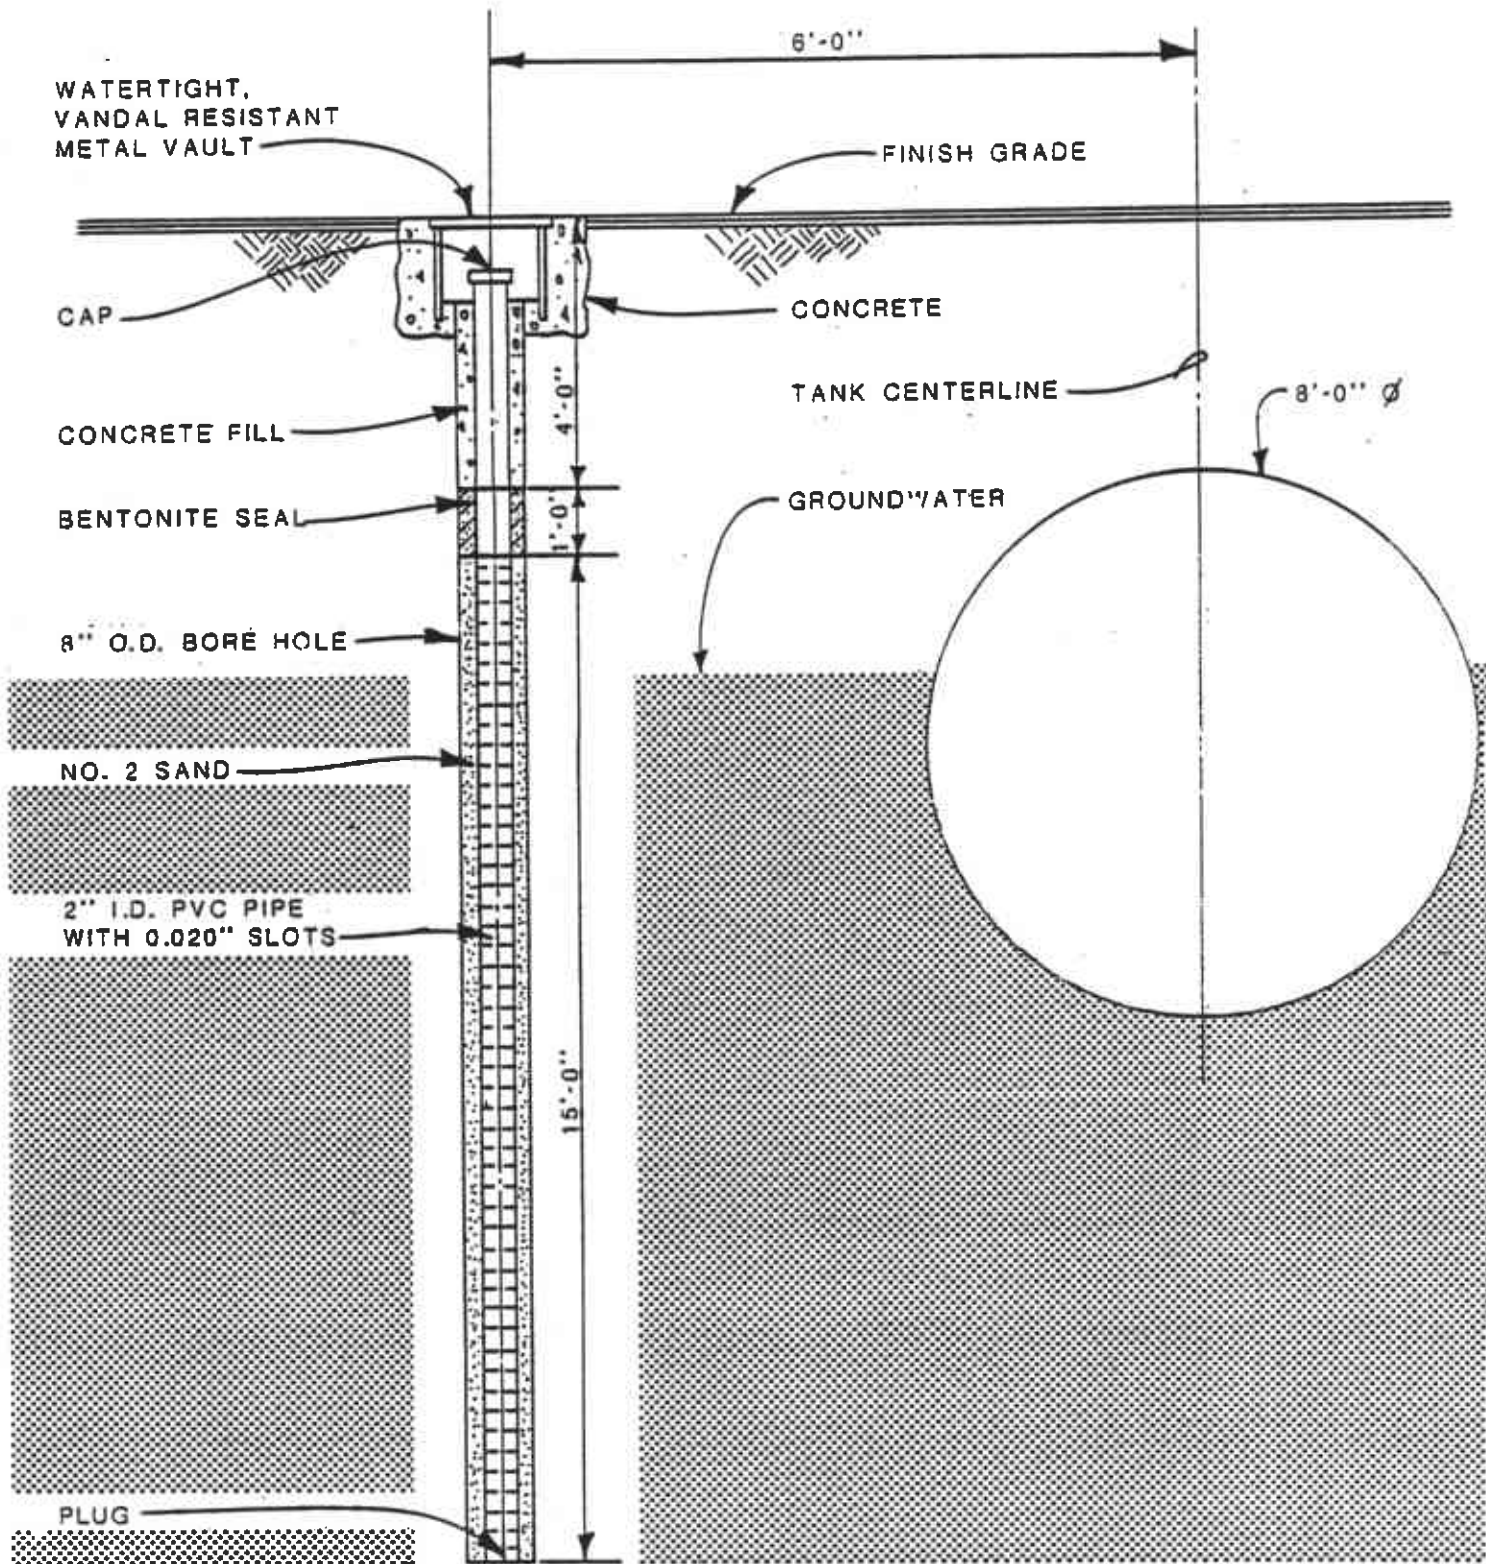
Figure 2. MONITORING WELL CONSTRUCTION
NTS

A total of three boreholes were drilled for placement of monitoring wells. In general, the soils encountered in each were very similar and consisted of sandy silts and sandy clayey silts, with varying amounts of very fine sand and clay. (see Appendix A for the logs of the boreholes). An unidentified deposit or obstruction was encountered at 20 feet in each borehole. It gave effective refusal to the drilling equipment used (Mobile Drill Model B-34). Chipping of the drill bit occurred during the attempts made to get past this depth. Monitoring wells were therefore installed to the limiting depth of 20 feet. Figure 2 describes the typical well construction as installed at the site.
