RCRA FACILITY INVESTIGATION REPORT

**SAFETY-KLEEN CORP.
400 MARKET STREET
OAKLAND, CALIFORNIA
EPA I.D. No. CAD053044053**

SECOR Job No. 70005-009-10

March 27, 1996

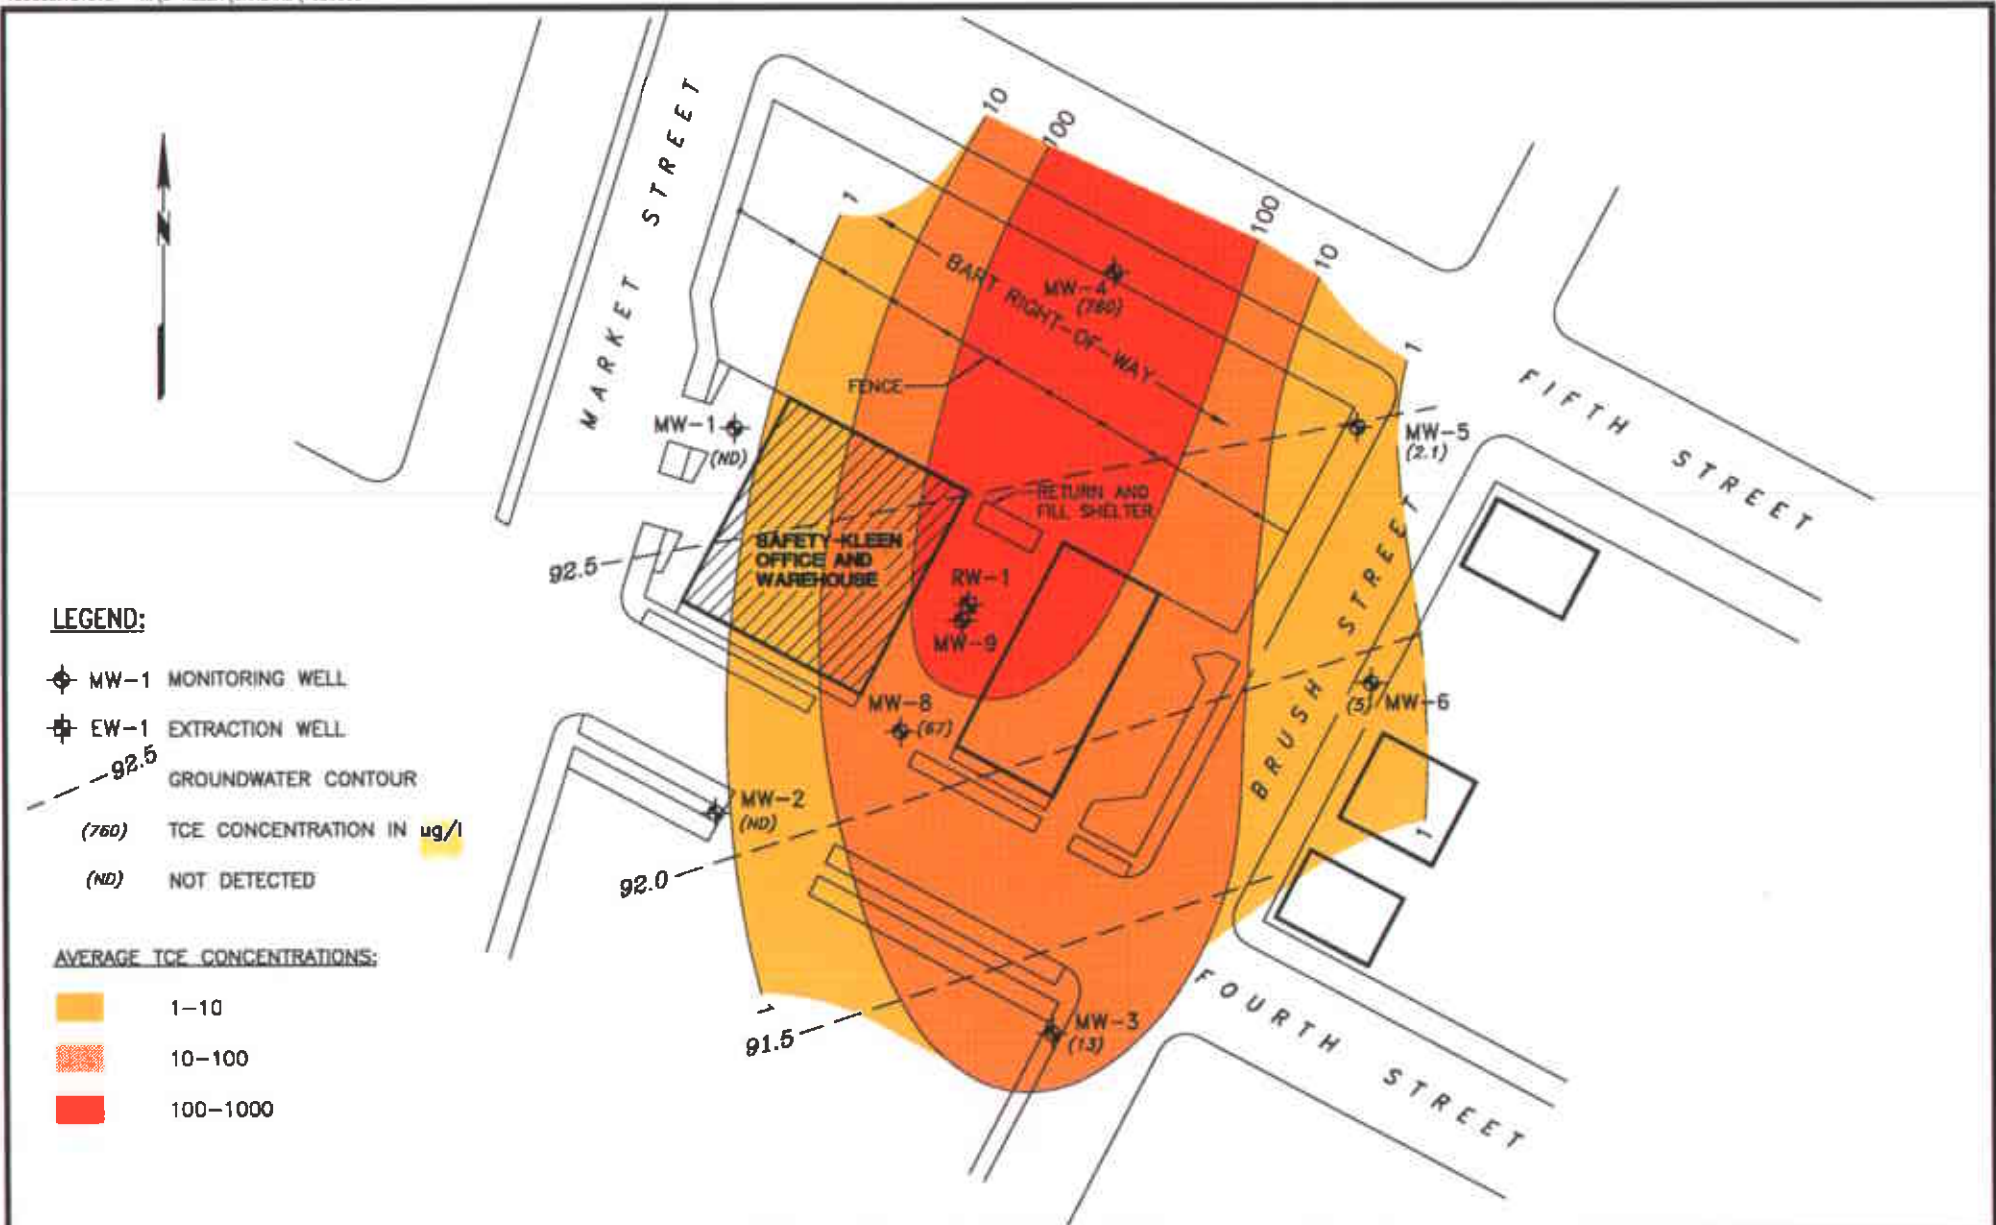
FIGURE 4
SAFETY-KLEEN
400 MARKET STREET
OAKLAND, CALIFORNIA
**TCE CONCENTRATIONS IN
GROUNDWATER - AUGUST 4, 1988**

The August 1988 map (Figure 4) shows data collected prior to the installation of monitoring wells MW-10 through MW-13. Subsequent monitoring confirmed the existence of elevated VOC concentrations in upgradient wells. Based on these data, monitoring wells MW-10 through MW-13 were installed in August and September of 1989. Figures 5, 6, and 7 present the TCE concentrations and groundwater elevation contours for three events after these wells were installed. The maps clearly show a TCE plume migrating onto the Safety-Kleen facility from a source located somewhere north of monitoring well MW-10. These facts, combined with the consistent groundwater gradient direction and magnitude indicate that an upgradient off-site source for VOCs has migrated on to the Safety-Kleen facility.

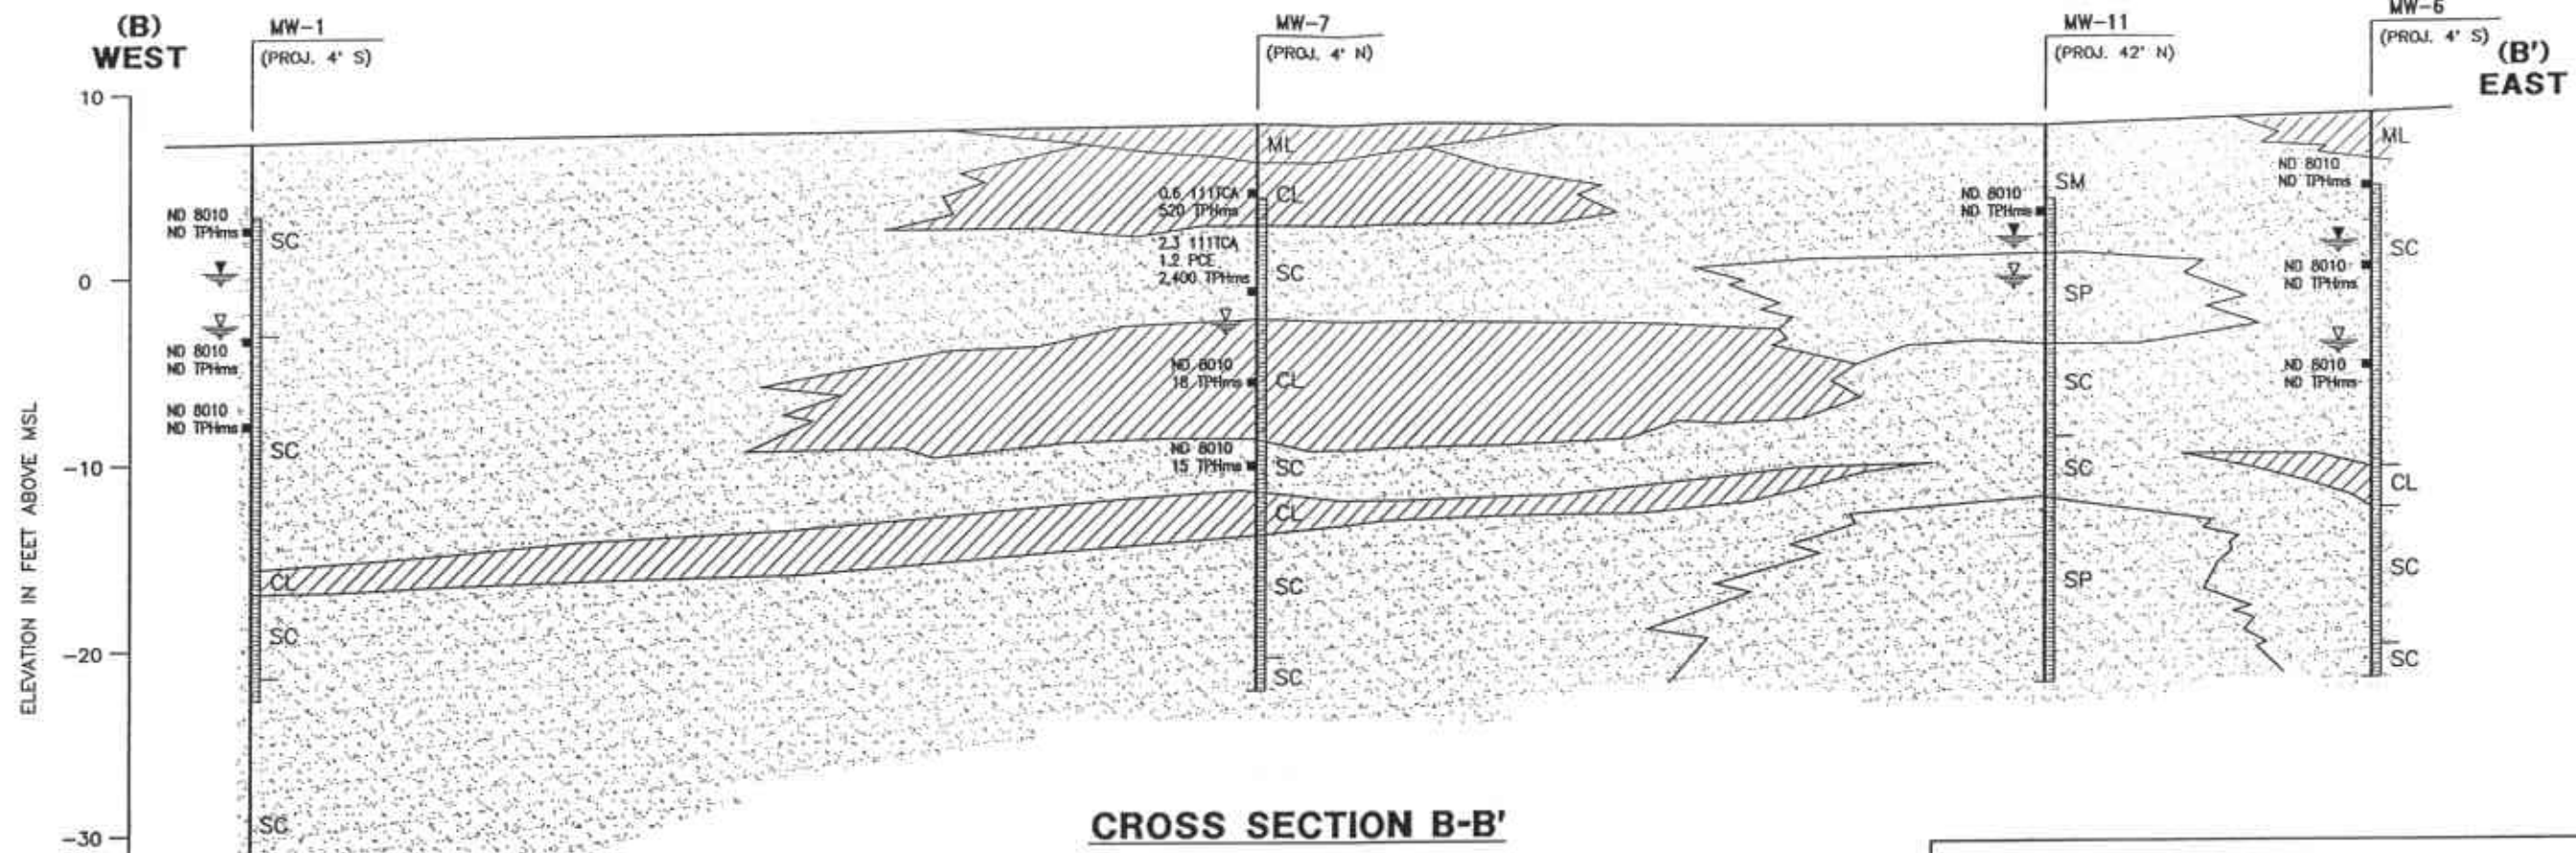
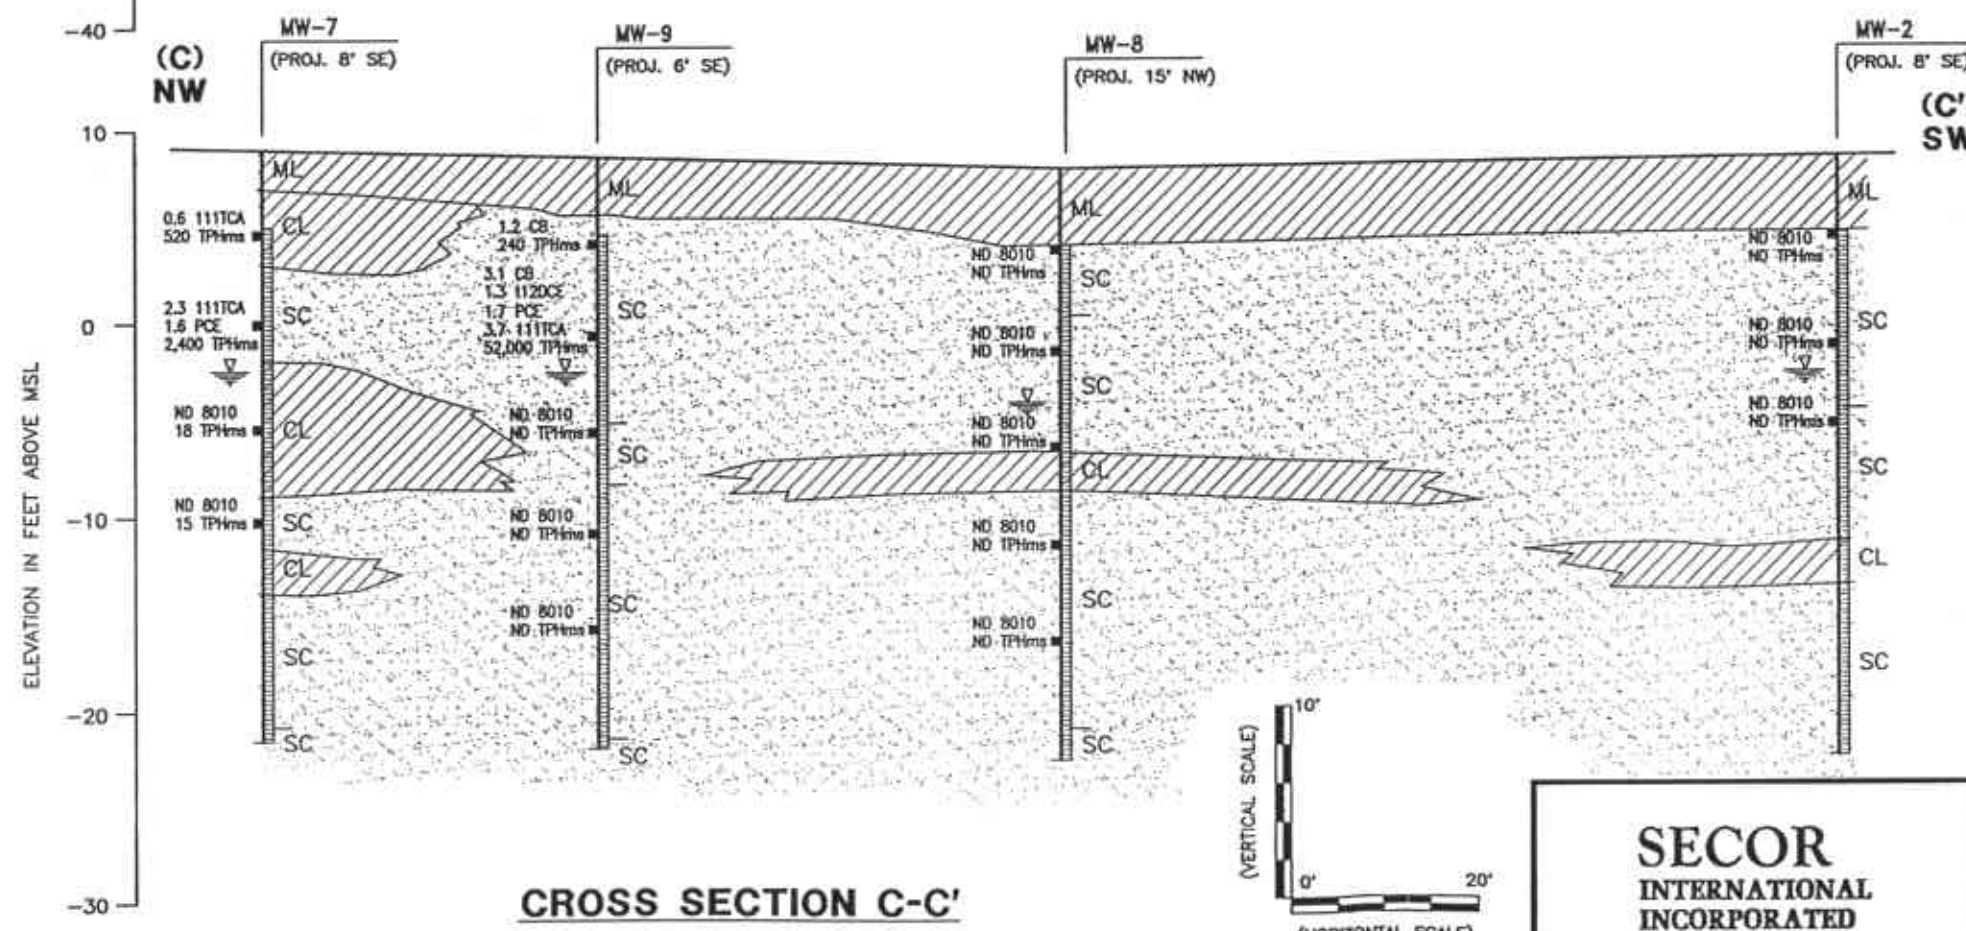
SECOR INTERNATIONAL INCORPORATED	DRAWN	CCR	FIGURE 10 SAFETY-KLEEN 400 MARKET STREET OAKLAND, CALIFORNIA
	APPR	RR/GH	
	DATE	24JAN96	
	JOB NO.		
GENERALIZED GEOLOGIC CROSS SECTION B-B' AND C-C'

Figures 8, 9, and 10 present generalized geologic cross sections based on soil boring data collected during the Site investigations. Included on the cross sections are the analytical results for soil samples collected from the borings. Mineral spirits and associated VOC impacts appear to have impacted the shallow soil in the vicinity of the USTs and return and fill shelter. Additionally, impacts have either directly impacted groundwater from the former USTs or have migrated from the vadose zone to the groundwater. Separate-phase product on the groundwater appears to be relatively static in the vicinity of the USTs and is present only in monitoring well MW-9 and extraction well RW-1. Dissolved VOC impacts from the Safety-Kleen facility are present in monitoring well MW-8 located in the entrance on Fourth Street. VOC impacts are present in monitoring wells MW-3 and MW-12 located downgradient from the Safety-Kleen facility; however, these impacts may be associated with the upgradient VOC plume detected in monitoring wells MW-4, MW-5, MW-6, MW-10 (prior to abandonment), and MW-11.
