**Site Characterization and Conceptual
Remedial Action Plan**

**Diesel Leak at
AC Transit, Emeryville**

Subject: AC Transit Facilities Improvement Program
Division 2, Emeryville
Site Characterization and Conceptual Action Plan
Diesel Fuel Discharge

89-021-R
July 1989

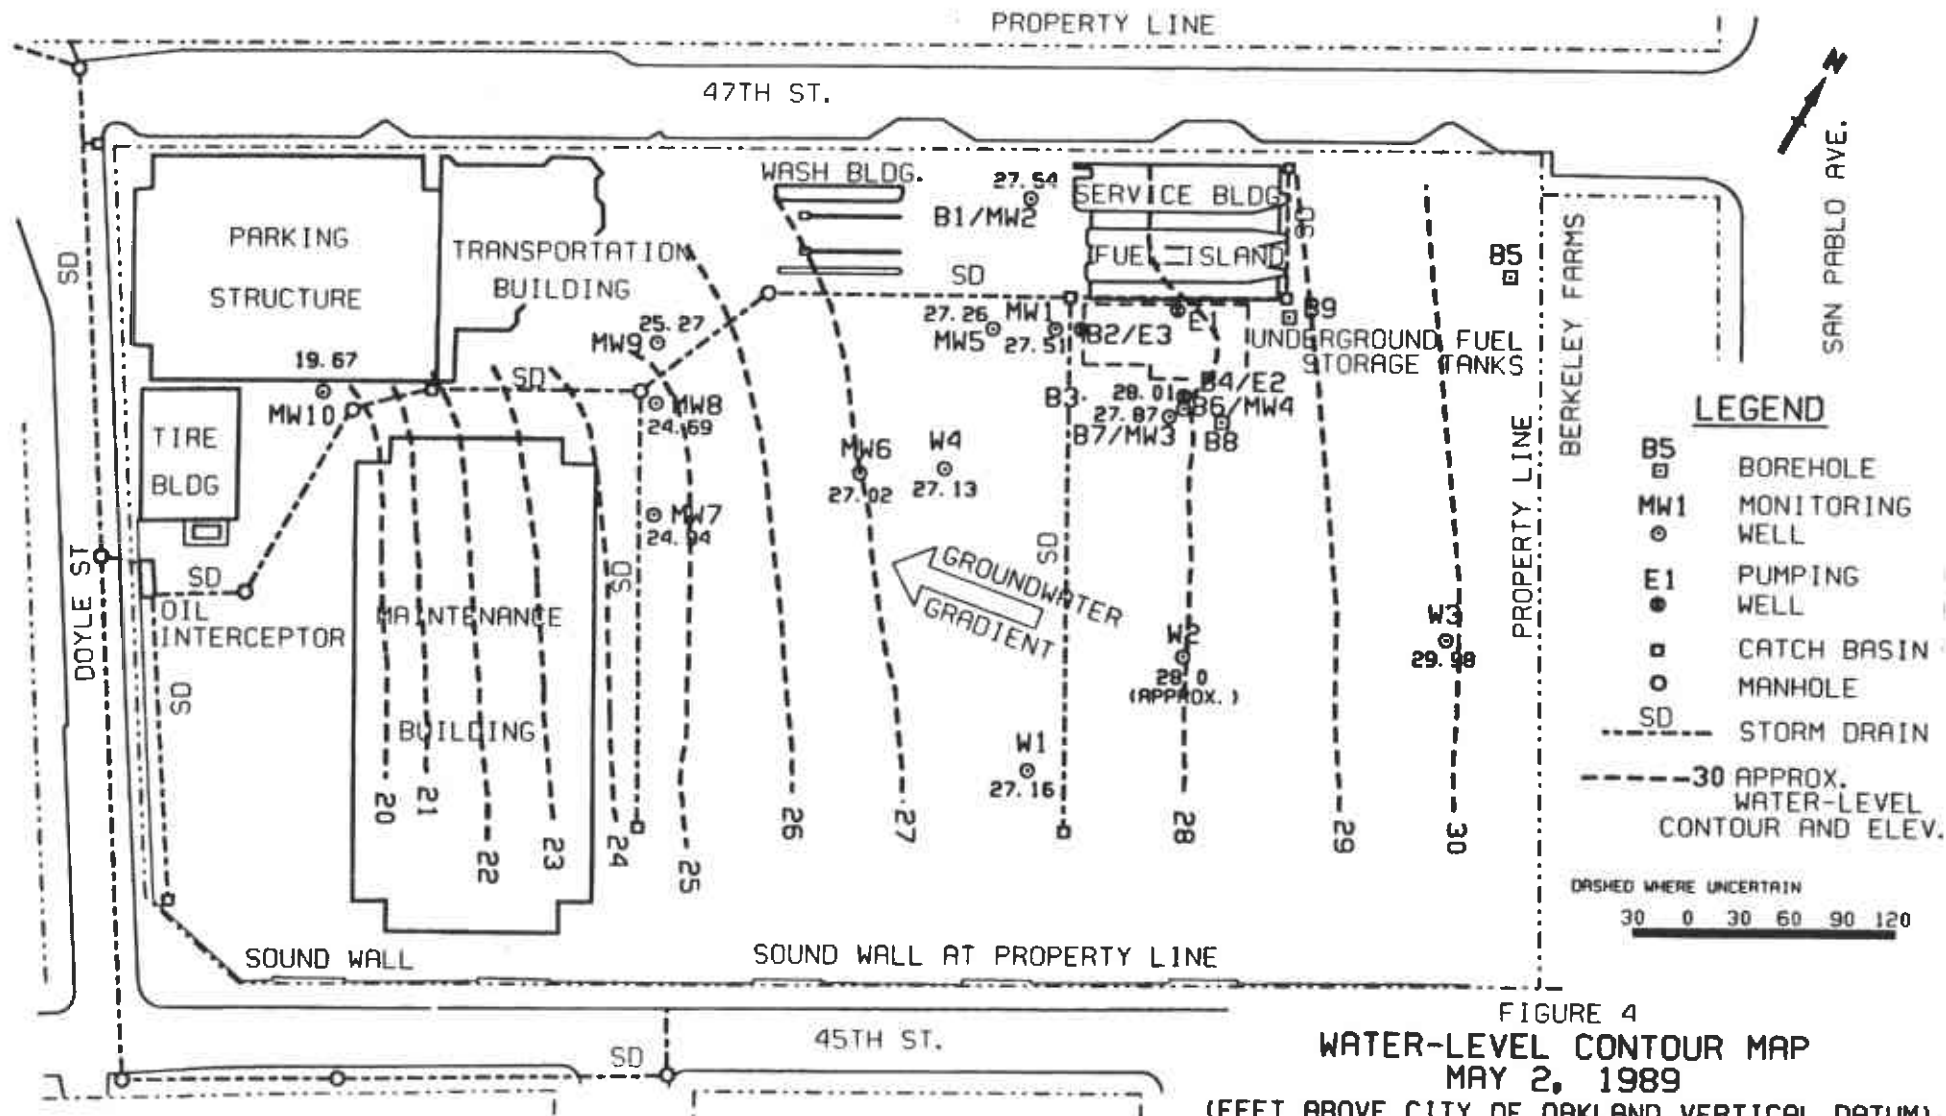
FIGURE 4
 WATER-LEVEL CONTOUR MAP
 MAY 2, 1989
 (FEET ABOVE CITY OF OAKLAND VERTICAL DATUM)
 AC TRANSIT EMERYVILLE
 KAISER ENGINEERS

Examination of Figure 4 indicates that groundwater flows from east to west across the site in a downgradient direction of approximately S65W (245° from north). The gradient is more gentle (flatter) on the eastern portion of the site. Steepening of the gradient to the west suggests the possibility of a reduction of transmissivity in that direction. The average gradient across the site is calculated to be 0.016 ft/ft.

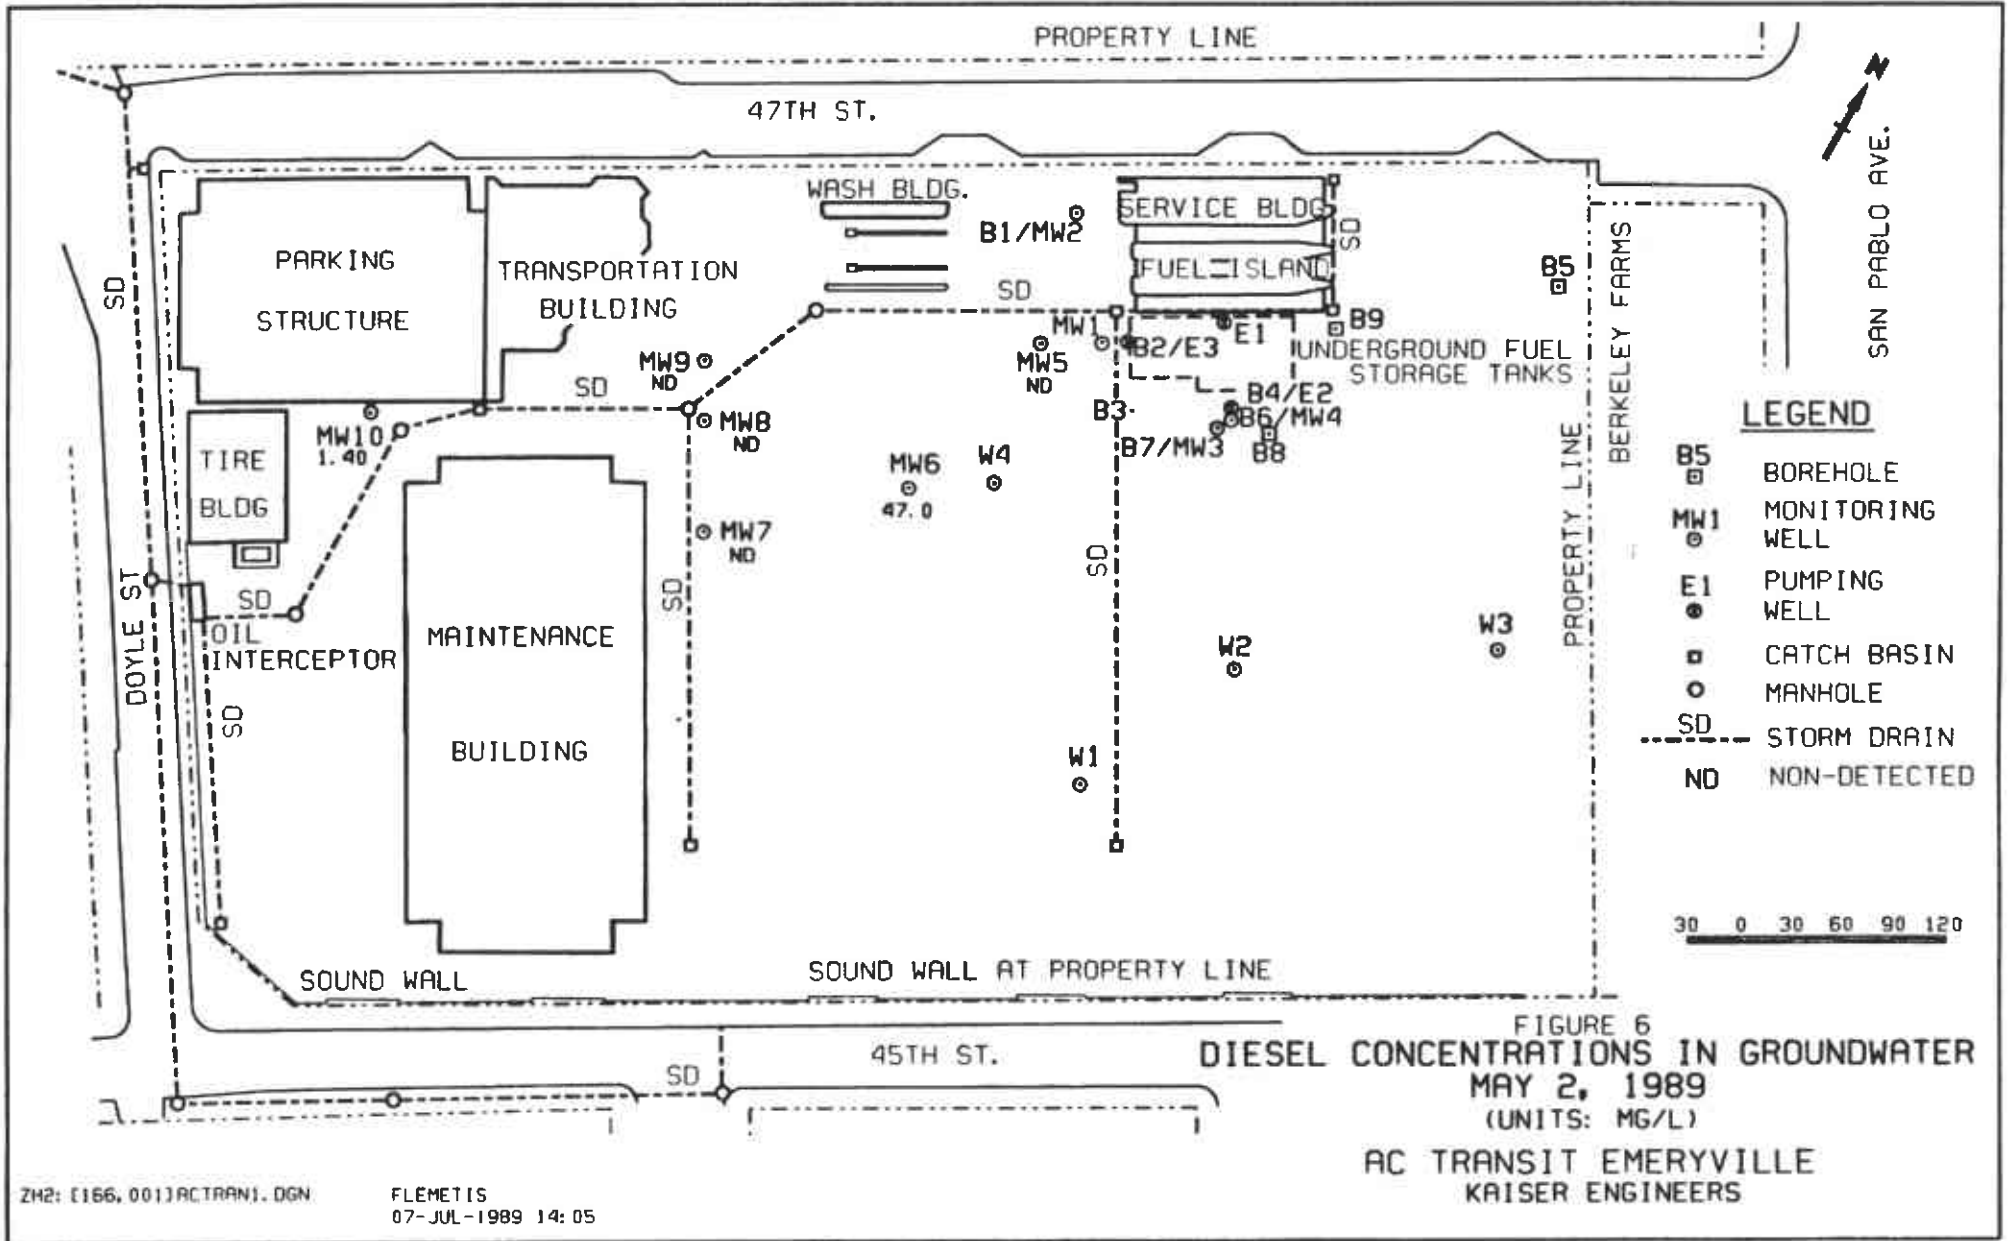
FIGURE 6
DIESEL CONCENTRATIONS IN GROUNDWATER
 MAY 2, 1989
 (UNITS: MG/L)
 AC TRANSIT EMERYVILLE
 KAISER ENGINEERS

Concentrations of dissolved TPH-D are shown on Table 3. Dissolved TPH-D in the vicinity of the tank farm was reported in groundwater from boring B9 (.066 mg/l), monitoring well MW4 (.07 mg/l), boring B8 (0.53 mg/l), and boring B3 (.48 mg/l). It is notable that boring B2/E3, which contains the highest reported concentration of TPH-D in the tank farm area, is between the tank farm and the subsurface N-S storm drain. B2/E3 is located in the pea gravel backfill area of the tank farm downgradient of the release point. The occurrence of dissolved TPH-D in groundwater diminished to nondetectable levels to the south at monitoring well MW3 and downgradient to the west at MW1. A TPH-D concentration of .56 mg/l was reported for the sample obtained from MW2 on May 2, 1989. However, groundwater obtained from this well on June 1, 1989, contained no detectable levels of TPH-D.

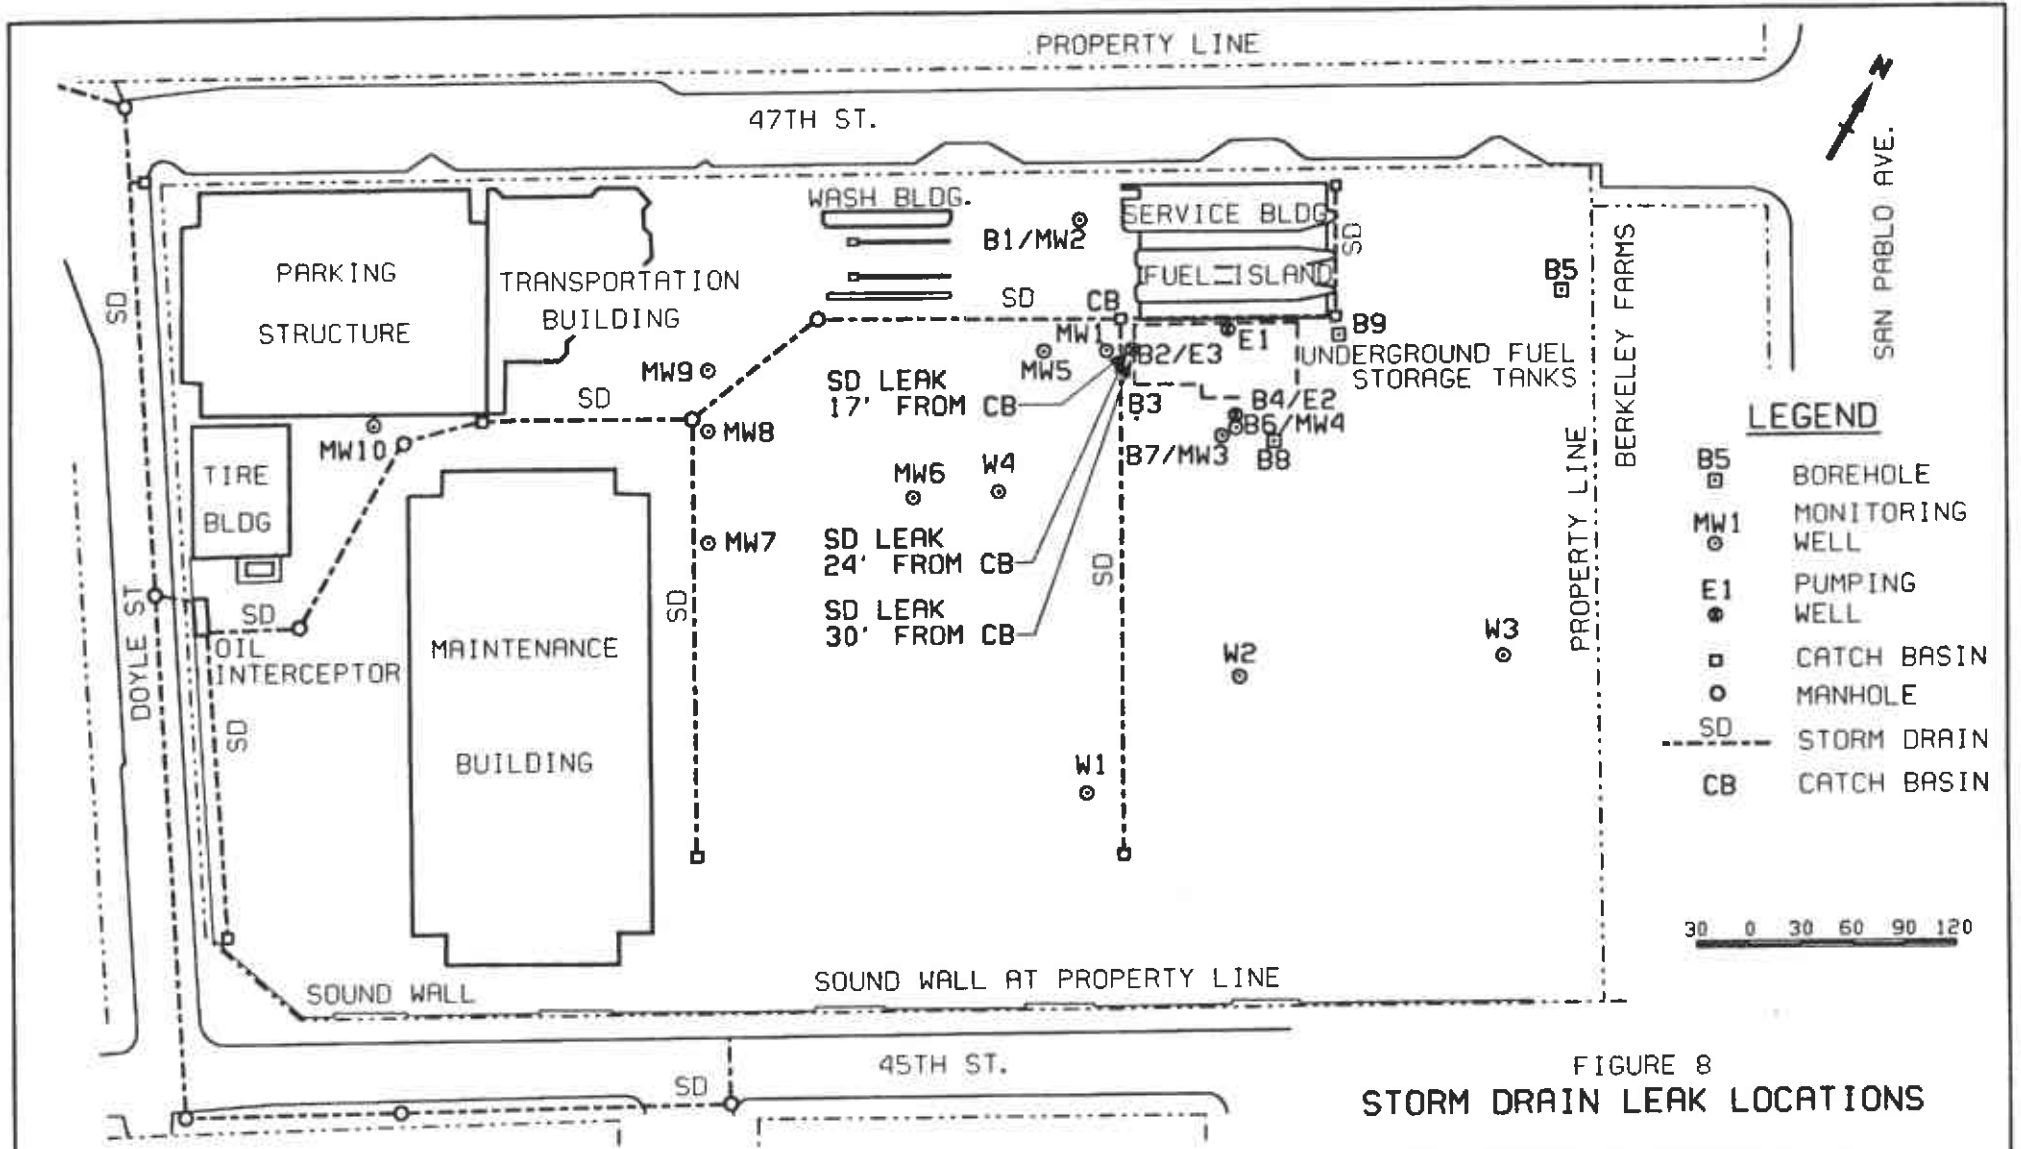
FIGURE 8
 STORM DRAIN LEAK LOCATIONS
 AC TRANSIT EMERYVILLE
 KAISER ENGINEERS

Because the storm drain was suspected of functioning as the conduit for flow of diesel from the tank farm to the oil interceptor, AC Transit undertook a video pipeline survey to obtain visual confirmation. Leaks of groundwater and free product into the storm drain at locations immediately adjacent to the western edge of the tank farm area are shown on Figure 8 and are clearly visible on the video tape. Leak location information is provided in Volume II, Appendix A.

Recognizing that the storm drain functioned as an intercept to collect the flow of diesel and groundwater from the tank farm, AC Transit did not repair the leaks.

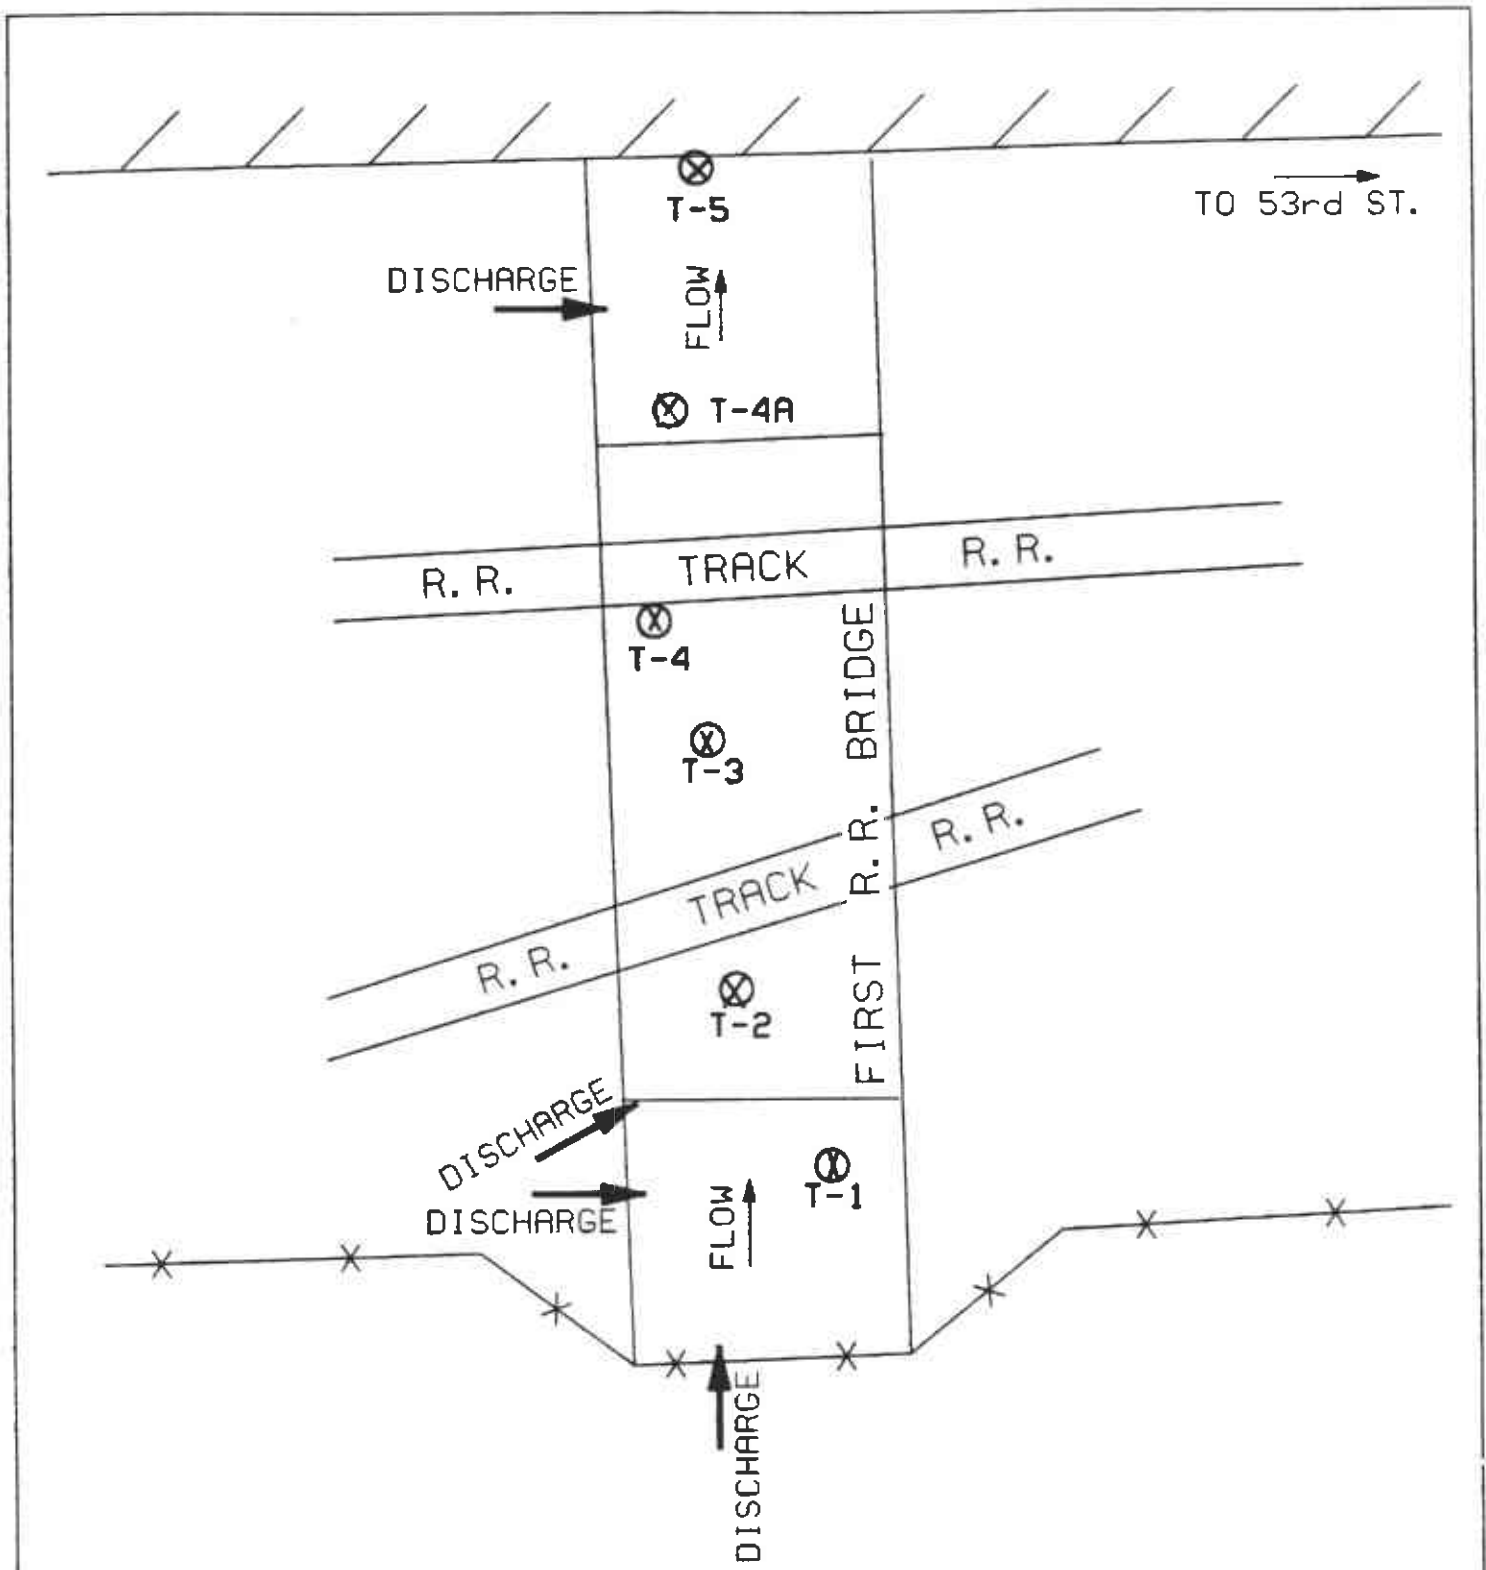
FIGURE 9
**TEMESCAL CREEK INVESTIGATION
 SAMPLE LOCATIONS**

Diesel levels in the soil ranged from 290 mg/kg at T2 to 4100 mg/kg at T4. At T4, 11,000 mg/kg of oil and grease was also detected.
