RE: Initial Remedial Measures at Union Pacific Motor Freight Facility located at 1750 Ferro Street, Oakland, California.

UNION PACIFIC MOTOR
FREIGHT FACILITY
OAKLAND, CA

SITE MAP

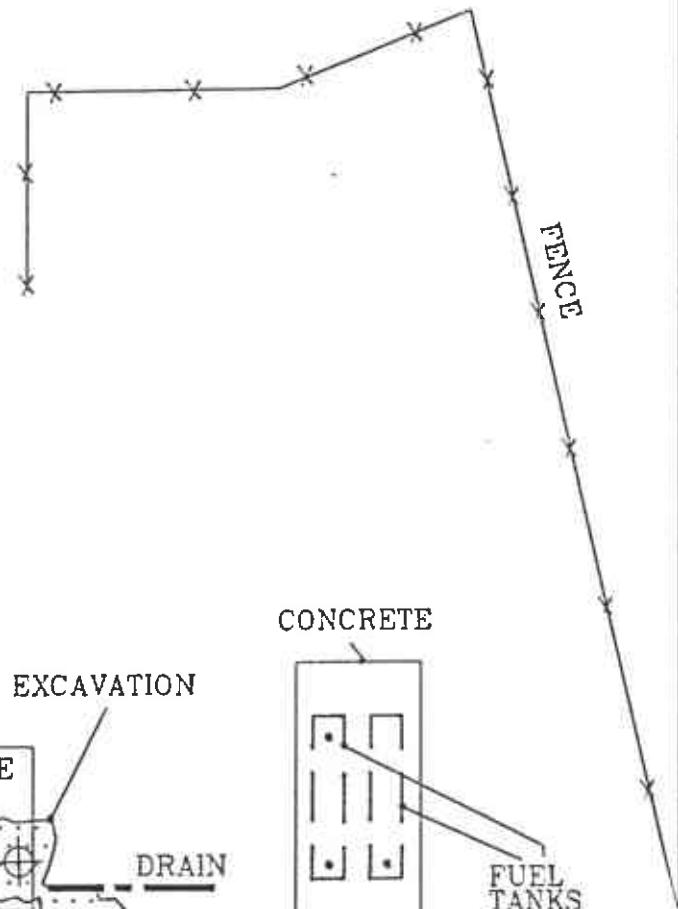
Results of tank integrity tests indicated that product lines leading from a 3,000 gallon bulk oil storage tank were not tight. In late November, Union Pacific requested the removal of the bulk oil storage tank and associated piping to eliminate the system as a discharge source of oil. On 17 December, 1987, HUNTER removed the tank and associated piping and removed approximately 350 gallons of oil from the excavation by a vacuum truck (Figure 1).

Oil was observed ^{not} entering the pit from 7 locations along the sidewalls of the excavation. A majority of this inflow occurred from 4 points shown on Figure 1. At location 1, a continuous low flow occurred at a depth of 10 feet. At location 2, a low flow of reddish oil and a dark oil occurred in the pit at depths of 3 and 10 feet, respectively. The largest flow occurred at a depth of 10 feet along the southern face of the pit at locations 3 and 4.

Prior to backfilling the excavation, a large diameter well will be constructed in the excavation. ~~3-24 inch diameter steel~~

ceasing will be completed to a depth of 4 feet beneath the bottom of the current excavation. The excavation will then be backfilled with gravel to a depth of approximately 8 feet. The remainder of the excavation will be filled with clean soil, re-compacted, and re-surfaced with concrete. A 36-inch OD concrete manhole with a steel cover will be placed over the well for protection. An extraction system will be installed after the replaced concrete surface has cured.
