**REPORT
SITE HISTORY RESEARCH
U.S. POSTAL SERVICE EMERYVILLE FACILITY
6121 HOLLIS STREET
EMERYVILLE, CALIFORNIA**

**Job No. 03711-127-043
March 26, 1993**

HAZARDOUS WASTE
SURVEILLANCE AND COMPLIANCE REPORT

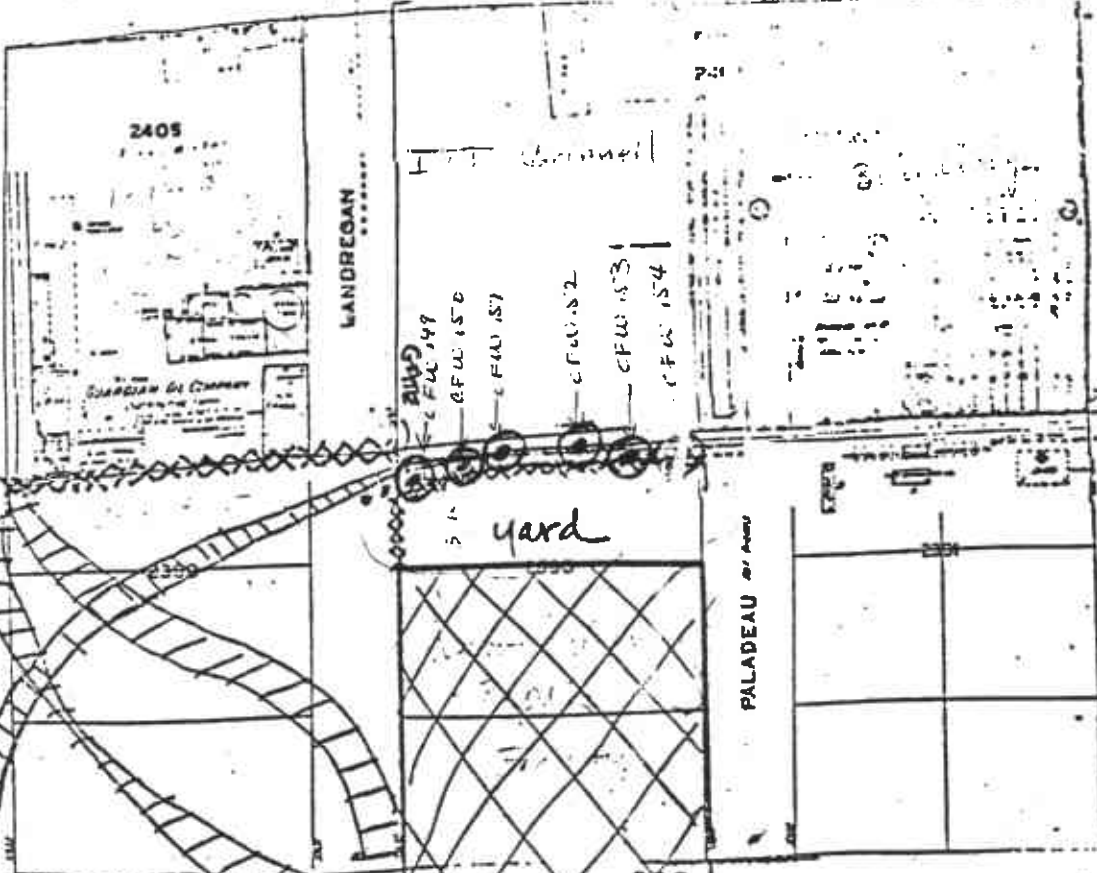
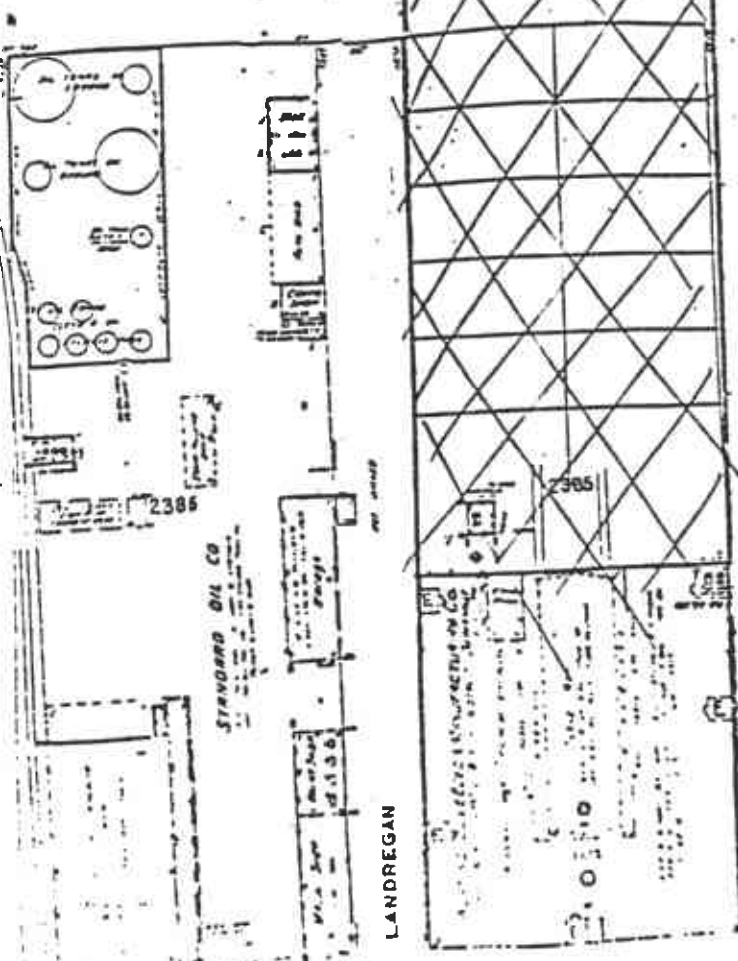
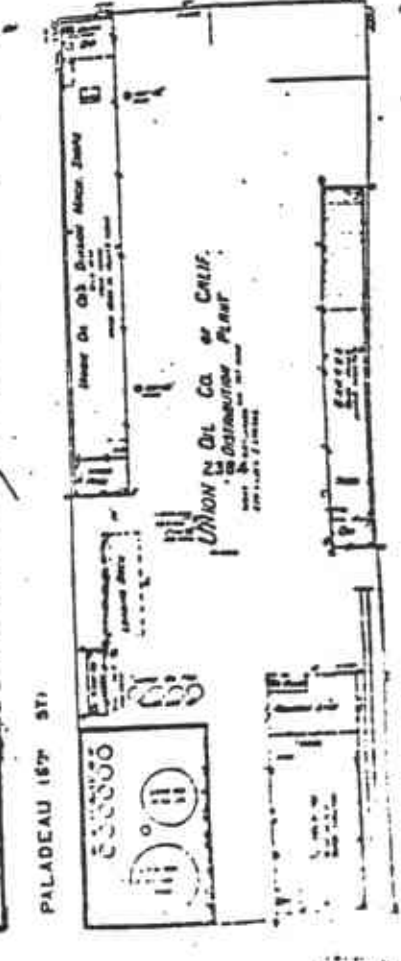
Observations: The RR spur mentioned above is an extension of the SW-NE spur that runs across the vacant lot owned by Westinghouse (see Westinghouse report of Feb. 9 and 10, 1981 and attached map). The oily stain which was present along this spur in the vacant lot extended along the spur onto the ITT Grinnell property. In addition, several other discrete oily stains were observed along this spur. At one point sawdust was seen at an oily stain next to the fence separating ITT Grinnell property from the Westinghouse repair facility yard. Directly on the other side of the fence on the Westinghouse side there was a transformer, ~ 3' x 2' x 2', in an open wood crate with sawdust surrounding its base. These areas were sampled (see attached map and sample receipt). Analyses results yielded PCB concentrations ranging from 17,000 ppm - 24 ppm (see attached laboratory report).

The Westinghouse repair facility yard is paved with concrete. At the north edge of the yard the concrete curves upward for ~ 2". This raised edge is present except for a distance of ~ 1' on the north side of the yard about 1' from the west edge (at location of sample CFW 149 on attached map). There the edge of the concrete

was not curved upwards so that any drainage from the yard would flow through this opening onto ITT Grinnell property and then west along the RR spur into the vacant lot.
