**Re: Emeryville, CA - Preliminary Soil Quality Evaluation  
Proposed Emeryville Postal Facility**

RE: PRELIMINARY SOIL QUALITY  
EVALUATION  
6121 HOLLIS STREET  
EMERYVILLE, CALIFORNIA

**PROPOSED EMERYVILLE POSTAL FACILITY**  
Emeryville, California

**PRELIMINARY SOIL QUALITY EVALUATION  
PROPOSED EMERYVILLE FACILITY  
6121 HOLLIS STREET  
EMERYVILLE, CALIFORNIA**

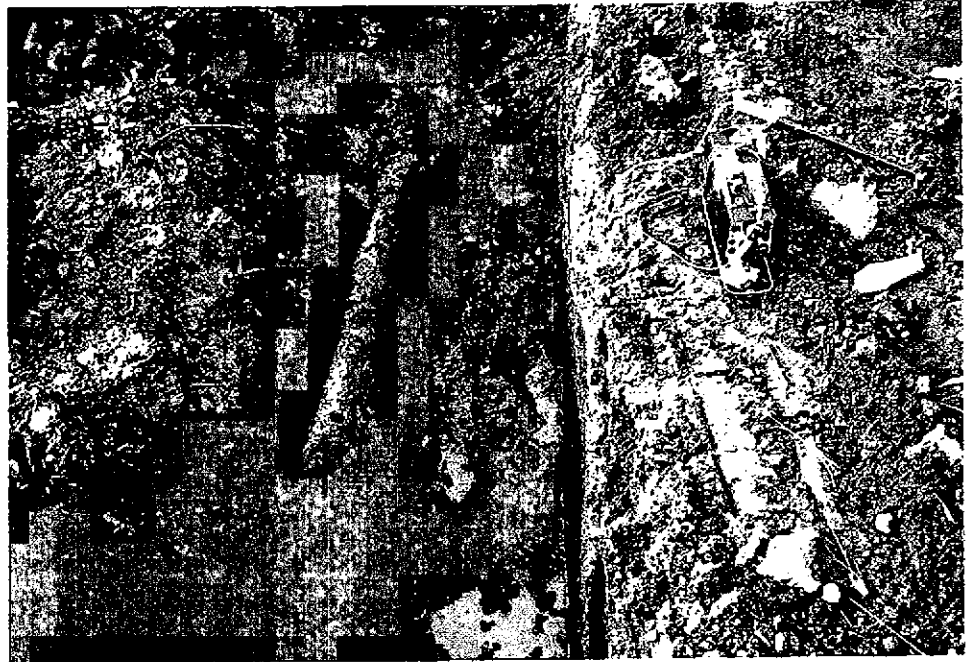
**Photograph #1**  
Trench A

Trench A was excavated at the southeast corner of the property to further evaluate a north-south trending pipeline that was previously encountered in this area (Dames & Moore, March 1993). The end of a 4-inch diameter pipe was encountered at a depth of approximately 1 foot. This pipe extends off-site to the north. The southern pipe end was capped; however, an approximately 1-inch diameter screw plug was open at the top of the pipe. No fluids were observed in the pipe. Black silty clay was encountered at the ground surface to the top of the ground water table at a depth of approximately 3.5 feet. The silty clay visually appeared to be saturated with petroleum oil. Two soil samples (SS-8) collected at a depth of 1.5 and 3.0 feet revealed TPH as gasoline, TPH as diesel and petroleum oil at levels up to 320 ppm, 2,500 ppm and 13,000 ppm. An oil sheen was also observed floating on the ground water (Figure 4B).

The source of oil encountered and the purpose of the pipe were unclear. However, Because the pipe runs off-site, it is likely a former utility line.

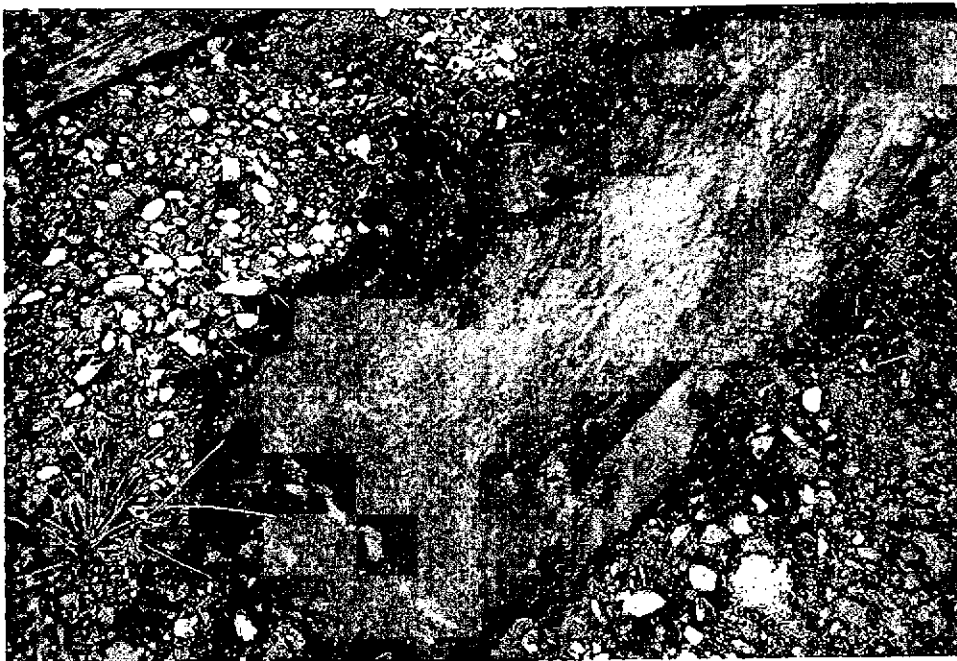
**Photograph #2**  
Trench B

To evaluate soil quality along a former railroad spur, Trench B was excavated along the western site boundary. Approximately 1 foot of dark brown gravelly fill was encountered below the former track spur. Soil sample SS-7 was collected at a depth of 0.5 feet; TPH as diesel, petroleum oil, and PCB 1260 were detected at 37, 670, and 0.62 ppm, respectively. This gravel was underlain by brown silty clay to a depth of 3.5 feet. Between 3.5 to 4.5 feet, an increase in sand and gravel content as well as a strong petroleum odor were noted. A grayish green soil discoloration and OVM reading of over 1,000 ppm were noted. A diesel-like product was observed on the ground water which was encountered at a depth of 4.5 feet.

PCB 1260 and elevated levels of lead and zinc were also detected in one soil sample collected beneath the railroad spur near the western property boundary. This sample was collected at a depth of 0.5 feet from the gravelly fill material. This gravel layer is approximately 1 foot thick. The lead, zinc, and PCB 1260 concentrations detected in this material were below their respective TTLC values of 1,000, 5,000, and 50 ppm, respectively.

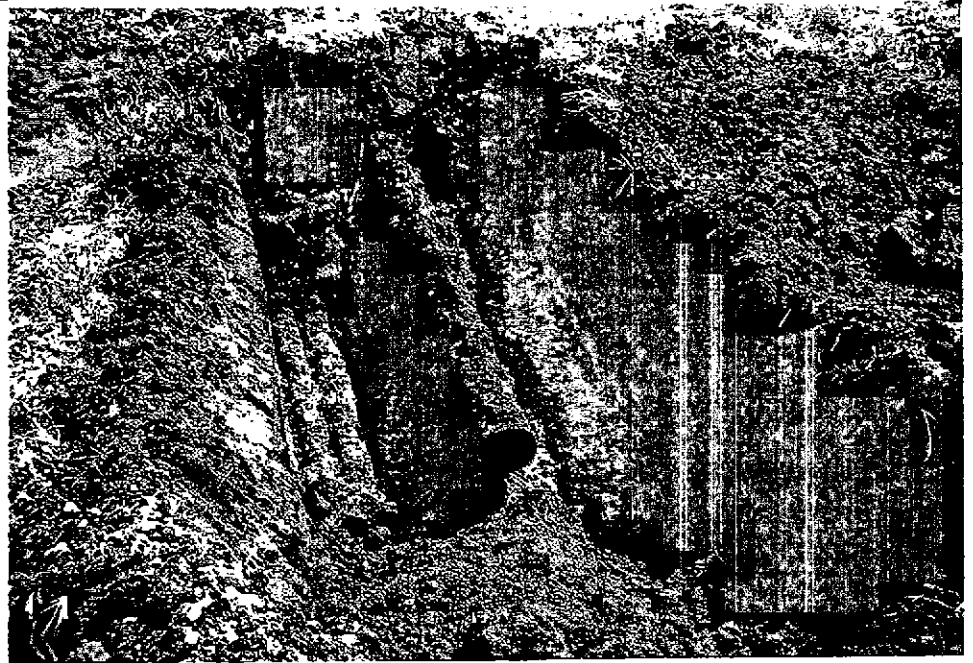
**Photograph #3**  
Trench C

Trenches C, D, and E were excavated along an east west trending pipeline that was uncovered during previous on-site work (Dames & Moore, March 1993). This pipe was buried at a depth between 2.0 and 3.5 feet; it was 6 inches in diameter at the west end and 4 inches diameter pipe at its east end. The west end of the pipe was open and filled with soil. The eastern end was submerged in the existing water filled excavation.

Discolored grayish green soil (sandy/gravelly clay) was generally encountered between depths of 2.5 to 5-feet. OVM readings ranged to over 1,000 ppm with the highest levels recorded in Trenches C and E. Soil Sample SS-4 was collected at a depth of 4.5-feet in Trench E. TPH as diesel, TPH as gasoline and petroleum oil was detected at 880, 320 and 1,200 ppm,

respectively. Between the depths of 5 and 7 feet, a decrease sand and gravel content as well as discoloration was observed. A second soil sample was collected at 7 feet. TPH as diesel and TPH as gasoline was detected at 34 and 2.6 ppm, respectively. Near the surface of the ground water, an increase in the grayish green discoloration was observed.

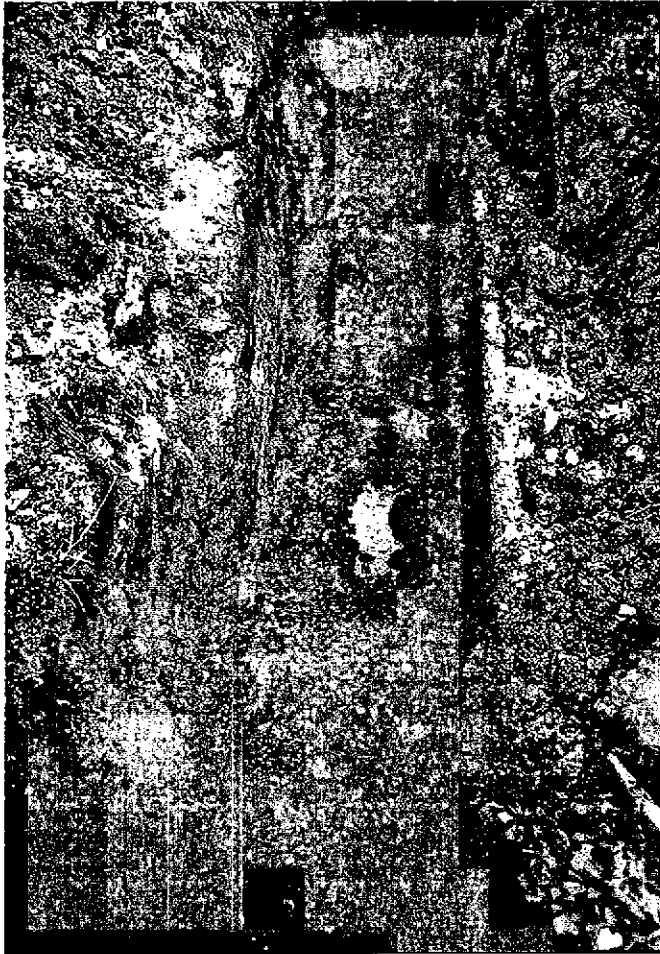
**Photograph #4**  
Trench F

Trenches F and G were excavated along a 2-inch diameter pipe that was capped at its western end. This pipe was buried at a depth of approximately 2.5 feet and extended off-site to the east. Similar to the other trenches, discolored grayish-green silty and sandy clay was encountered extending downward from a depth of approximately 3 feet. An increase in sand and gravel was observed with depth. Ground water was encountered at a depth of approximately 6 feet. A diesel-like product was observed on the ground water. OVM readings ranged to over 1,000 ppm. Four soil samples were collected from Trenches F and G. TPH as diesel, TPH as gasoline and petroleum oil were detected at levels up to 2,900, 2,200 and 980 ppm, respectively.
