**Phase I
Environmental Site Assessment
40th Street Right-of-Way
Emeryville, California**

**June 29, 1993
1649.00-15**

**Prepared for
Catellus Development Corporation
201 Mission Street
San Francisco, California 94105**

**PHASE I ENVIRONMENTAL SITE ASSESSMENT
40TH STREET RIGHT-OF-WAY
EMERYVILLE, CALIFORNIA**

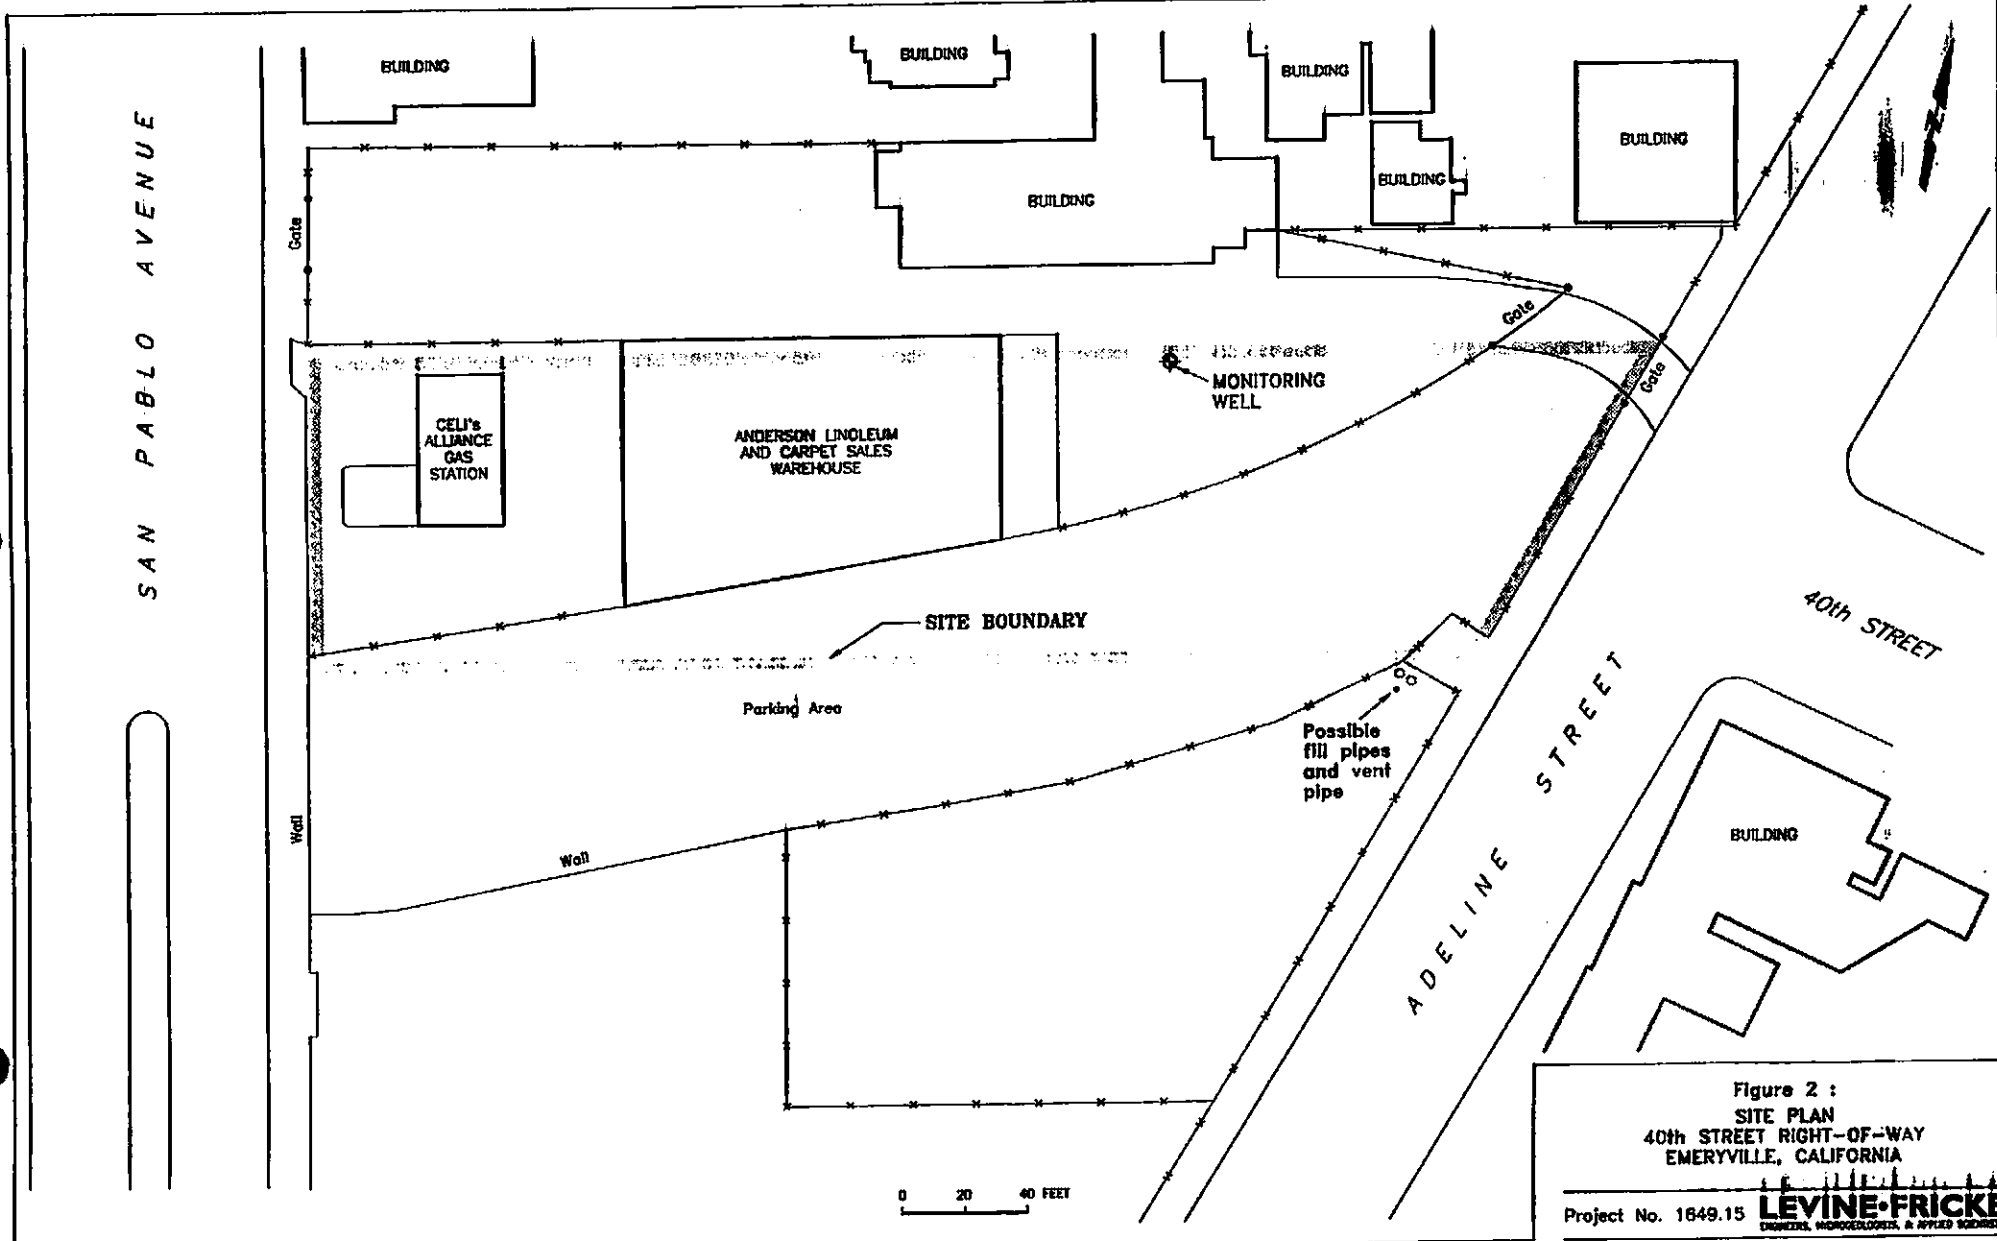
Figure 2 :
 SITE PLAN
 40th STREET RIGHT-OF-WAY
 EMERYVILLE, CALIFORNIA

At the time of the site visit, the Site consisted of a fuel station located along San Pablo Avenue, a warehouse building located behind this station facing Adeline Street, and a portion of an asphalt-paved parking lot (Figure 2). The fuel station was operating and had numerous vehicles parked in and around the station building in various stages of disrepair. The paved surfaces in and around the station and many of the automobiles appeared to be moderately to heavily oil stained. The area behind the station building was heavily stained with oil and a 55-gallon drum with a hand pump, possibly containing oil or fuel, was visible in this area. Vent pipes, apparently connected to underground storage tanks (USTs), were observed to extend from the ground surface to above the roof line at the southeast corner of the building. The position of the associated tanks could not be assessed because of the presence of the vehicles. Fill pipe covers were visible in front of the station, near the northwest corner.

The warehouse building was located directly behind the fuel station and was occupied by Anderson Linoleum and Carpet Sales at the time of the site visit (Figure 2). The entrance to the warehouse faced Adeline Street, and consisted of loading docks and doors. The area directly in front of the loading docks was concrete paved with the remainder of the area paved with asphalt. The cover to a monitoring well was observed immediately adjacent to the concrete-paved area along the site boundary (Figure 2). A 55-gallon drum labeled MW-1, and apparently containing water from the monitoring well, was observed on the adjacent property immediately north of Site (Tire Center, Inc., 4070 San Pablo Avenue). Mr. Donald Moore was listed on the label of the drum (telephone number 415-882-1548). The Tire Center site is listed by the RWQCB as a fuel leak case (under the name of the San Francisco Bread Company); therefore, the monitoring well could be associated with the investigation of the fuel leak case. No numbered address was identified for the warehouse, and the address posted on the fence (40th and Adeline streets) was not found on any of the agency lists checked. No significant staining was observed in the vicinity of the warehouse.

The parking area portion of the Site did not contain visible structures (Figure 2). Railroad tracks were visible crossing San Pablo Avenue and the adjacent sidewalk. Portions of the tracks appeared to have been paved over in-place or removed and the roadway or sidewalk surface repaved. The asphalt paving appeared to be in good condition without significant staining. A concrete-paved area with a slightly raised platform (approximately 6 inches) was observed immediately adjacent to the approximate southeast corner of the Site (or possibly on the Site, depending on the exact boundary location). The ends of two possible tank fill-pipes and a possible vent pipe (cut off at the ground surface) were observed north of the platform (Figure 2).

On the basis of the observations made during the perimeter site visit and agency record review, Levine-Fricke recommends that a comprehensive site visit be conducted as soon as access to the Site can be negotiated.

Because of the fuel station's lengthy history at the Site, the likelihood of potential environmental concerns is high. Records regarding the current condition and status of the USTs located at the fuel station should be obtained from the ACHA as soon as they are available. If records regarding the USTs are not available or are inconclusive regarding the past and

present condition of the USTs, tank integrity testing and possible soil and ground-water sampling may be necessary to evaluate the potential effects of the USTs on soil and ground-water quality beneath the Site.

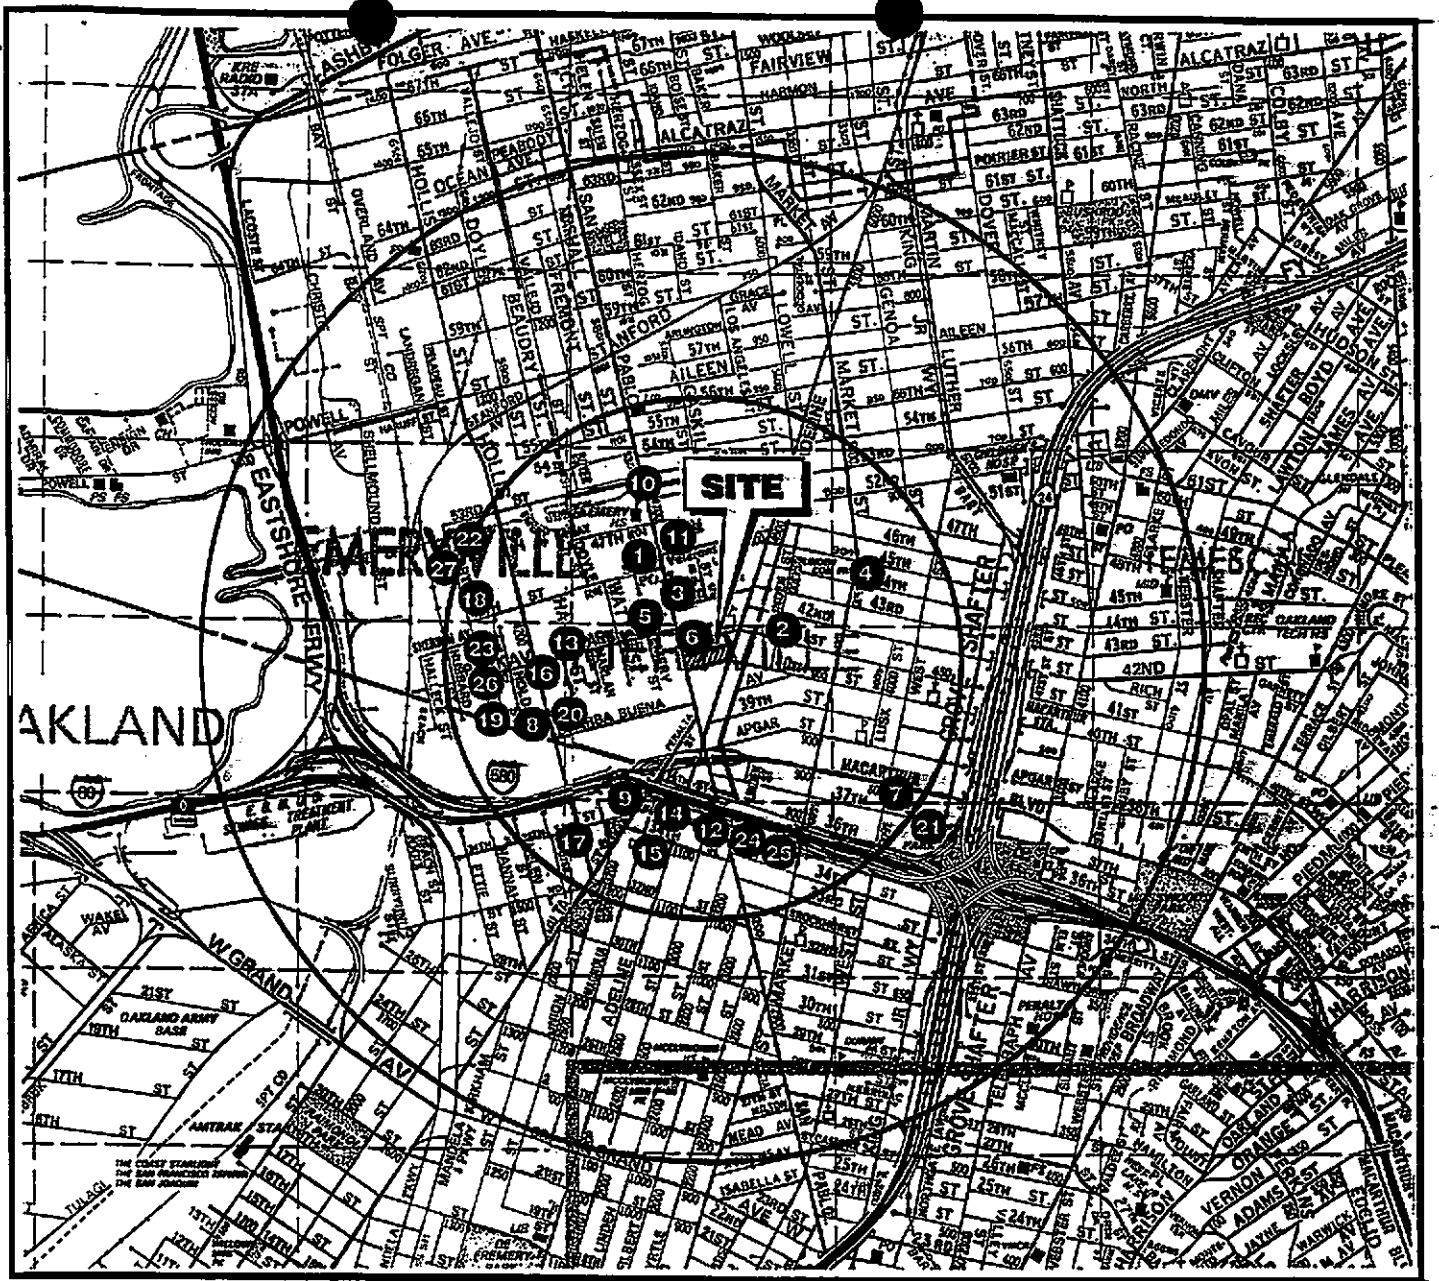
**Figure 3 : FUEL LEAK CASES LOCATION MAP
 YERBA BUENA PROJECT SITE**

The Site was not found on the lists reviewed. Twenty-seven fuel leak cases have been reported within 0.5 mile of the Site (Figure 3), and 19 toxics or CalSites cases have been reported within 1 mile of the Site (Figure 4). No federal Superfund sites under the jurisdiction of the RWQCB have been reported within 1 mile of the Site.

Six of the 27 identified fuel leak cases (1 through 6 listed above) were located upgradient or crossgradient (within 0.25 mile) from the Site (Figure 3). Summaries of these six cases are presented below.

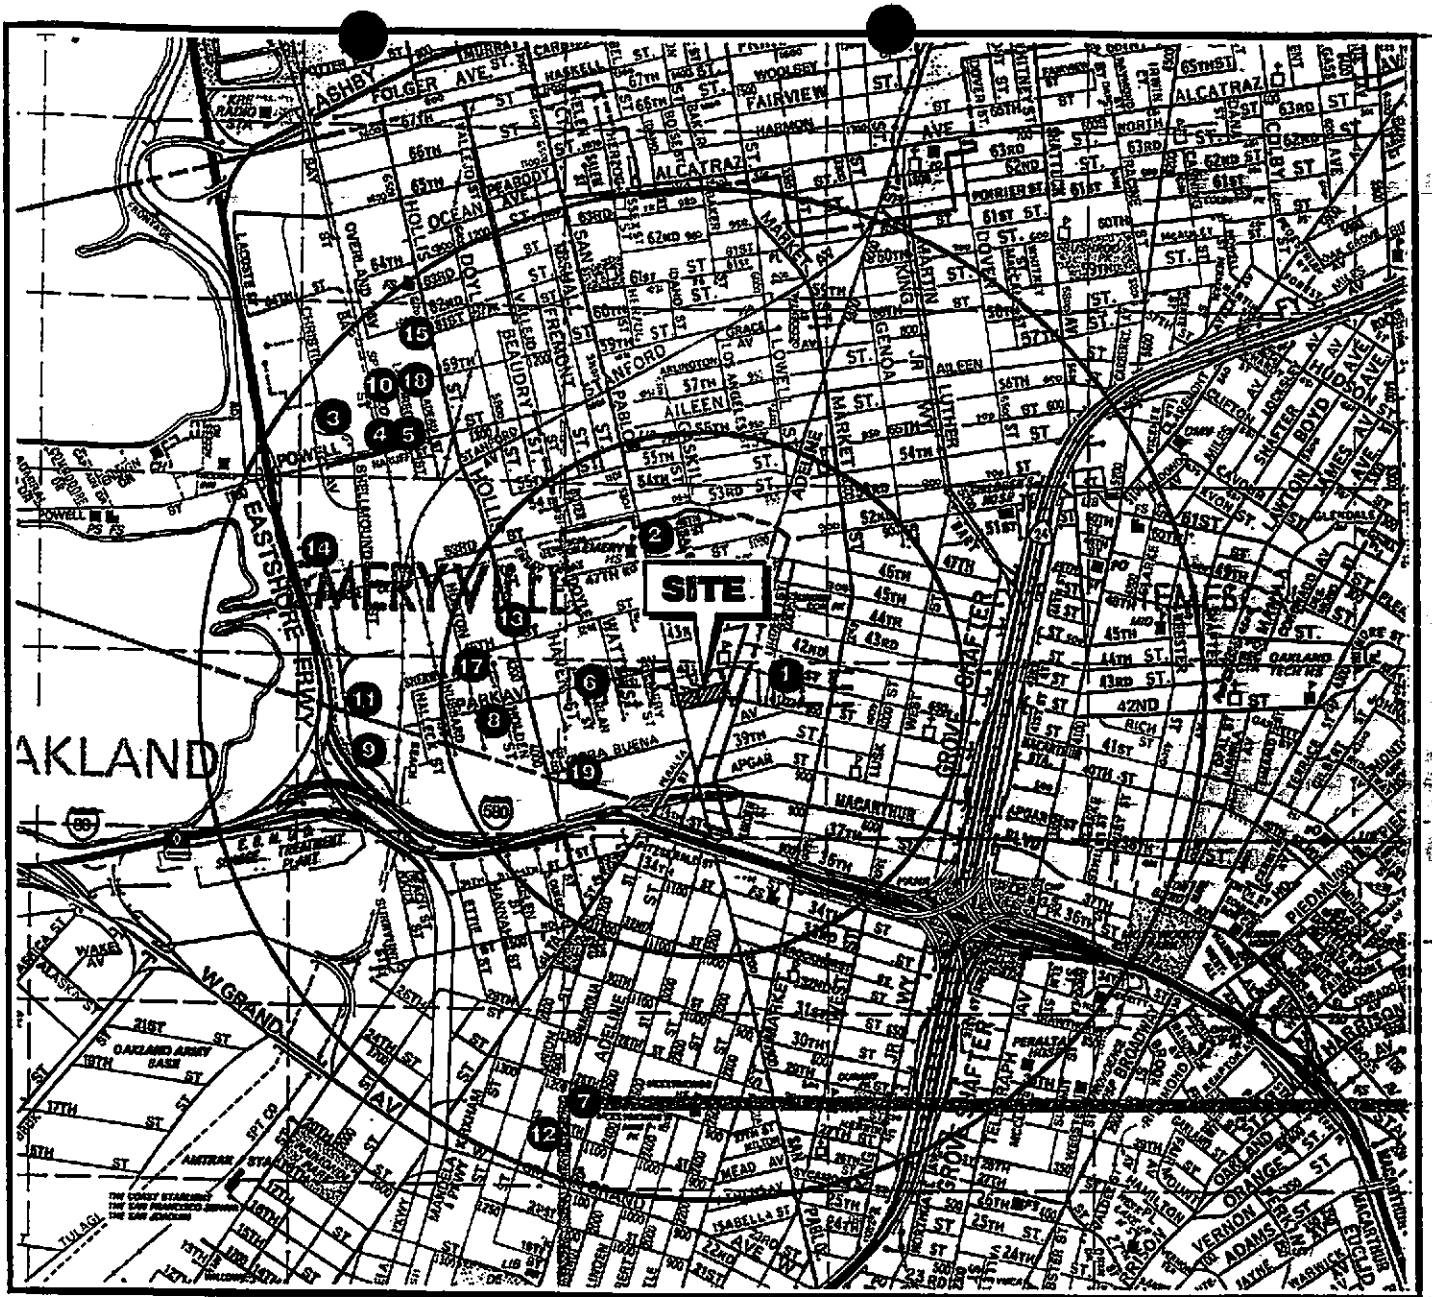
One of the 19 identified fuel leak cases (Dunne Quality Paints) was located upgradient from the Site (Figure 4). A summary of this case is presented below.
