**REPORT
ASBESTOS BUILDING INSPECTION**

Former Unocal Service Station 1871
96 MacArthur Boulevard
Oakland, California

ERI Job No. 227026.R01

January 30, 1998

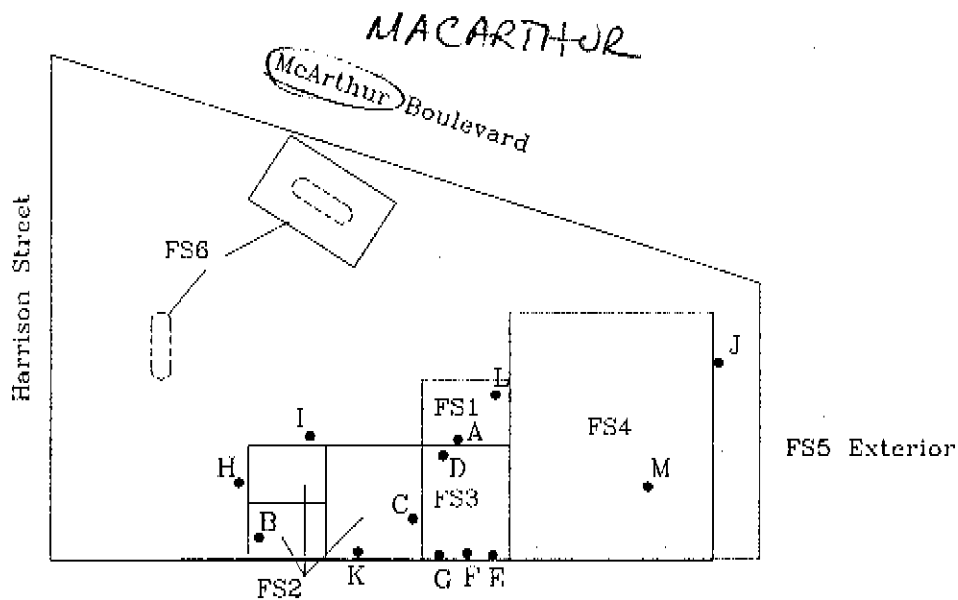
PLATE

analyzed using PLM. Asbestos in the form of chrysotile was detected at a concentration of 2% in the interior panel seam caulking, 1% in the 12"x12" VAT tiles and mastic, and 2% in the brown roofing mastic. The caulking is also present in the cashier's office and manager's office (total amount: approximately 300 ln ft). Asbestos was not detected in any of the remaining samples collected and analyzed. A single line sketch indicating the location of each sample is presented as Plate 1.

- A 1-5-1
- B 2-7-2
- C 2-8-3
- D 3-5-4
- E 3-6-5
- F 3-6-6
- G 3-6-7
- H 5-4-8
- I 5-4-9
- J 5-4-10
- K 5-7-11
- L 5-7-12
- M 5-7-13
