FREE PRODUCT INVESTIGATION REPORT FORMER GLOVATORIUM FACILITY 3815 BROADWAY OAKLAND, CALIFORNIA

November 19, 2002

Project 2512

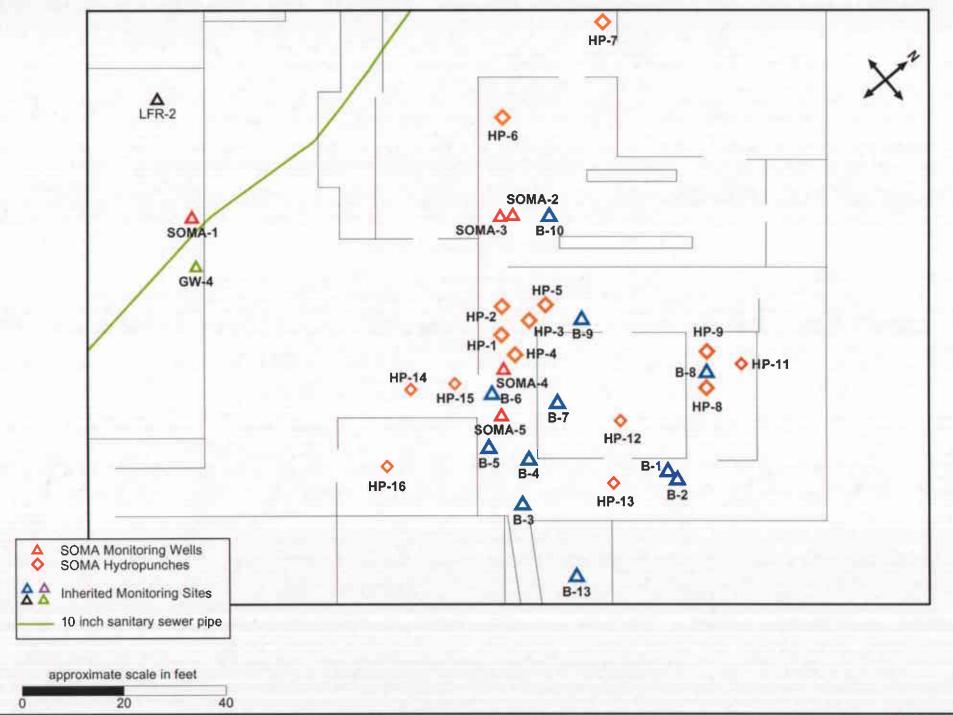
Figure 2: Location of SOMA monitoring wells, SOMA hydropunches, and inherited monitoring locations within the former Glovatorium building.

On October 1, 2002, SOMA drilled six hydropunches as proposed to the ACDEH. Figure 2 shows the locations of all hydropunches (HP-11 through HP-16), and B wells where the free product was reported in the past. During the previous investigation no hydropunches were placed south of SOMA-4, which contains a significant amount of free product. In conducting the current investigation more hydropunches were placed to the south and in the vicinity of other locations where free product has been detected.

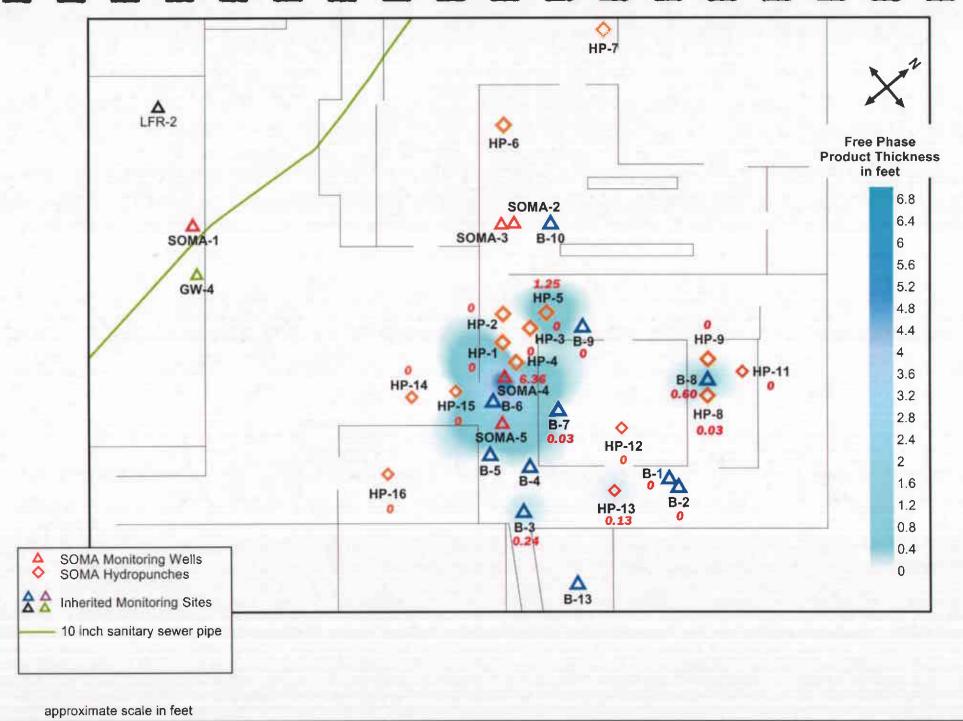
Figure 3: Contour map of free phase product thickness in feet. Oct. 8, 2002.

The current subsurface investigation revealed the potential extent of free product at the Site. Given the fact that the current investigation was conducted in the middle of a dry period the reported free product thickness could be considered maximum. To evaluate the horizontal extent of free product, the previous and recent hydropunch data on free product thickness along with product thickness measurements from B wells and SOMA-4 were compiled. The data were used to plot a product thickness contour map of the Site. As Figure 3 shows there are two distinct free product plumes inside the Glovatorium building. The first plume

is generally located around SOMA-4 and HP-5. The second free product plume is a small and isolated plume and is generally located around B-8. The maximum free product thickness was observed in SOMA-4. As discussed earlier, a passive free product removal canister was installed in SOMA-4 in June 2002.

Currently, free product is being removed from SOMA-4 on a weekly basis. To date a total of 19.75 gallons of free product has been removed from SOMA-4. SOMA will continue removing free product from SOMA-4 until the entire product is removed to the extent practicable, which is consistent with the RBCA process.
