July 12, 2002

Status of Free Product Removal from Monitoring Well SOMA-4 and Our Recommendation for Better Delineation of the Free Products Extent at the Former Glovatorium Site, 3815 Broadway Oakland, California

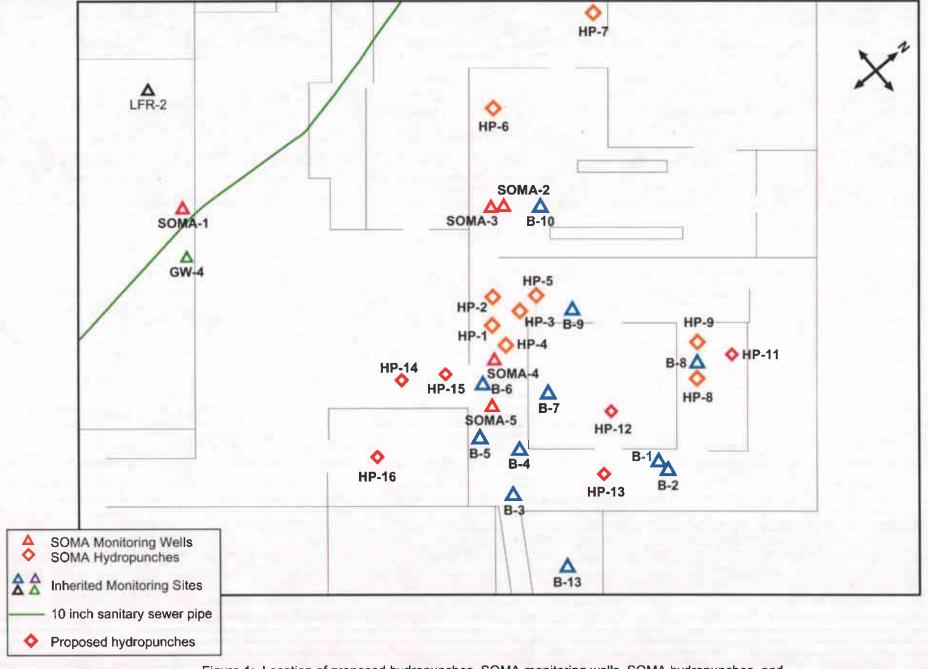
As you are aware in April 2002, depoint high groundwater elevations the extent of free product could not be delineated. Plesently, due to the decline in groundwater elevations, the free product, aness and its extent can be easily delineated using hydropunches. The hed Figure-1 shows the proposed locations of new hydropunches, HP-11 through HP-16. During the previous investigation no hydropunches were placed south of SOMA-4, which contains a

Figure 1: Location of proposed hydropunches, SOMA monitoring wells, SOMA hydropunches, and inherited monitoring locations within the former Glovatorium building.

significant amount of free product. In conducting the proposed investigation more hydropunches will be placed to the south and in the vicinity of other locations where free product has been detected.

Upon delineation of the extent of the free product the need for installing additional product removal skimmers will be evaluated. We believe that this process will adequately address the free product delineation and removal at the site. Once the free product issue is resolved, SOMA will conduct groundwater modeling and risk based corrective action (RBCA) in order to define the site's regulatory status as discussed in our approved workplan.
