Subject: Interim Remedial Action Progress Report

Former Sears Store No. 1058

2600 Telegraph Avenue, Oakland, CA 94612

IT Corporation Project 782807

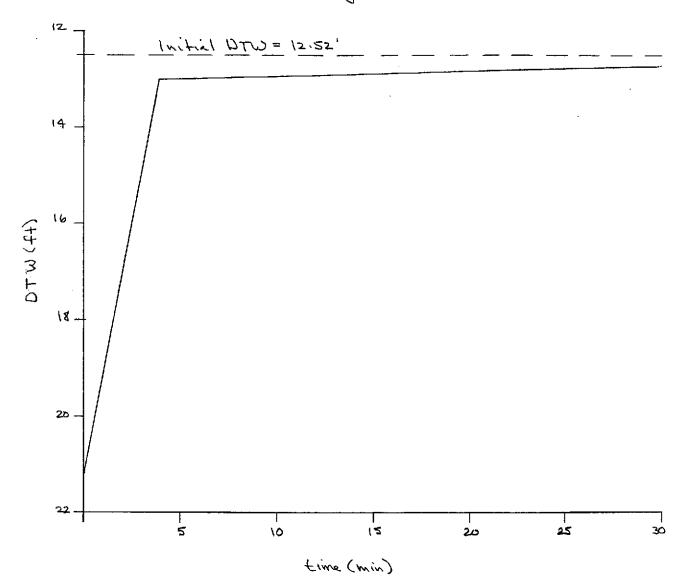
PROJECT Seavs Oakland Site # 1058	PROJECT NUM	MBER
SUBJECT Well Recharge - MW-3	BY	DATE
<u> </u>	PAGE	OF
CHECKED BY	DATE	5-11-99

Initial OTW = 12.52'

DTP = 12.52'

PT = Shean (Strong odor)

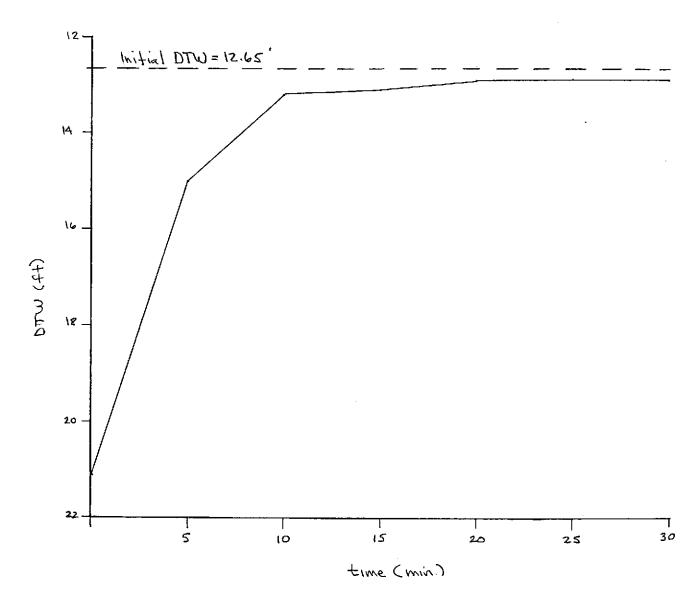
PROJECT Sears Oakland Site# 1058	PROJECT NU	MBER
SUBJECT Well Redwige - MW-3	BY	DATE
9	PAGE	OF
CHECKED BY	DATE 6	.2.99

Initial DTW = 12.65' DTP = 12.63' PT = 0.02'

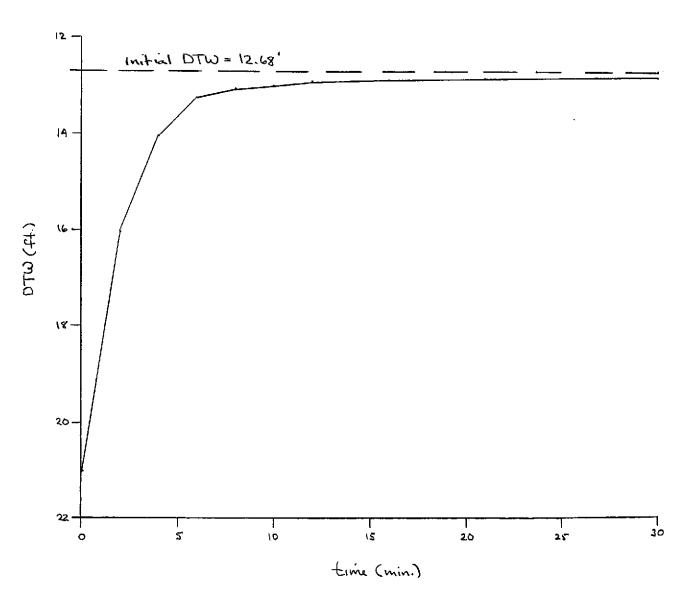
PROJECT Sears Oakland Site # 1058	PROJECT NUMBER
SUBJECT Liell Lechange - Mus-3	BYDATE
<u>a</u>	PAGE OF
CHECKED BY	DATE 6-10-99

NO PRODUCT DETECTED W/ I.P. OR BALLER HOWEVER A SHEEN WAS SEEN,

Initial OTW = 12.68' DTP = Sheen @ 12.68'

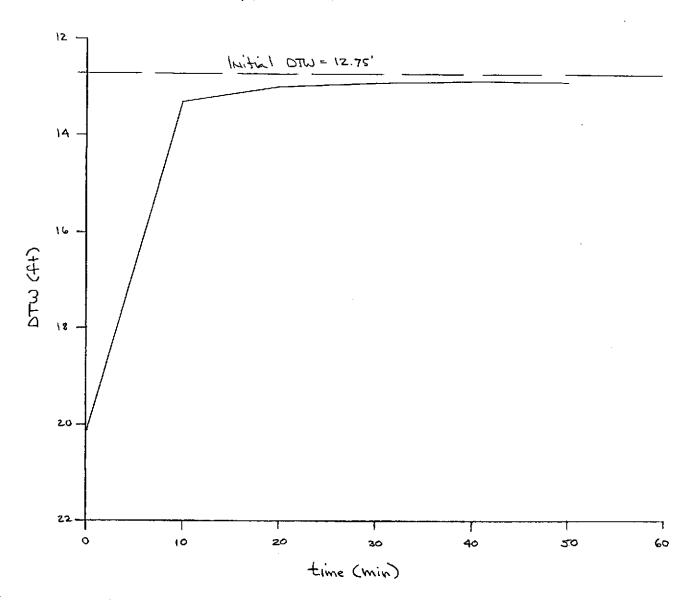
PROJECT Seaves Oakland Site # 1058	PROJECT NUMBER
SUBJECT Well Recharge - MW-3	BY DATE
3	PAGE OF
CHECKED BY	DATE (25:99

Initial DTW = 12.75° DTP = 12.74° PT = 0.01°

Note: On 6.28.99, no product detected in well
