# AIR CHANGE MEASUREMENT REPORT

FORMER SHELL SERVICE STATION 2350 (2368) HARRISON STREET OAKLAND, CALIFORNIA

MARCH 9, 2012 REF. NO. 060119 (22) This report is printed on recycled paper. Prepared by: Conestoga-Rovers & Associates

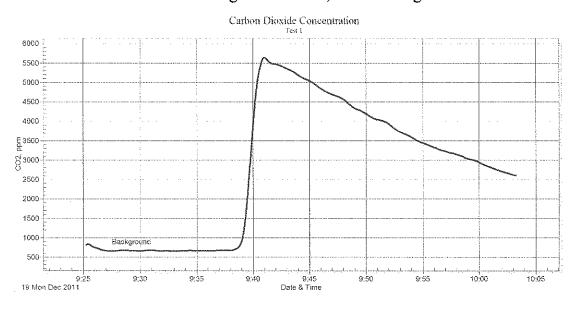
Figure 5-1 Test 1, Mid Morning

On December 19, 2011, approximately 10 pounds of carbon dioxide were released from a 20-pound cylinder into the space to be measured for each test. After allowing time for mixing and the concentration to decay, the concentration and time were recorded. Figure 5-1 shows the decay of the tracer gas concentration.

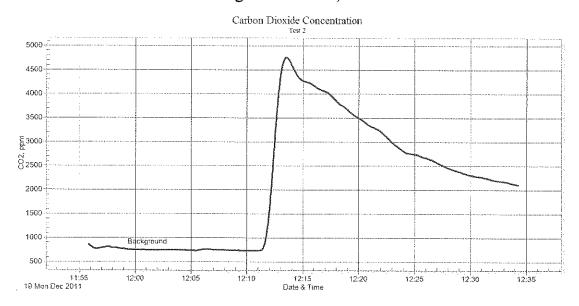
Figure 5-2 Test 2, Lunch Hour

The measurement was repeated over the lunch hour when more activity in the store would change the results. Figure 5-2 shows the rate of decay of the tracer gas concentration not significantly different at mid day compared to mid morning.
