Downtown Auto Center

February 23, 2010
Report 0271.R2
Project # PZ19226

SUBJECT: WELL SURVEY REPORT
County File #RO0000509
Downtown Toyota
4145 Broadway
Oakland, California

SUBJECT: PREFERENTIAL PATHWAY SURVEY REPORT
ACEHS File #RO-509
Downtown Toyota
4145 Broadway
Oakland, CA

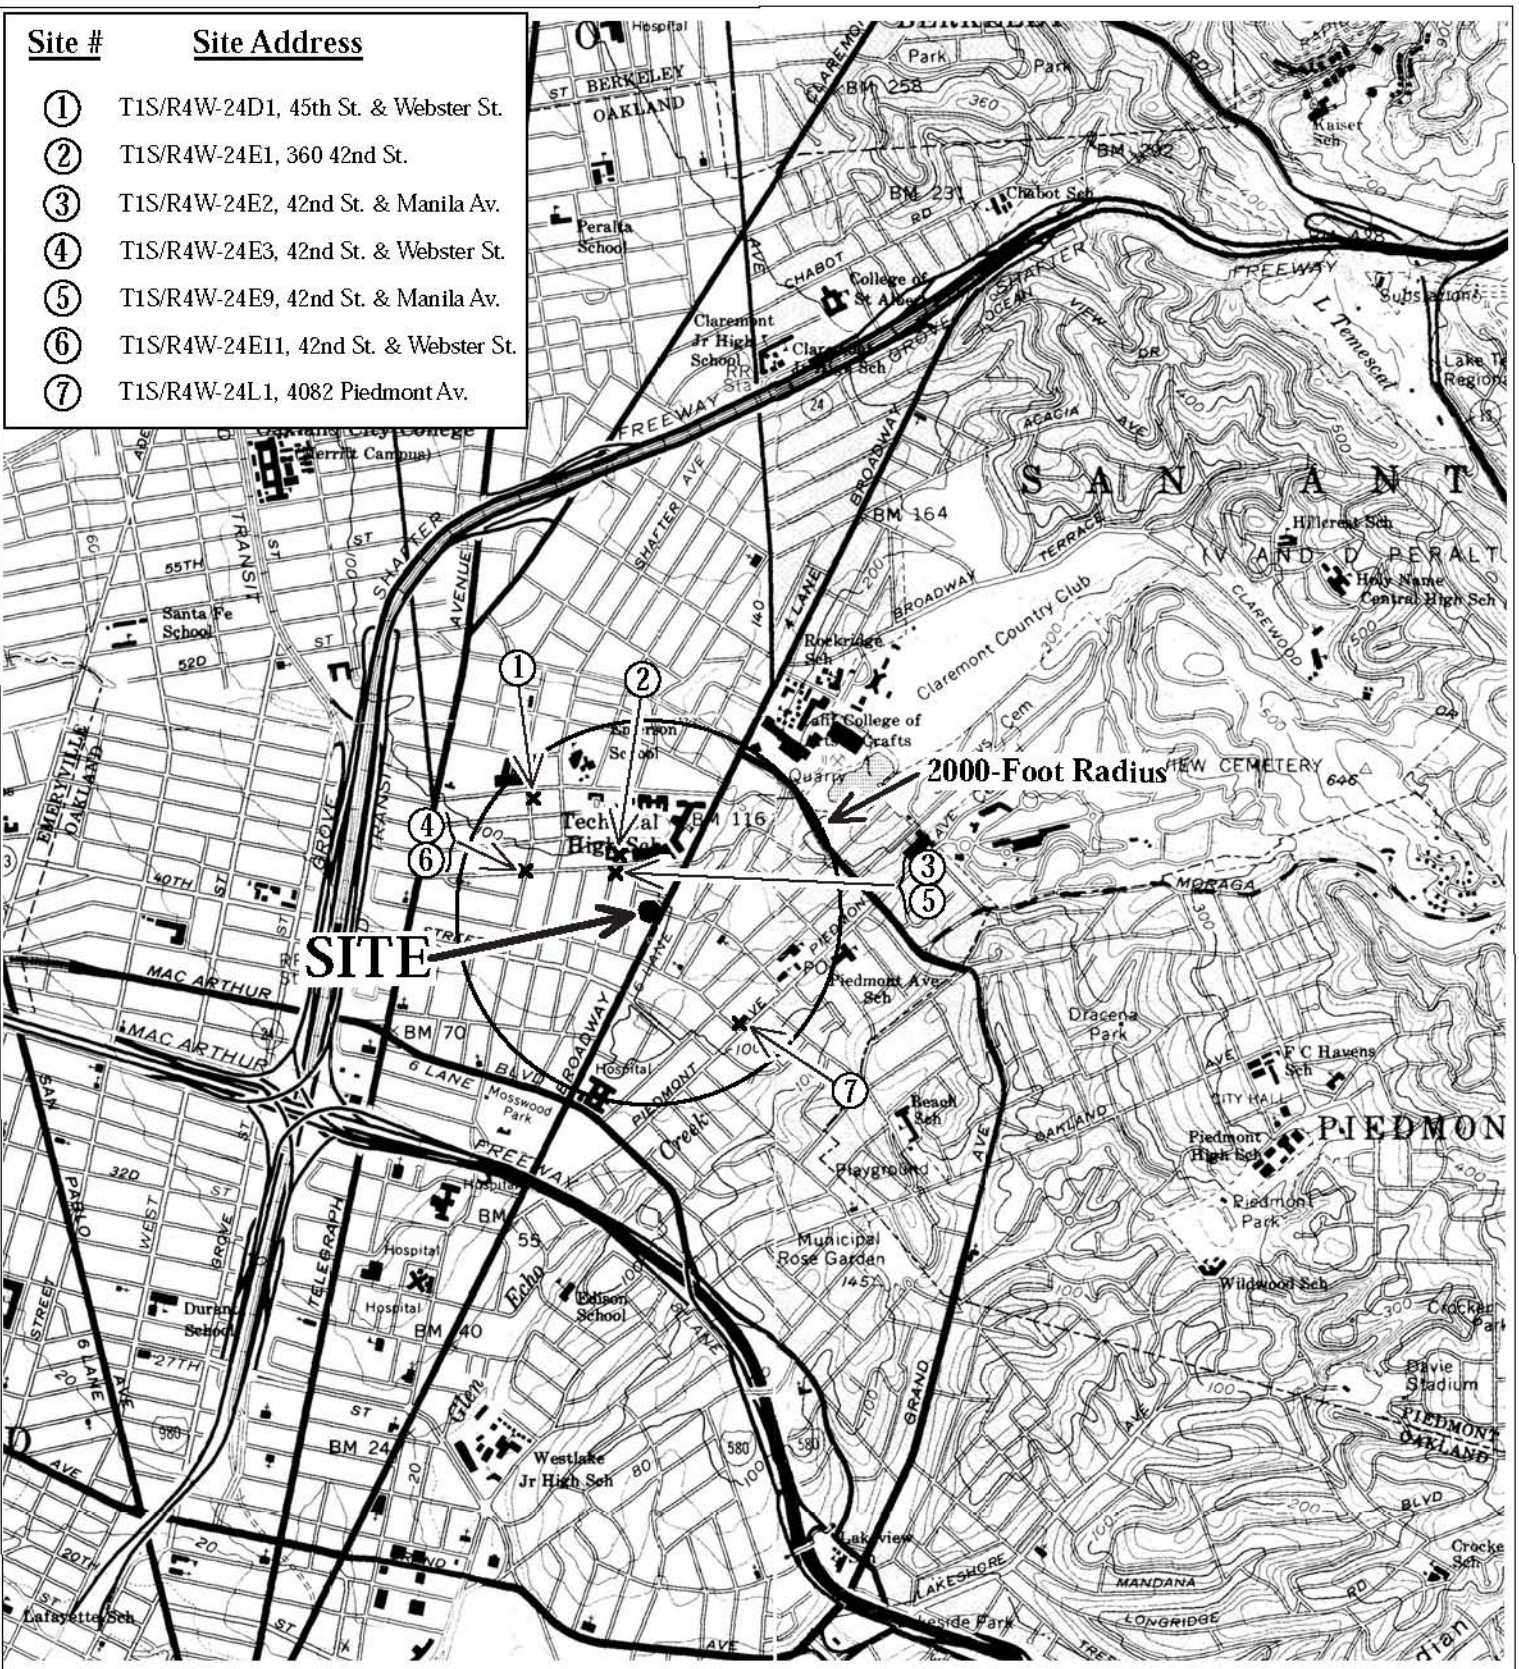
Figure 1
 Site Location Map
 Downtown Toyota
 4145 Broadway
 Oakland, California

Review of Figure 1 shows that a topographic ridge is located on the east side of Broadway, and that the topography slope is comparatively gentler on the west side of Broadway. The topographic slope is consistent with the range of groundwater flow direction from the west-southwest to the southwest identified from groundwater monitoring wells at 3943 Broadway, located approximately 800 to 1000 feet west-southwest of the subject site.

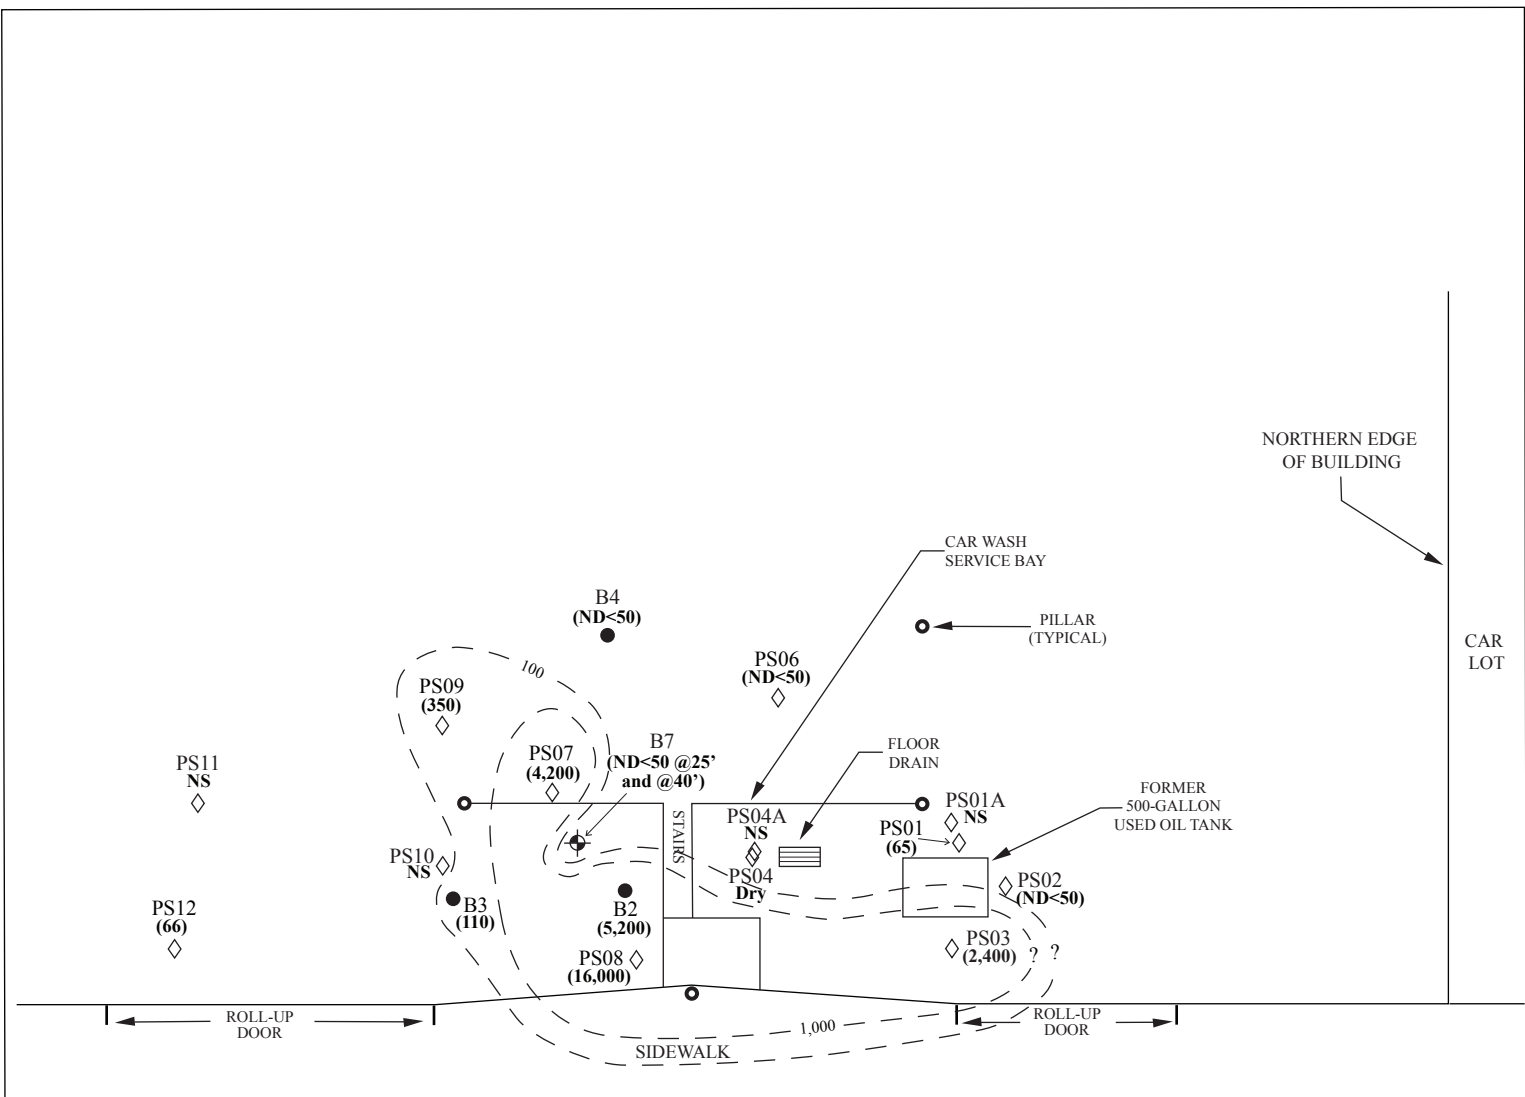
Figure 3
 Site Plan Detail Showing TPH-G Concentrations in Groundwater
 Downtown Toyota
 4145 Broadway
 Oakland, California

Based on investigation of a former waste oil UST release at the subject site, the known extent of petroleum hydrocarbons in groundwater is shown in Figures 3, 4, and 5. MBTEX compounds are generally absent, and when detected do not exceed applicable screening levels with only a few exceptions.

Comparison of the locations of wells identified in the vicinity of the subject site with the known extent of petroleum in groundwater as shown in Figures 3, 4, and 5 shows that none of the wells identified during the survey are impacted by petroleum in groundwater at the site. Comparison of the locations of the wells in Figure 1 with the west-southwest to southwesterly groundwater flow direction in the vicinity of the site shows that none of the wells identified during the survey are located downgradient of the subject site. Similarly, review of Table 4 shows that none of the sensitive receptors identified in Table 4 are impacted by petroleum in groundwater at the site. Review of Table 4 shows that the closest sensitive receptor identified in Table 4 is 600 feet from the subject site, and that only one sensitive receptor (Thunder Road Adolescent Chemical Dependency) is located downgradient of the subject site (at a distance of 1,000 feet).

Based on the survey results, RGA recommends that no further action be performed for the subject site.

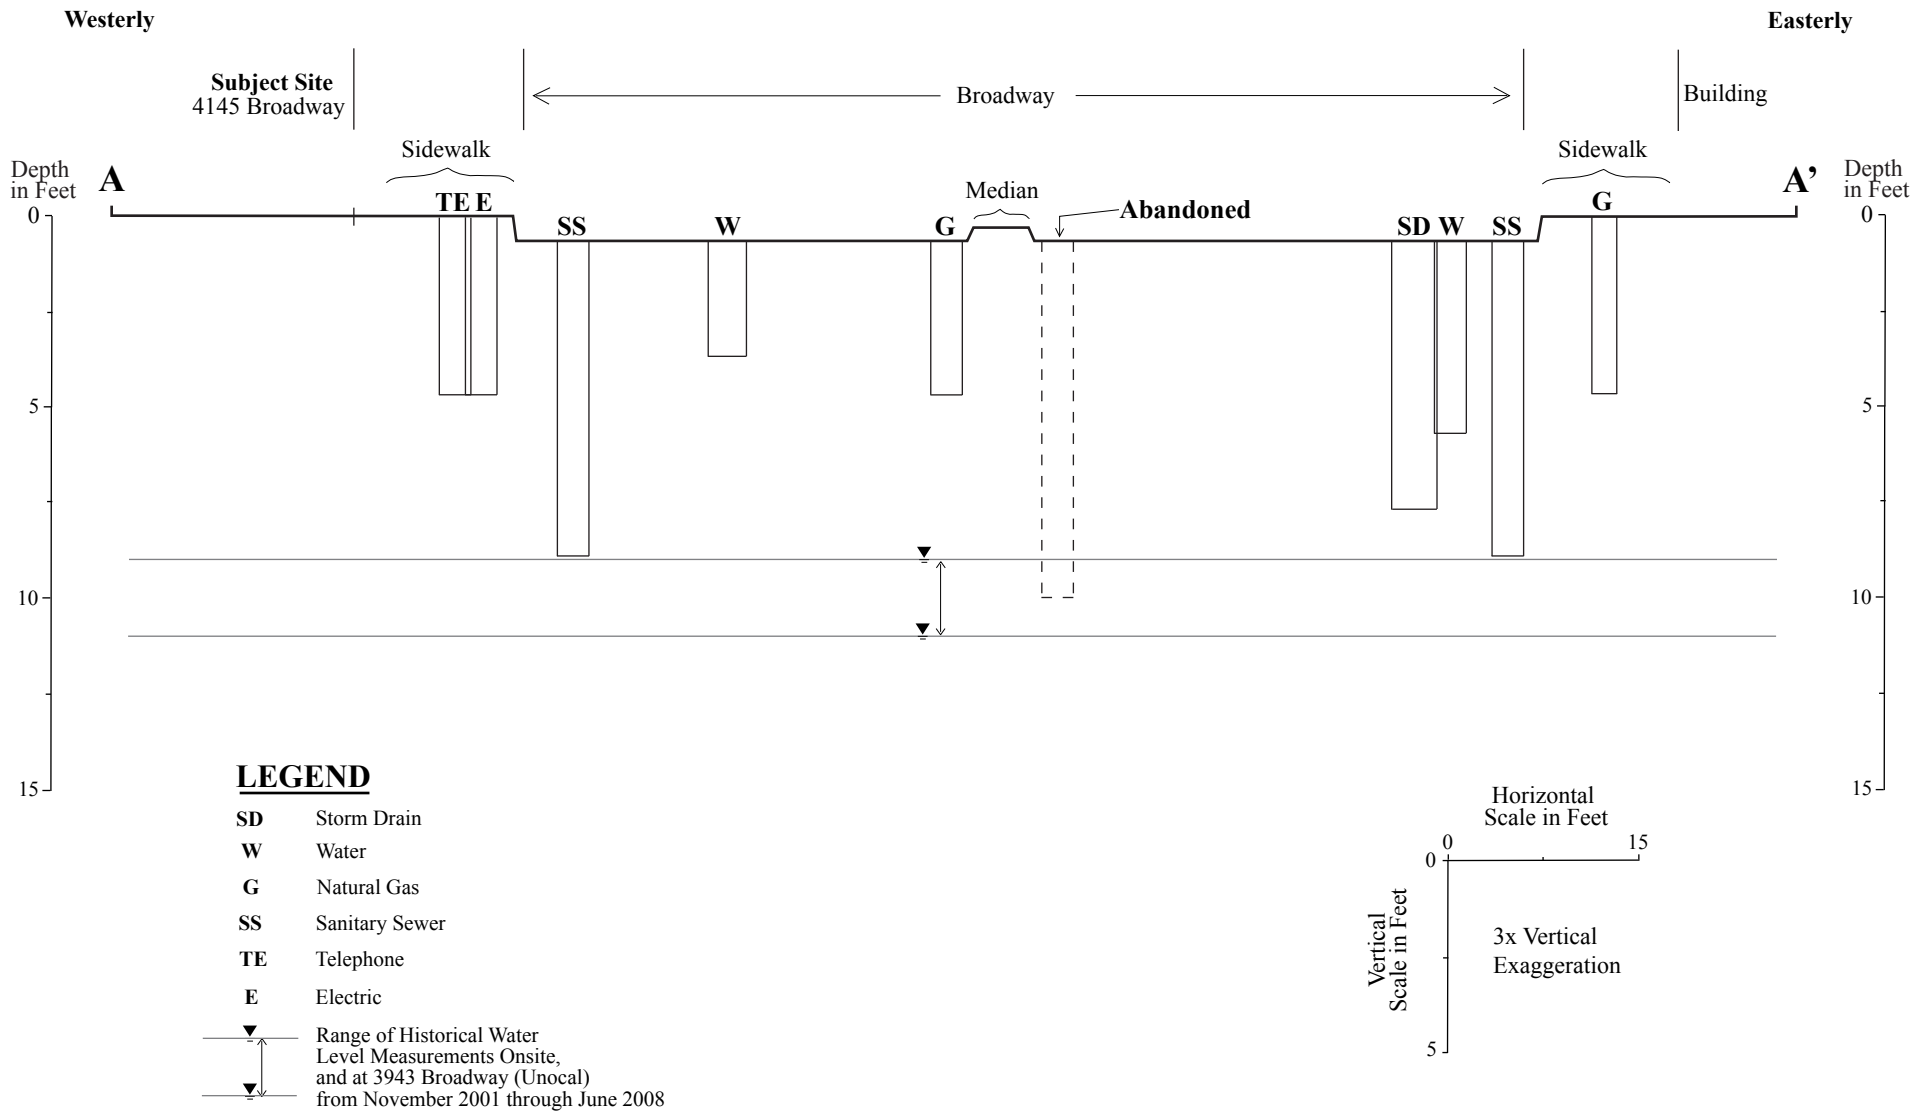
Figure 3
 Cross Section A-A' Showing Utility Trench Locations and Depths
 Downtown Toyota
 4145 Broadway
 Oakland, California

Review of Figures 5 through 7 shows that only TPH-BO/MO appears to have extended beneath Broadway at concentrations exceeding the applicable ESL value of 100 ug/L. Based on the known extent of petroleum hydrocarbons in groundwater in the vicinity of the subject site and the observed attenuation of TPH-BO/MO concentrations in groundwater in the vicinity of Broadway, the only utility trench that appears to have potentially been impacted by TPH-BO/MO petroleum hydrocarbons is the sanitary sewer trench located on the west side of Broadway. Based on the historic water levels shown in Figure 3, groundwater appears to have entered the trench only intermittently.
