MONTGOMERY WARD AUTO SERVICE CENTER, DUBLIN, CALIFORNIA

11/92

Montgomery Ward & Co., Incorporated

HCI Project No. 584

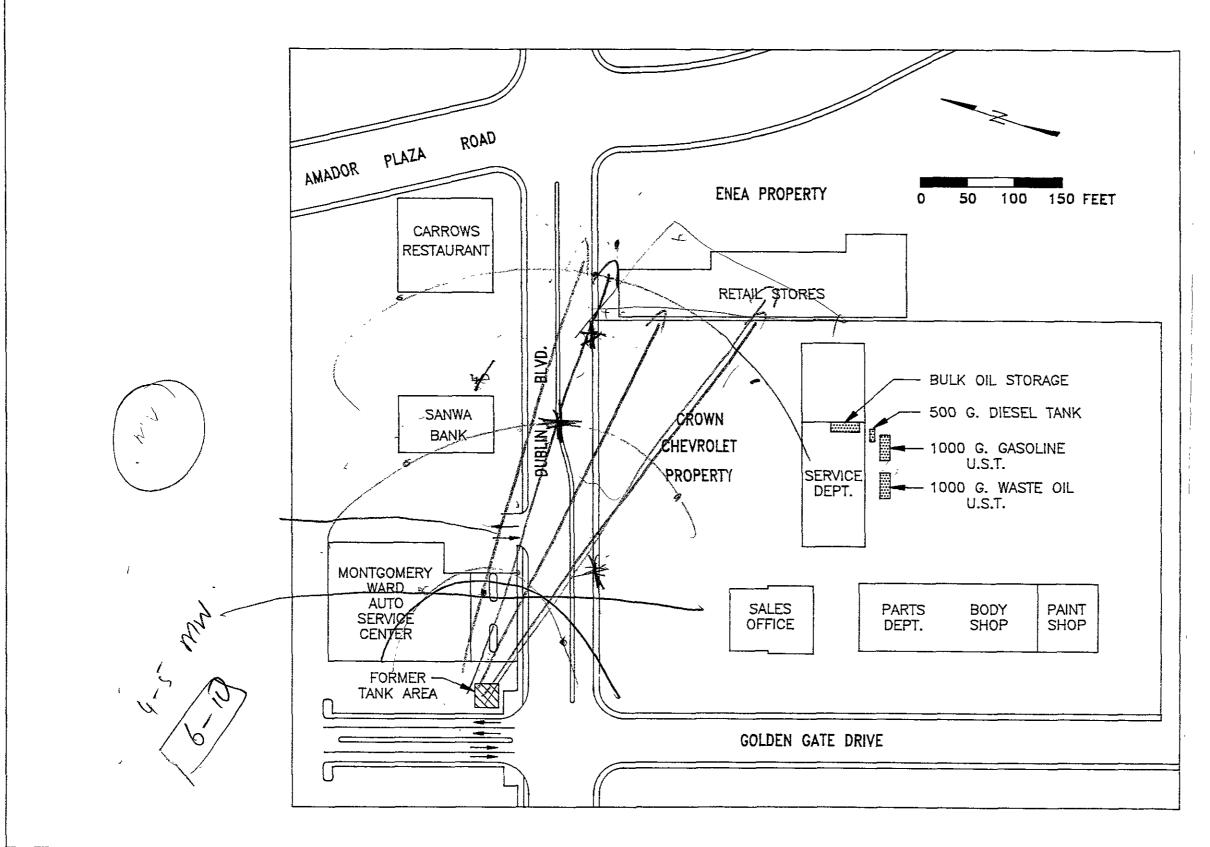
SITE MAP OF MONTGOMERY WARD AUTO SERVICE CENTER AND VICINITY

The objective of the work performed by HCI was to identify the lateral occurrence of hydrocarbons within the shallow ground water in the vicinity of the Montgomery Ward Auto Service Center. The site and adjacent properties are shown on Figure 1.

Based on the findings of this investigation, no hydrocarbons have migrated within ground water across Dublin Boulevard to the Enea property (see Figure 1).

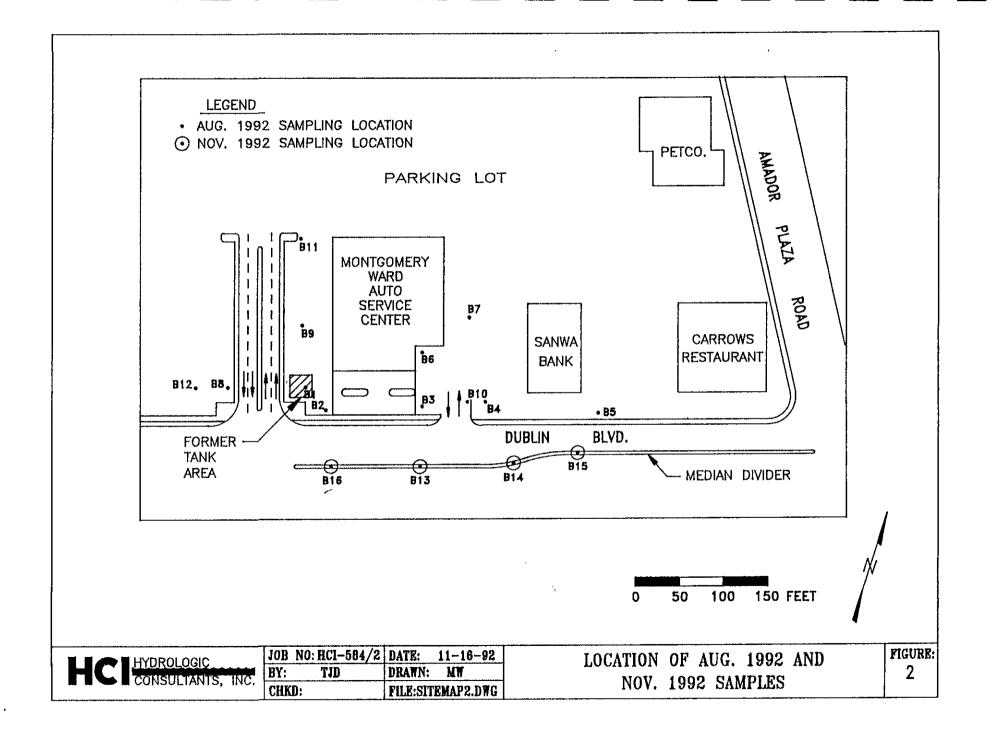
A total of 16 soil samples were obtained at the site (see Figure 2 for sample locations). All samples except one (B1) were collected from depths of at least 15 feet below land surface. At the time of the investigation, the water level at the site was approximately 13 feet below land surface, as measured from a site monitoring well. Sample B1, located within the former tank area, was collected from a depth of approximately 13 feet below land surface because a hard barrier was encountered at that depth.

The results show that the highest concentration of Total Hydrocarbons (37,000 ug/kg) was found at B1, located in the former tank area, with diminishing concentrations generally occurring along the sampling lines outward from the former tank area. Specific findings progressing away from the former tank area indicate that:

- In an easterly direction parallel to Dublin Boulevard, the concentration of Total Hydrocarbons decreases by approximately one order of magnitude from B1 (37,000 ug/kg) to B2 (2,700 ug/kg) to B3 (230 ug/kg) to B4 (14 ug/kg). The levels of hydrocarbons at B4 are very low and approaching the detection limit. An additional sample, B10, located approximately 20 ft west of B4, showed no hydrocarbons. This indicates that the eastern extent of the hydrocarbon plume is bracketed in the vicinity of B4.
- In a westerly direction parallel to Dublin Boulevard, low levels of Total Hydrocarbons (39 ug/kg) were detected at B8, while no volatile hydrocarbons were detected at B12. This

brackets the western extent of the hydrocarbon plume in the vicinity of B8.

- In a northerly direction perpendicular to Dublin Boulevard, low levels of Total Hydrocarbons (60 ug/kg) were detected at B9, and a nondetect was obtained at B11. This brackets the northern extent of the hydrocarbon plume in the vicinity of B9.
- In a northeasterly direction, very low levels of Total Hydrocarbons (10 ug/kg) were detected at B6, and nothing was detected at B7. The northeasterly extent of the hydrocarbon plume is therefore bracketed in the vicinity of B6.
- In a southerly direction, the four samples taken in the median divider in Dublin Boulevard contained no hydrocarbons. Therefore, the hydrocarbon plume does not cross Dublin Boulevard.

This subsurface investigation has delineated the lateral extent of the hydrocarbons in ground water originating from the former tank area of the Montgomery Ward Auto Service Center. The hydrocarbon plume is primarily limited to the Montgomery Ward property.
