REF: 92-221-1088

**SUBJECT: QUARTERLY GROUNDWATER MONITORING AND SAMPLING
RESULTS FOR QUIK STOP MARKET #47, 6001 MACARTHUR
BOULEVARD, OAKLAND, CA**

QUIK STOP # 47
 6001 MACARTHUR BLVD.
 OAKLAND, CA
 WELL LOCATIONS, GROUNDWATER
 FLOW DIRECTION SHOWING
 GROUNDWATER CONTOUR INTERVALS

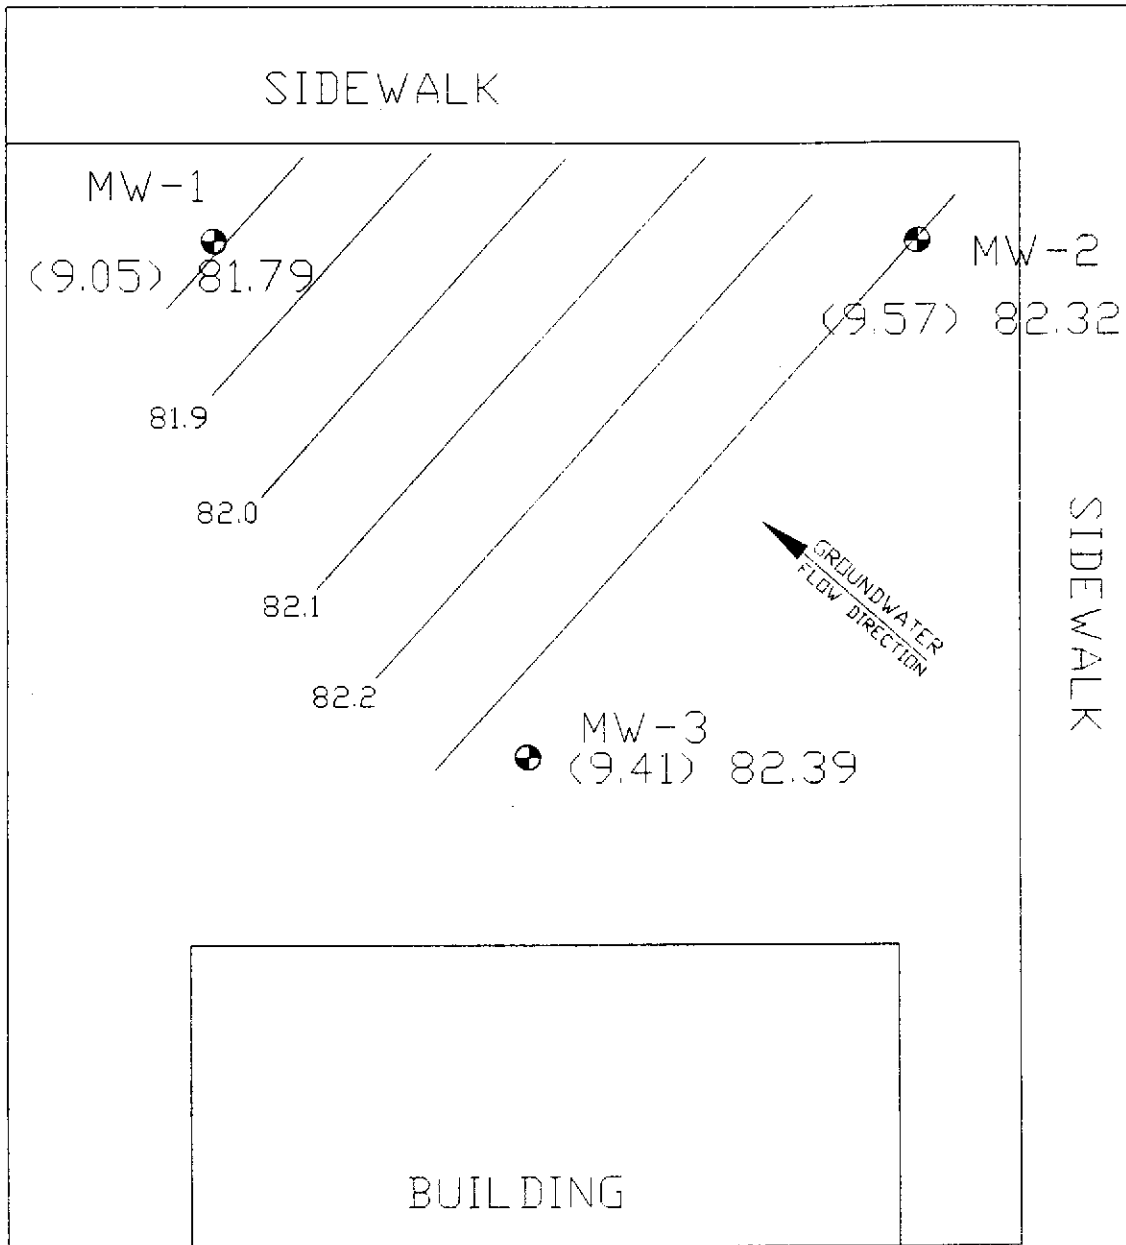
FIGURE 1

The groundwater flow direction for this sampling event was calculated to be N 65° W. Groundwater flow direction has varied between N 65° W and S 86° W during our monitoring events. With this in mind, the diesel source must be located east or northeast of the site. Possible upgradient sources include the PG&E facility on MacArthur Blvd., the Chevron station on the corner of MacArthur and Seminary, the Caltrans or Mills College vehicle maintenance stations on Seminary Ave., small businesses or older residences. The Alameda County Flood Control "J Line" which contains Leona Creek may be a pathway for contaminants migrating from sites along Seminary Avenue.

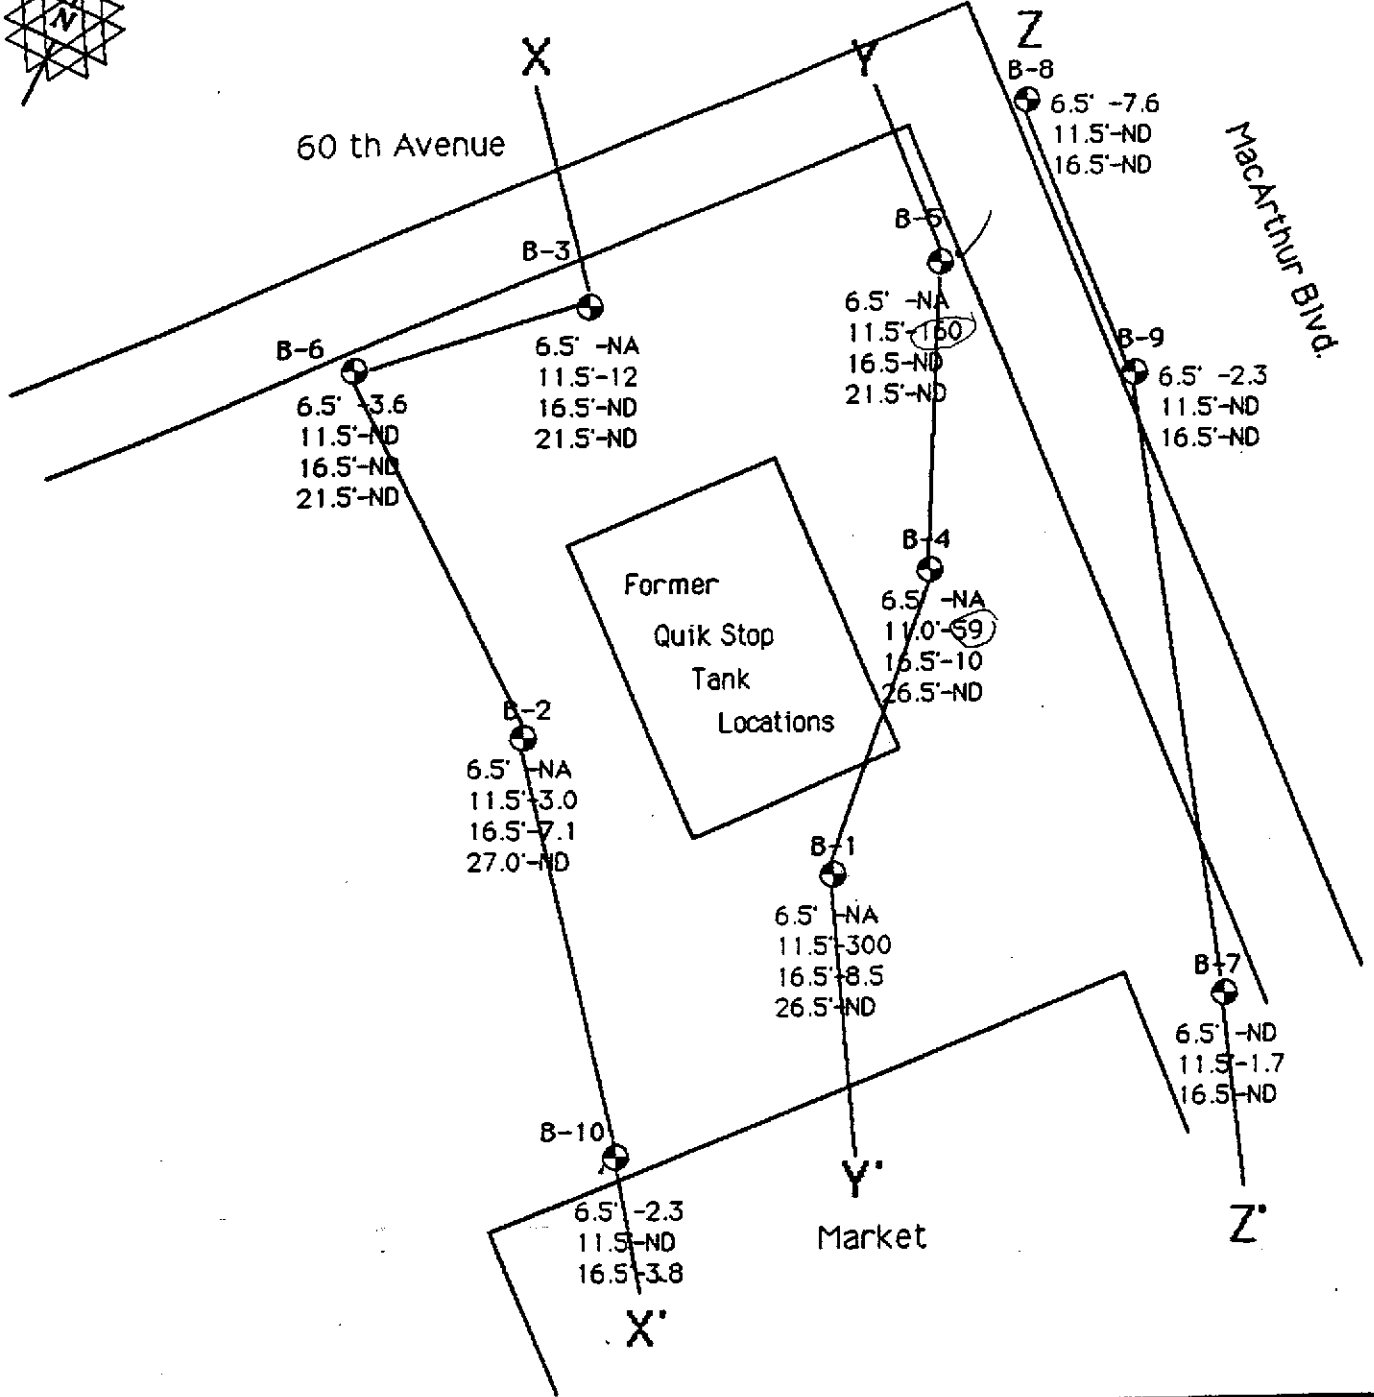
Certified Environmental Consulting, Inc.	Figure 3
	DETAILED SITE MAP SHOWING CROSS SECTION LOCATIONS QUIK STOP MARKET #47 6001 MacArthur Blvd. Oakland, CA	
Job # 92-221-791		DWJ 6-92

Hydrocarbons were not detected at a depth of 11.5 feet bgs in two of the five holes drilled north of the former tank excavation (B-8 and B-9). No hydrocarbons were detected below 11.5 feet in any of the holes drilled north of the former tank excavation (B-3, B-5, B-6, B-8, B-9). Hydrocarbons were detected at a depth of 16.5 feet in all holes drilled south of the former tank excavation (B-1, B-2, B-4, B-10), with the exception of B-7. This indicates soil contamination has migrated to greater depths and to greater distances in a southerly direction. It did not appear contamination had migrated off-site and it did not appear a significant amount of contamination was present beneath the market. Refer to Figure 3.

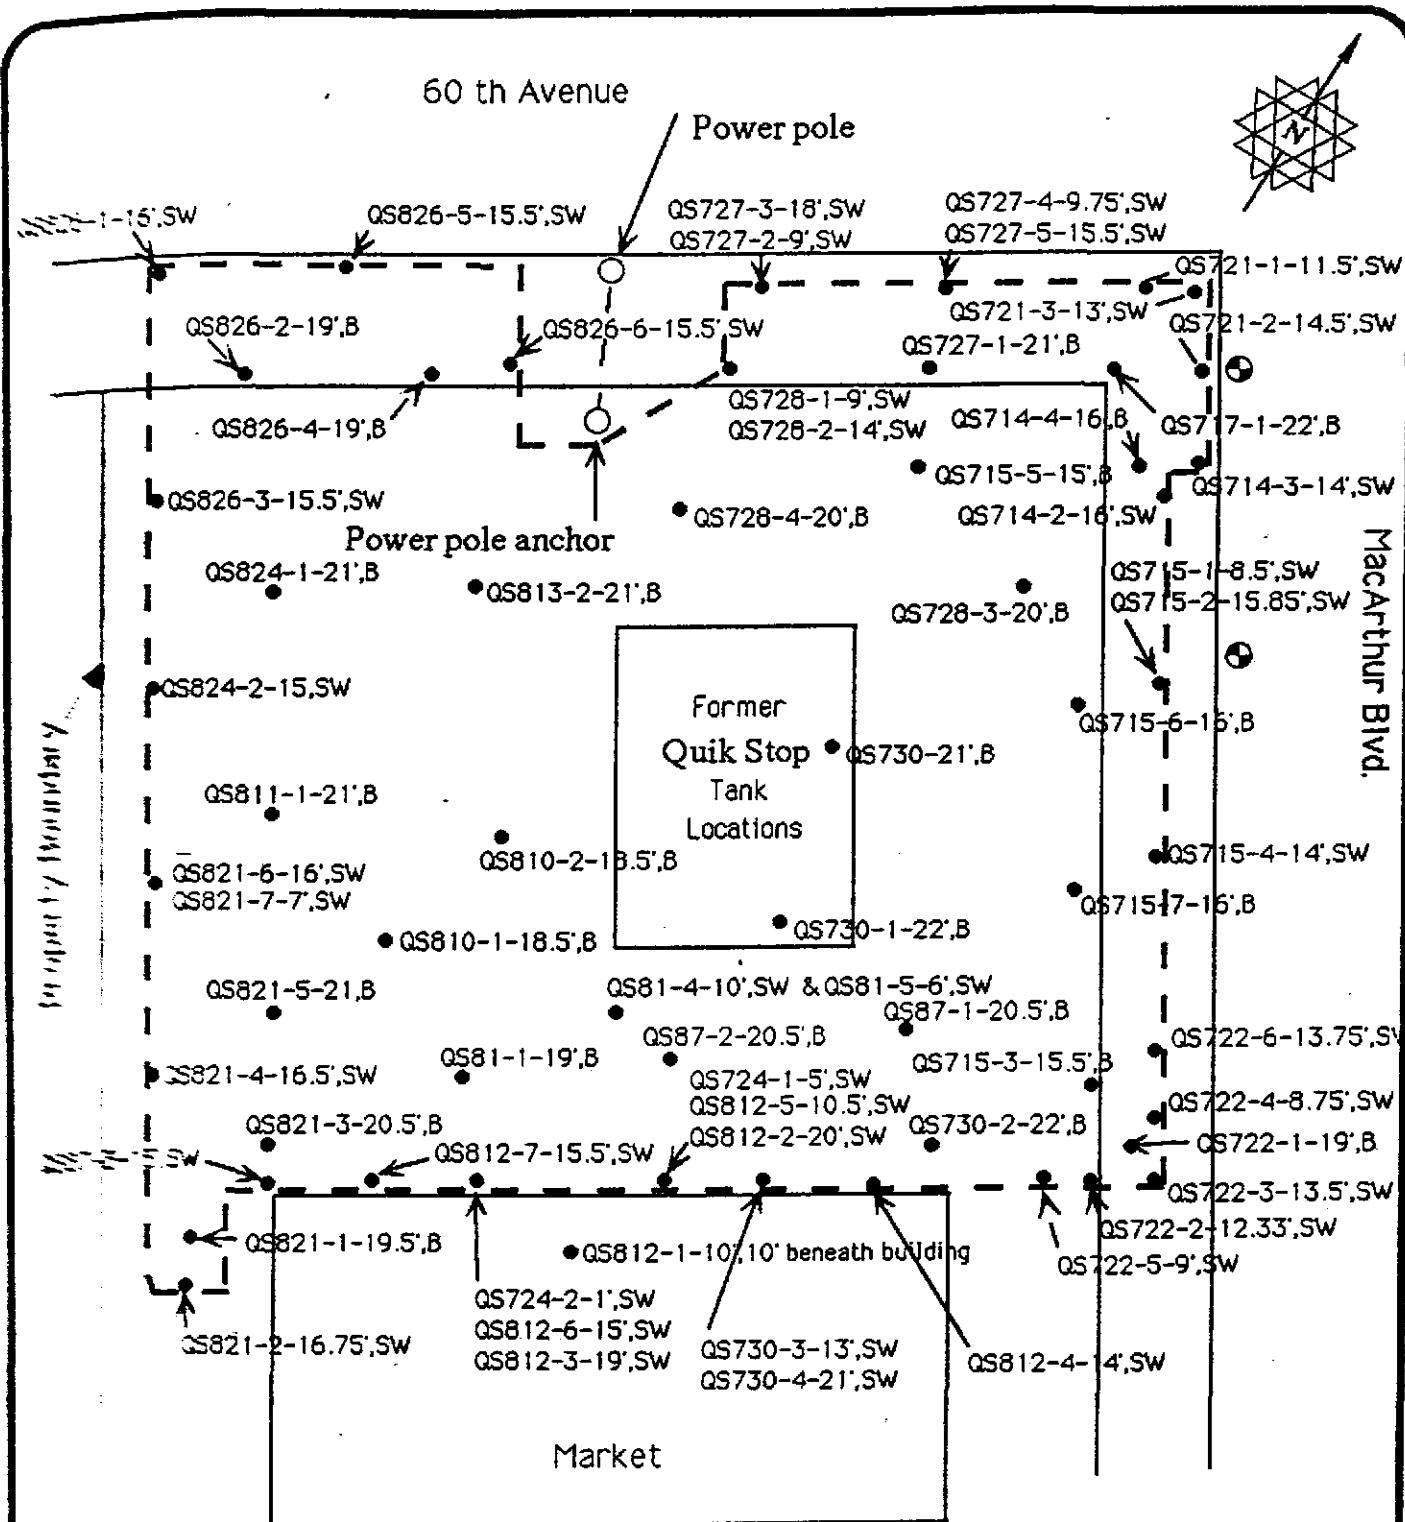
FIGURE 5

Soil samples were collected from excavation sidewalls every 20 linear feet and in different soil types. Bottom samples were collected at various depths for every 400 square feet of excavation bottom. All samples were collected with a slide hammer-tube sampler according to SFBRWQCB guidelines outlined in the work plan. Samples were transported under chain of custody to the on-site Coast to Coast mobile lab or refrigerated and transported to McCampbell Analytical in Pacheco, California. All samples were analyzed for TPH-G and BTEX. Selected samples were analyzed for total lead (Pb). Samples QS812-1 and QS812-5 were analyzed for organic lead, none was detected. Sample QS730-3 was analyzed for soluble lead, none was detected. Analytical results for excavation completion samples are summarized in Table 5. Completion sampling locations are presented in Figure 5.
