REMEDIAL ACTION COMPLETION CERTIFICATION

RE: Former Oakland Diesel Facility  
1301 65th Street, Emeryville, California 94608  
STID # 363

## Leaking Underground Fuel Storage Tank Program

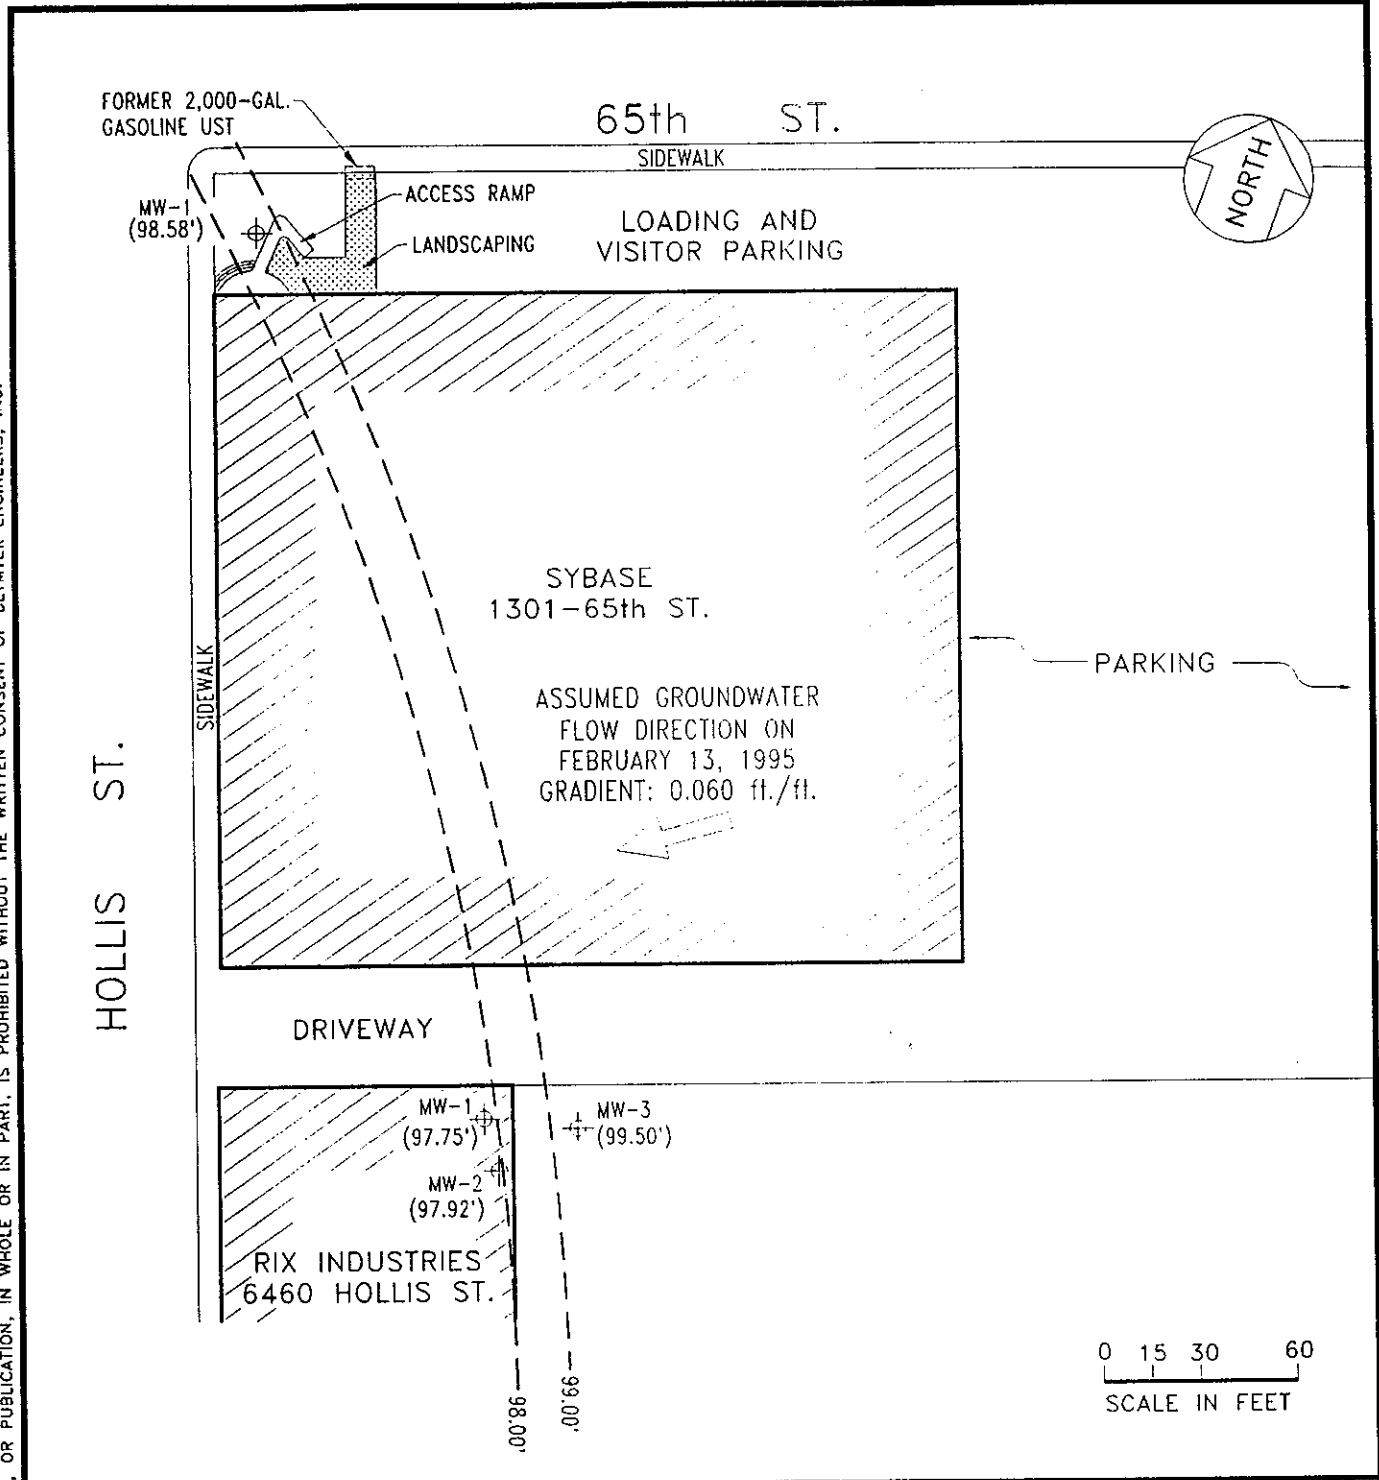
<b>LEGEND</b> MONITORING WELL (98.58') GROUNDWATER ELEVATION ON 2/13/95 UST UNDERGROUND STORAGE TANK	<b>SITE PLAN</b> 1301 65th ST. ASSOCIATION EMERYVILLE, CA, CA	<b>FIGURE</b> 2
BEI JOB NO. 89070	DATE 2/23/95
