OVERVIEW

Blymyer Engineers, Inc. was retained by Diesel Recon Company to perform a Phase I Subsurface Investigation at the Northwest Motor Welding site located at 2100 Orchard Avenue in San Leandro, California. This report, documenting the investigation, is prepared for the Alameda County Health Care Services Agency and the San Francisco Bay Regional Water Quality Control Board.

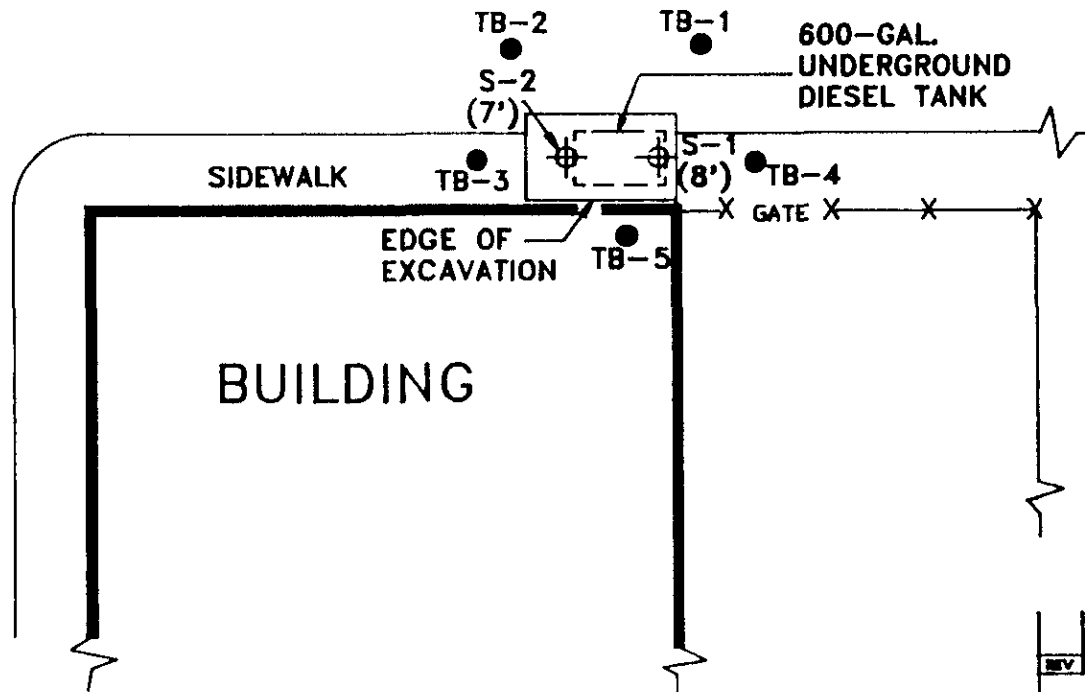
REV	DESCRIPTION	DATE	BY
BLYMYER ENGINEERS, INC ALAMEDA, CALIFORNIA			
SCALE SHOWN	FOR	DIESEL RECON. CO. SAN LEANDRO, CA	
JOB NO.	LW 8/91		
APPROVED	TITLE SOIL BORE LOCATION MAP		
JOB NO.	91108	PAGE NO.	FIGURE 2

Five soil bores were installed around the tank excavation to determine the vertical and horizontal extent of petroleum contamination in the soil surrounding the tank excavation. Soil samples were collected at 5-, 10-, and 15-foot depths and were analyzed for TPH as diesel. The laboratory results showed that TPH as diesel was not detected above the reporting limits in any of the five soil bores.

- Groundwater at the site is found at an approximate depth of 19.5 feet below grade surface.
- Soil samples collected during the installation of five soil bores around the tank excavation in June 1991 did not contain detectable levels of TPH as diesel.

- Petroleum hydrocarbon contamination of the soil around the tank excavation appears to be limited to the area around the tank excavation that is bounded by the five soil bores installed in June 1991.

- There is a limited areal extent of soil with elevated levels of TPH as diesel in the former tank location as shown by the laboratory results from the soil samples collected from the five soil bores installed around the tank excavation. Blymyer Engineers recommends excavation of the petroleum-contaminated soil and stockpiling of the soil at the site. Verification samples should be collected from each face of the excavation and analyzed for TPH as diesel and BTEX to confirm the removal of petroleum-contaminated soil that resulted from the leaking underground storage tank. The stockpiled soil should be profiled and properly disposed of at an appropriate facility. The excavated soil should be replaced with clean, imported fill and properly compacted and resurfaced.

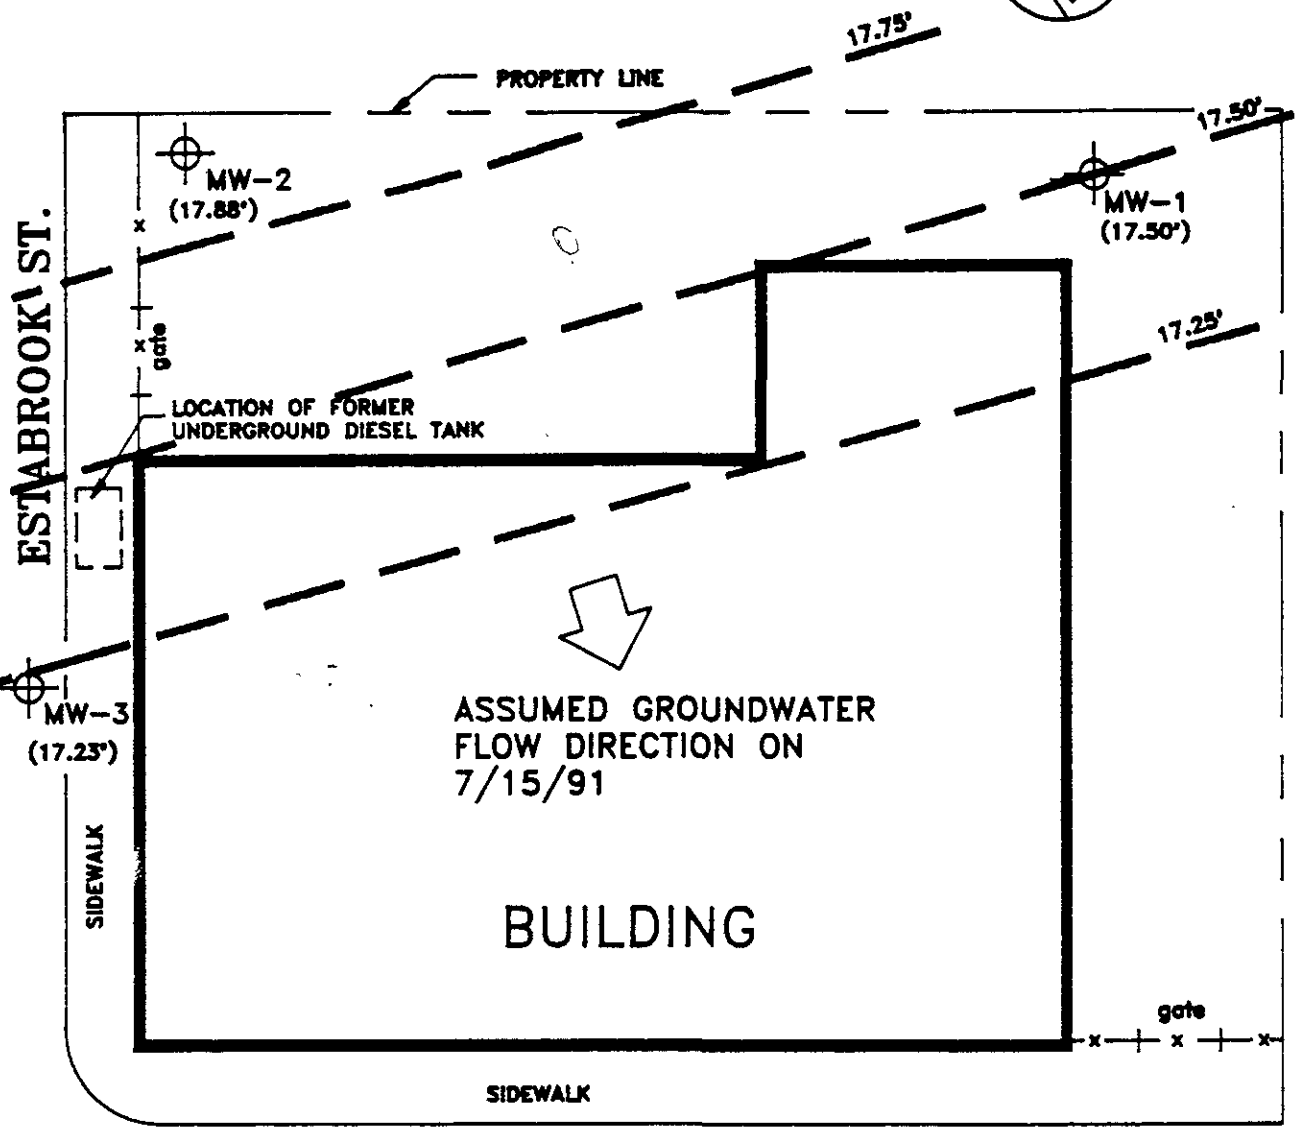
REV	DESCRIPTION	DATE BY
BLYMYER ENGINEERS, INC ALAMEDA, CALIFORNIA		
SCALE SHOWN	DATE	TITLE
LW 8/91		DIESEL RECON. COMPANY SAN LEANDRO, CA
APPROVED		TITLE
		GROUNDWATER GRADIENT MAP
JOB 91108	PAGE NO.	FIGURE 4

Groundwater at the site is found at a depth of 19.5 feet below grade surface and flows to the southwest.

TABLE IV, GROUNDWATER ELEVATION SURVEY DETAILS July 15, 1991 BEI Job No. 91106, Diesel Recon Company 2100 Orchard Avenue, San Leandro, California			
	TOC ELEVATION (feet)*	DEPTH TO WATER (feet from TOC)	WATER SURFACE ELEVATION (feet)*
MW-1	35.60	17.50	18.10
MW-2	35.99	17.88	18.11
MW-3	35.29	17.23	18.06
