Report on Helium Leak Test of Underground Tanks
at American Can Company
on January 19, 1987

HELIUM LEAK TESTS

AMERICAN CAN COMPANY
OAKLAND

OCT. 21, 22, 1986

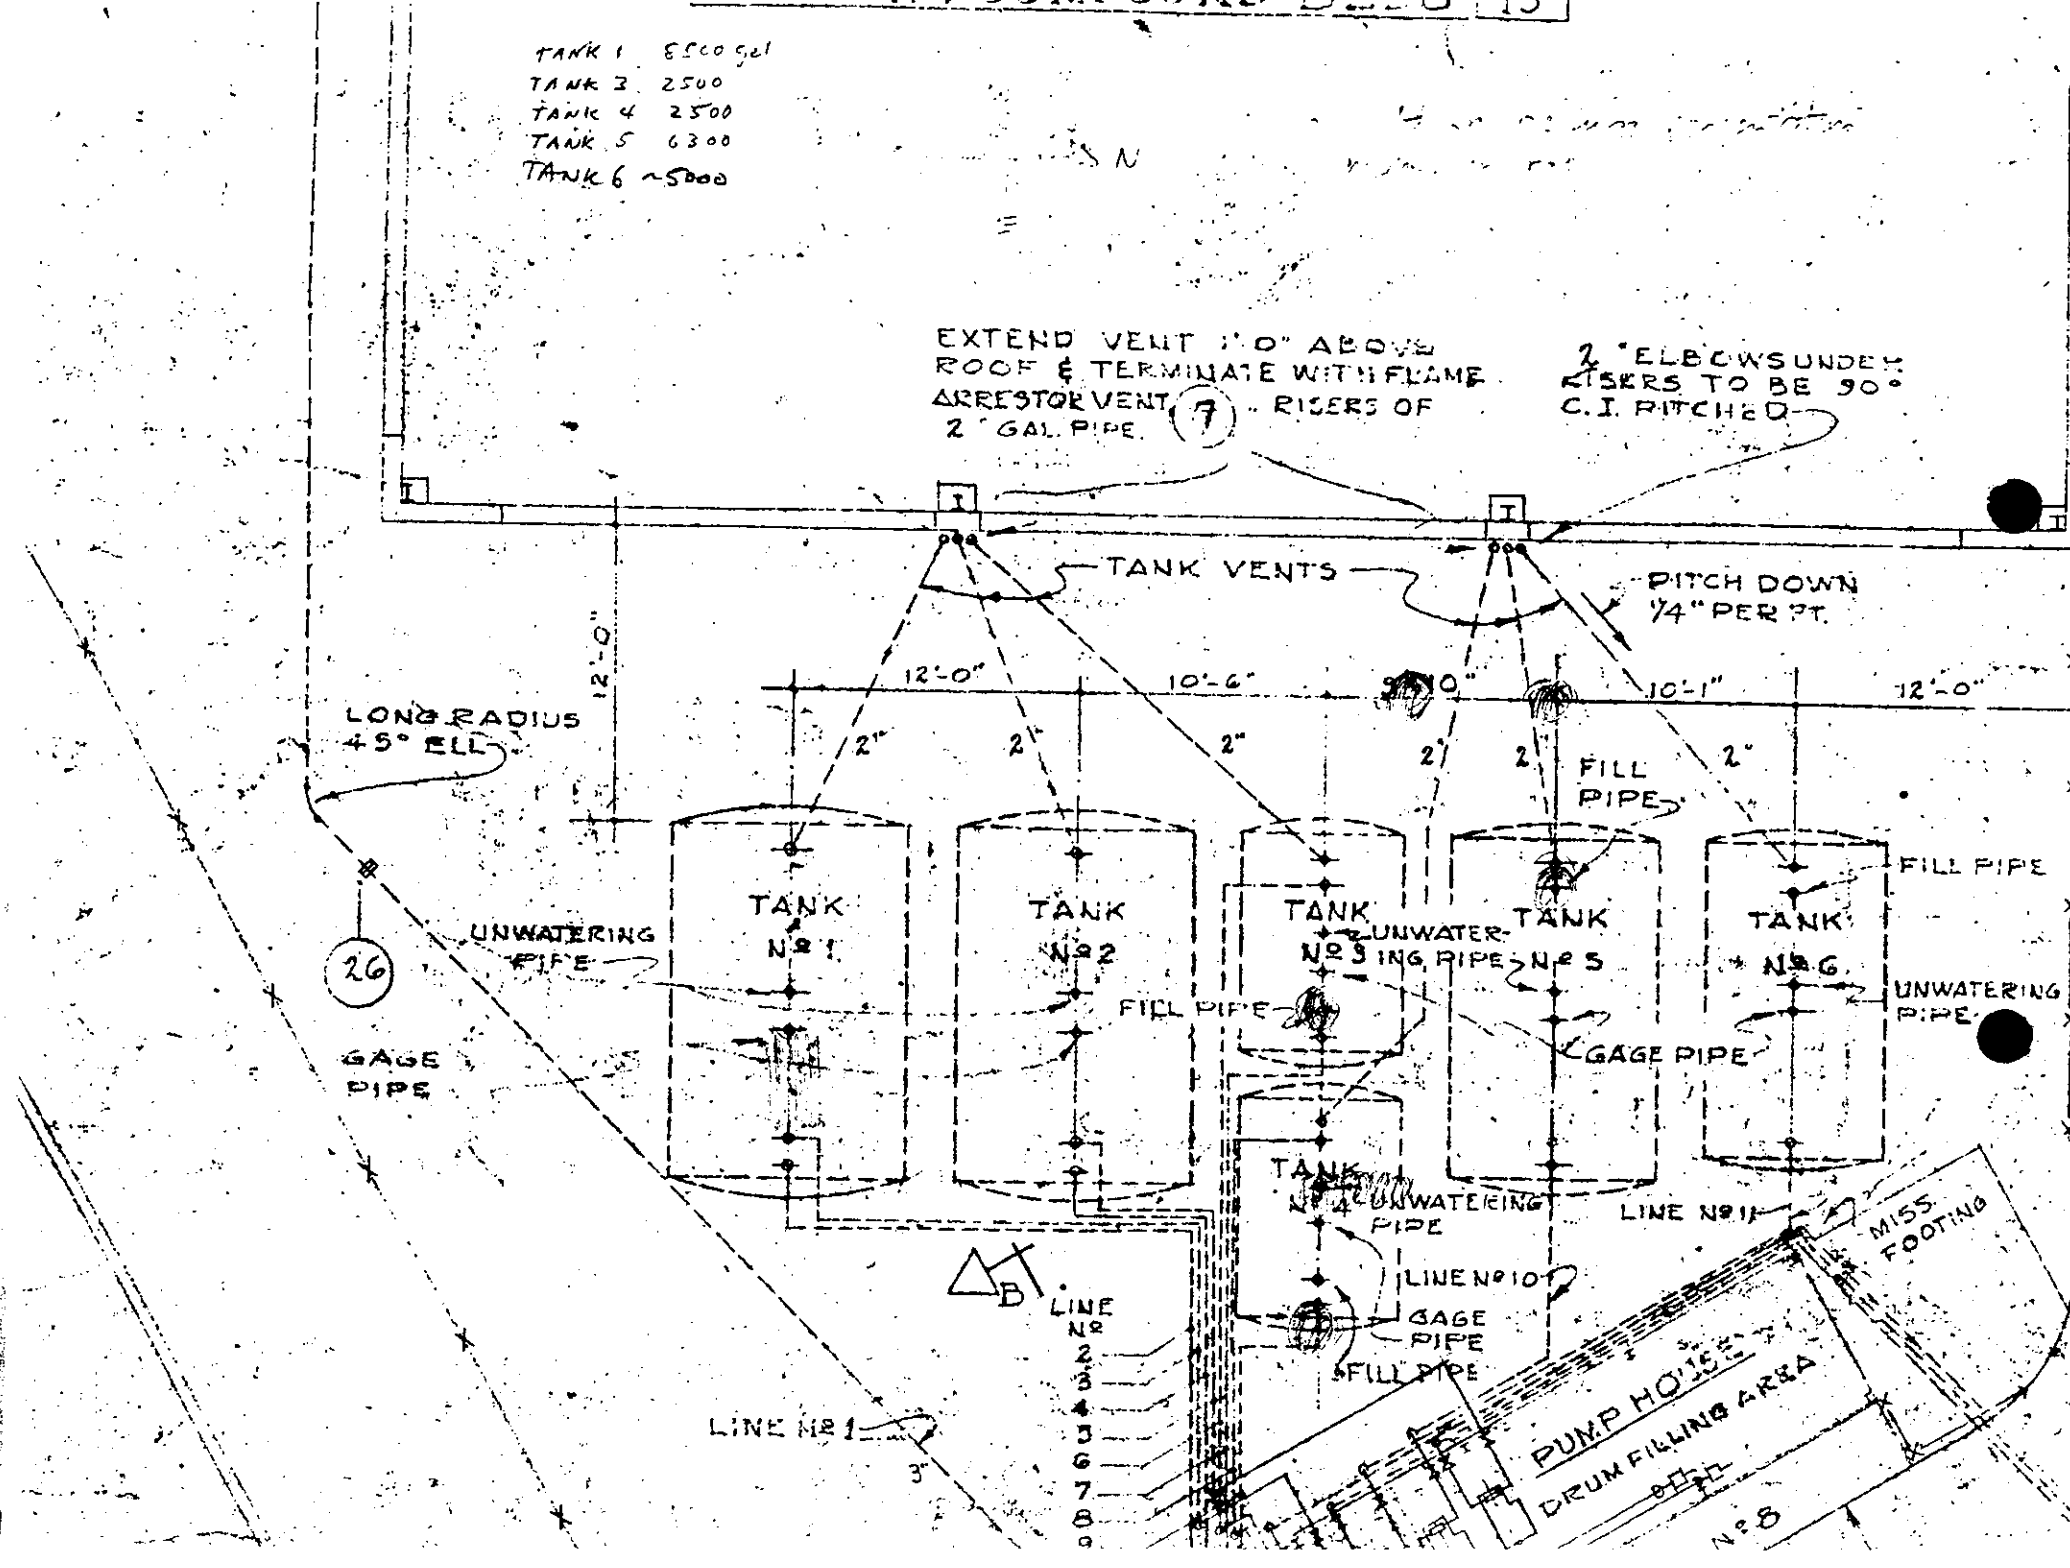
The method used in leak pinpointing is described in an attached 1983 paper. The enclosed marked drawing shows the areas where highest helium concentration were observed. We cannot be certain that the fill pipes are positioned exactly as shown on the plan view of the tanks, so most leak areas were recorded in our notes using the actual fill pipe as a reference point for measurement.

Highest helium concentrations were at the fill neck and points between the fill neck and building 13. The center of this helium-rich area is about 17 feet from building 13 along the line of tank bungs.

Helium peak concentrations were found at the fill neck and at a point six feet east of building 13 and 3 feet north of the tank centerline.

Peak helium concentration was found about 4 feet west and 4 feet north of the fill neck. Possibly this is a leak in the vent pipe or an elbow in that pipe. Another area of high concentration is at the fill neck.

One point of high helium concentration is at the fill neck. Another is halfway between the fill neck and the vent riser at Building 13. This tank held pressure well during the test.

The least cost way to save the system is to remove the overburden, tighten all pipe connections and pump the tanks dry for a second test in which, all tanks are filled and tested at the same time.

Cathodic protection of the tank system (costing less than \$5,000.) is recommended to extend the life of the tanks should further testing show them to be sound.
