ENSR Consulting
and Engineering
1320 Harbor Bay Parkway
Alameda, CA 94501
(510) 865-1888
(510) 748-6799 FAX

May 21, 1992

Subject: Soil excavation and sampling activities at the Ballena Isle Marina,
1150 Ballena Boulevard, Alameda, California.

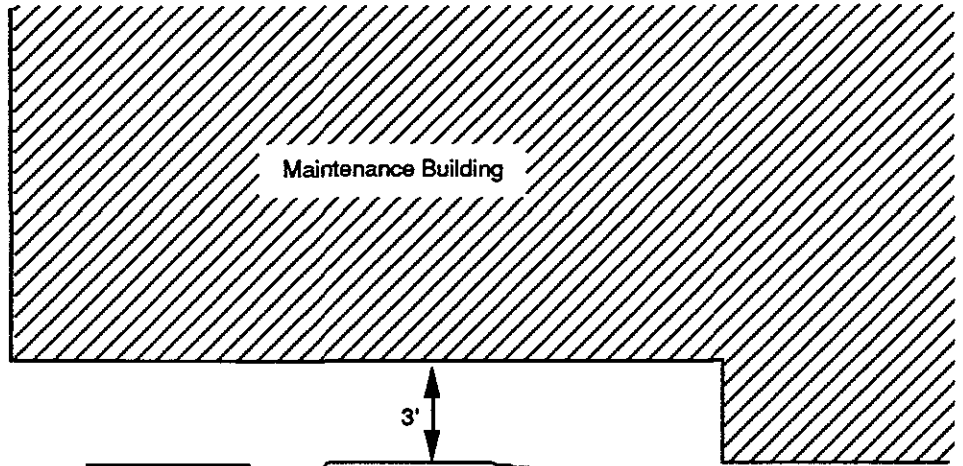
SOIL SAMPLE LOCATION MAP

Recent excavation of contaminated soil enlarged the pit, so that the pit currently measures 9.5 feet by 11.5 feet and is approximately 9 feet deep. During excavation of contaminated soil, soil staining appears to have extended beneath the maintenance building adjacent to the pit. The stained soil is at a depth of 5 feet. Further excavation of the stained soil was not possible without incurring possible damage to the foundation of the maintenance building. Groundwater was encountered at a depth of approximately 9.5 feet.

Two soil samples were collected from the pit. One soil sample (PB-1) was collected from the bottom of the pit (approximately 9 feet below grade), and the other soil sample (SW-1), was collected from the base of the sidewall on the north end of the pit. This soil sample was collected from a depth of 8.5 feet.

Sample PB-1
collected from
depth of 9 feet.

Sample SW-1
collected from
depth of 8.5 feet.

Instead, it is our recommendation that the Ballena Isle Marina backfill the open pit with clean fill material, and that an impermeable cap in the form of concrete pavement be placed over the former pit and surrounding area. This barrier would prevent surface runoff and rainwater from infiltrating the soil, thereby preventing further mobilization of the contaminants downward into the water table.
