REPORT
ENVIRONMENTAL SERVICES
19051 LAKE CHABOT ROAD
CASTRO VALLEY, CALIFORNIA

JCH&A Job Number 650.1

Job Prepared for
Frederick C Divine Associates
1214 Lincoln Avenue
San Rafael, California 94901

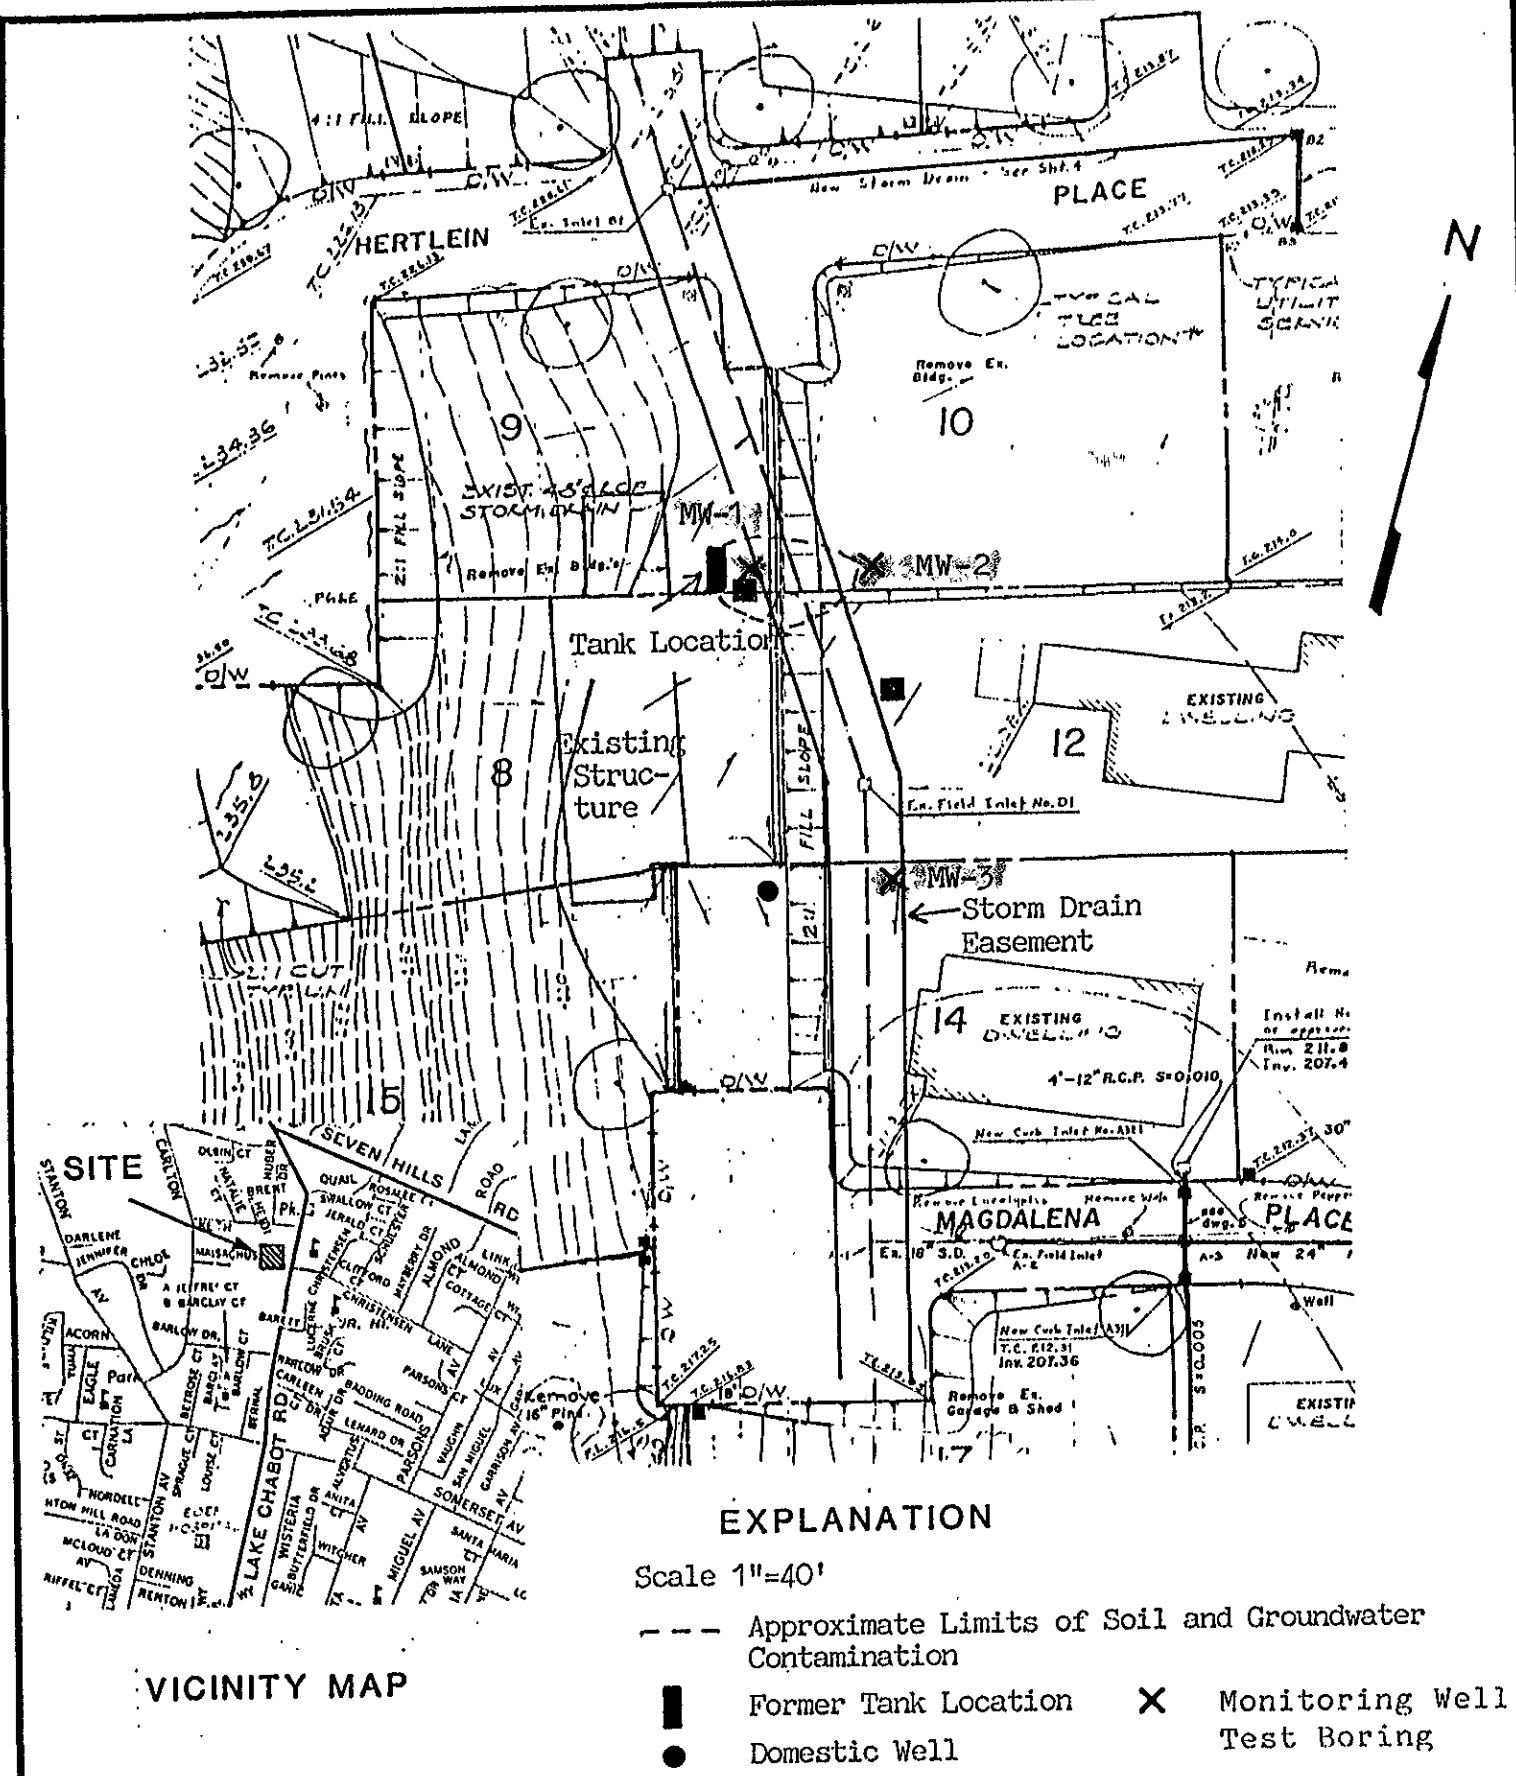
PLATE
1

Based upon the results of our work, we conclude that significant levels of contamination of soil and ground water have occurred and were present in the vicinity of monitoring well #1. Significant levels of B, T, X, E, and TPH were generally found at a depth of 8-feet below the existing grade and extended into the ground water. Ground water sampling indicated that free product is absent. Therefore, we conclude that a fire or safety hazard is remote.

Samples tested at monitoring wells 2 and 3 indicate no detectable contamination of the soil, and a trace of xylene and benzene were found in the ground water at Well #2. No detectable contamination was found in the ground water at Monitoring Well #3 and the existing domestic water well. These wells are situated down gradient of the former tank location. Based on this information, it is our opinion that the contamination is localized and confined to the area of the tanks. The cleanup consisted of excavating the contaminated soils and removing groundwater.

We recommended and observed removal of contaminated soil and groundwater in the areas outlined on Plate 1. Soil in this area was removed and bedrock exposed at the bottom of the excavation. The excavation was sloped back to about 2-horizontal to 1-vertical (2:1). Excavated soil below 3-feet was stockpiled on the site and allowed to aerate. The groundwater was at the bottom of the excavation and was pumped into the soil stockpile. Some amounts of water seeped into the excavation after the initial pumping. This excavation was then pumped dry. We sampled and tested the water and soil at the bottom of the excavation. The results of the tests are shown on Plate 10. The excavation was then filled with "clean" soil, not excavated material. Fill was placed in lifts, moisture-conditioned to near optimum, and compacted to at least 90-percent relative compaction.

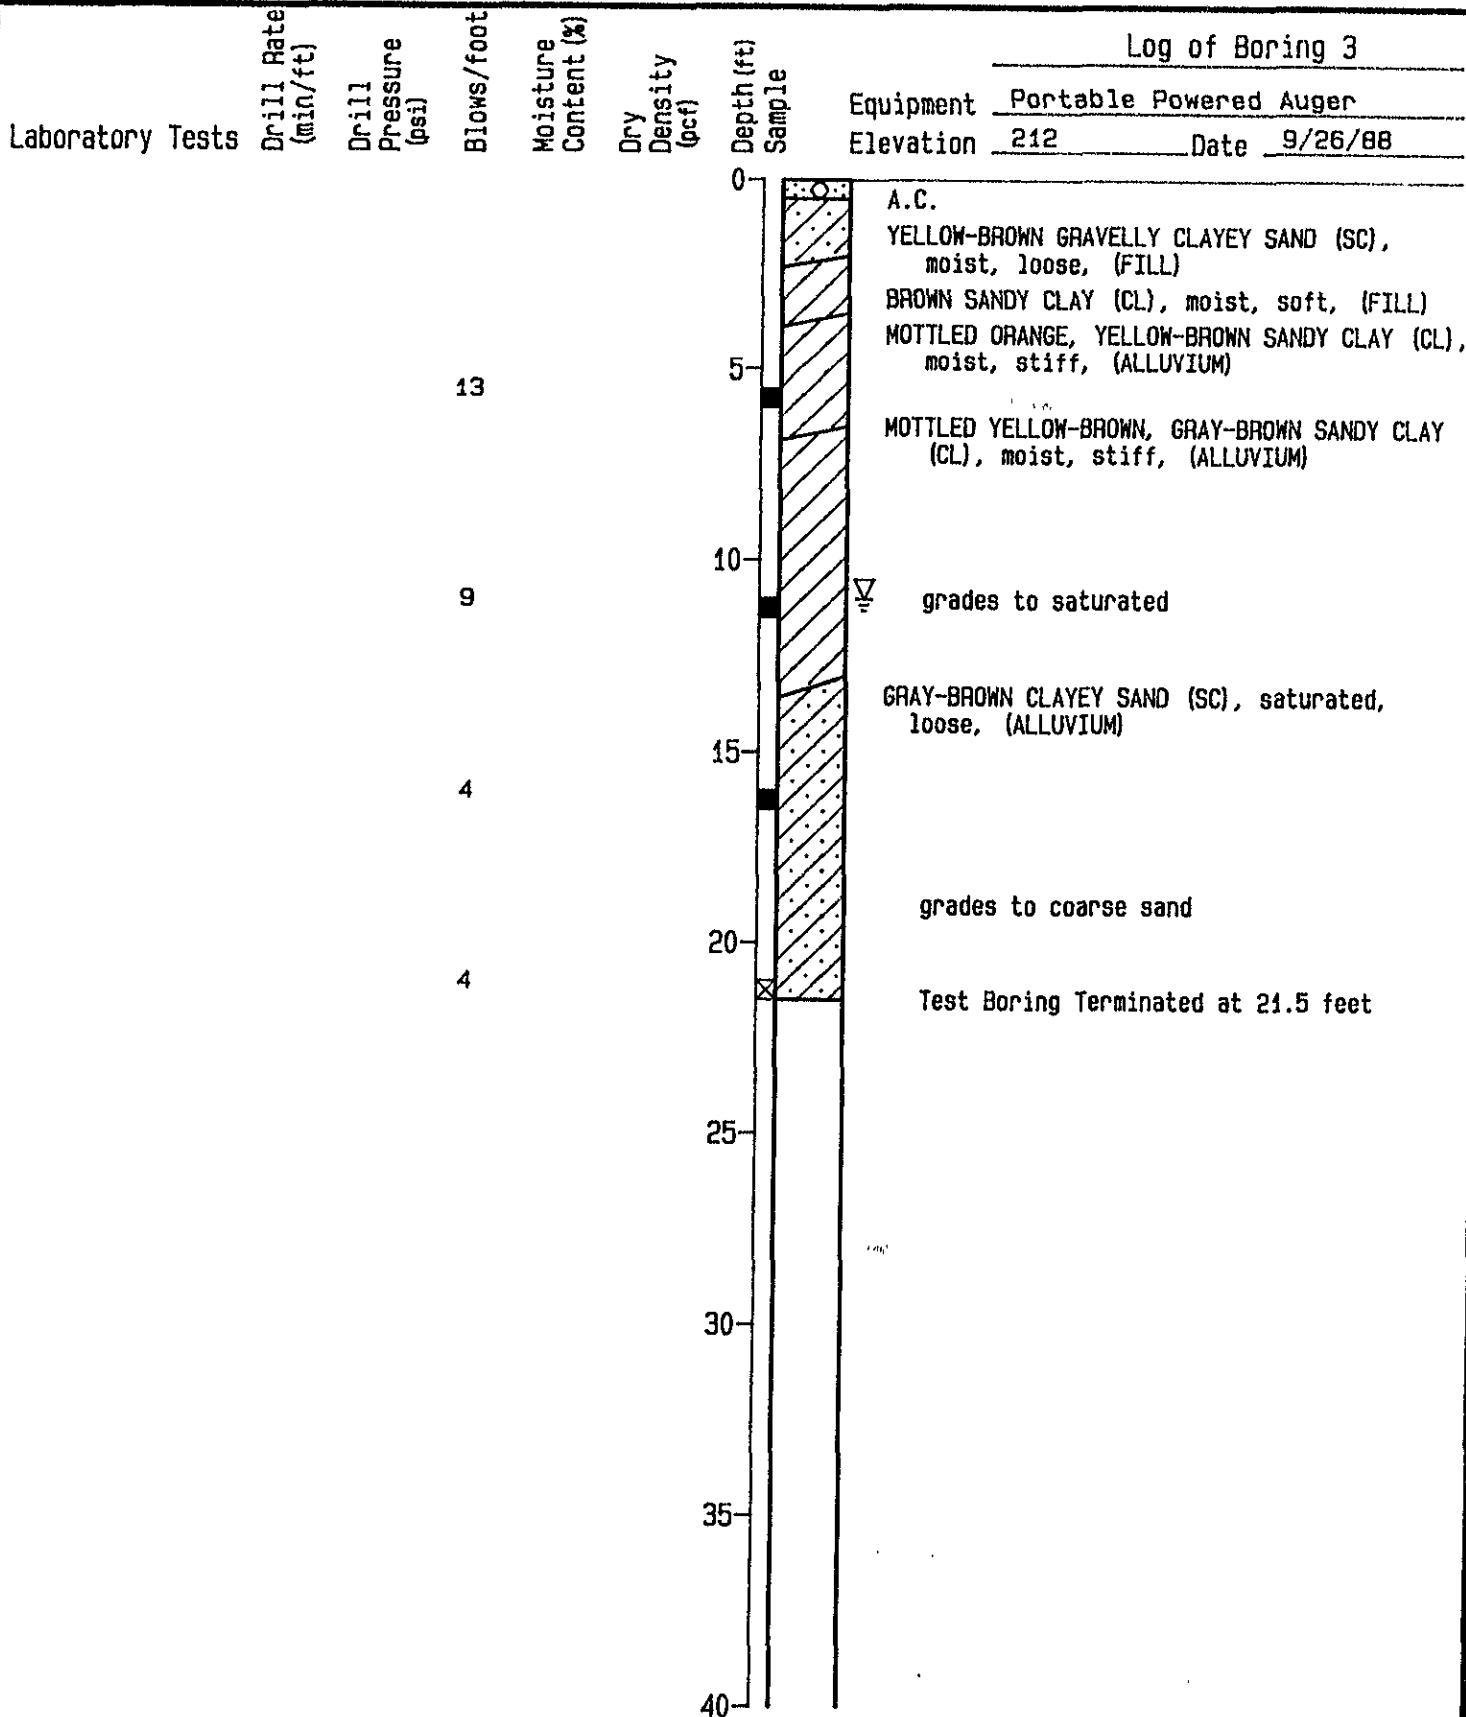
PLATE
5

The test borings encountered fill soils and alluvium over bedrock. The fills encountered varied in thickness and composition. Generally, they ranged from 1/2- up to 4-feet below the existing grade. The fills consisted of a random mixture of sands, clays and gravels, and existed in a medium dense or stiff state. Underlying the fill soils, the test borings encountered alluvial soils. The alluvial soils consisted primarily of clay material with significant amounts of sand and gravels. Bedrock was only encountered in Test Boring 1 at a depth of 16-feet.

In Test Borings 2 and 3, the alluvial soils extended up to 20-feet below the existing ground surface.

Ground water was encountered in three of the test borings. The depths are indicated on the boring logs. The ground water probably varies with seasonal rainfall.
