PRELIMINARY ENVIRONMENTAL ASSESSMENT
PHASE 1
CITY OF EMERYVILLE
EMERYVILLE SENIOR HOUSING PROJECT
4300-4322 SAN PABLO AVENUE
EMERYVILLE, CALIFORNIA
SCI 537.002

December 4, 1989

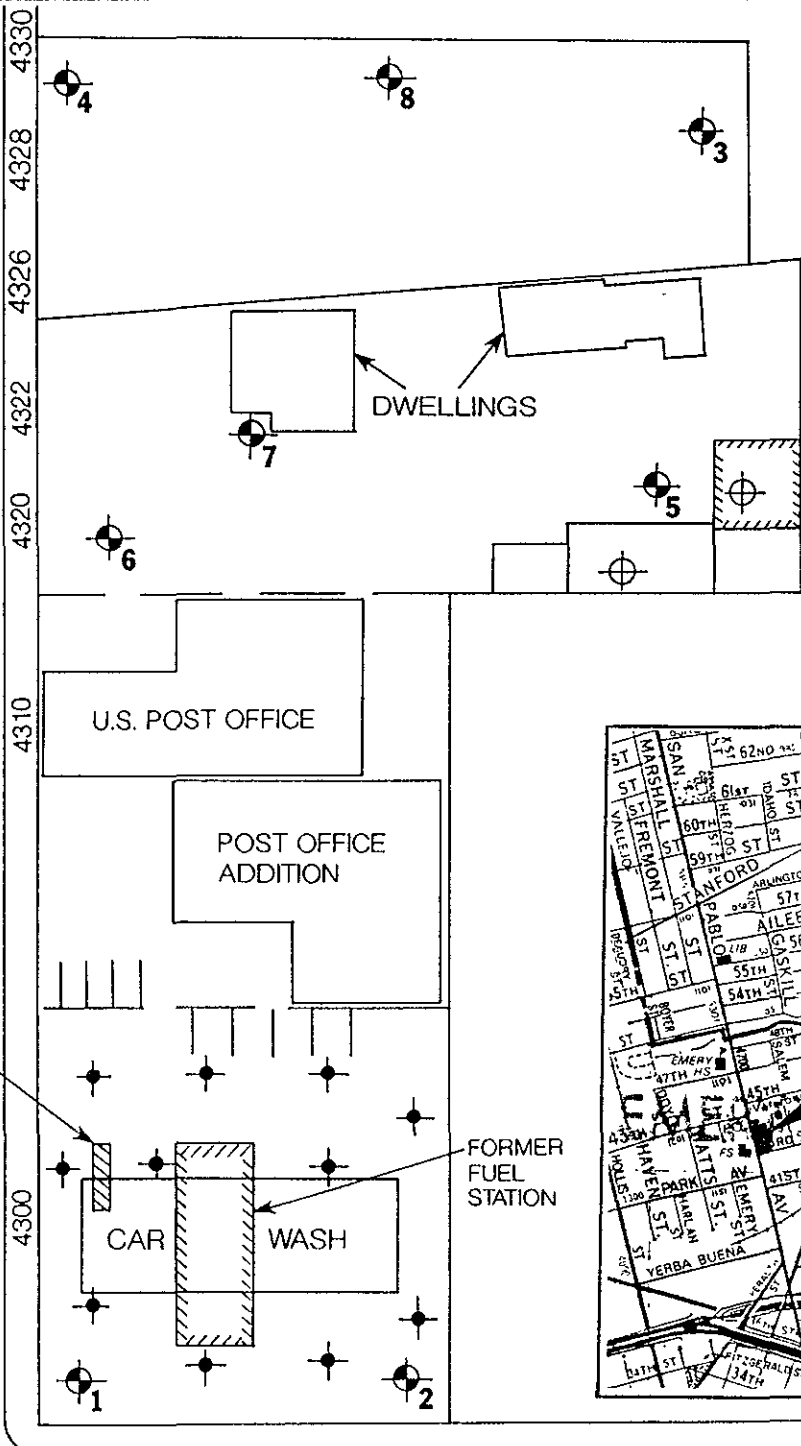
PLATE 1

Based on our review of environmental case lists compiled with the San Francisco Bay Regional Water Quality Control Board (RWQCB) and the Department of Health Services (DHS), there are 8 sites with documented releases from underground storage tanks within 2000 feet of the property. These sites are shown on Plate 1, and described in the Appendix.

In addition to the sites with documented releases from underground storage tanks, there are 5 sites having documented contamination from materials considered hazardous under State and Federal laws within approximately 2000 feet of the site. These sites are also indicated on Plate 1. A brief summary of information available from the files regarding these cases is presented below.

SCI conducted a site reconnaissance which included observing the site and surrounding features. While we observed no visual indications of current on-site activities which, in our opinion, could have resulted in significant on-site contamination, we judge that areas of concern do exist. These areas are associated with past use of 4300 San Pablo Avenue as a gasoline station, and

The gasoline station at 4300 San Pablo Avenue operated from about 1930 to 1966. What is not known about the station includes (1) the underground gasoline storage tank location(s), (2) whether other materials, such as diesel fuel or waste oil, were stored in underground tanks, (3) whether the tanks were removed or not, and (4) whether hydraulic lifts or a sump existed.

The property at 4300 San Pablo Avenue was previously a service station and is judged to be a potential source of contamination from gasoline, diesel fuel, waste oil, hydraulic oil and/or solvents. It is unclear whether underground fuel storage tanks remain on the property, or have been removed. We recommend at least 3 test borings/groundwater monitoring wells be installed at 4300 San Pablo to determine whether soil and groundwater contamination exists. As part of the investigation, test borings should be drilled at the location of the former pump islands and service garage.

An auto repair facility was formerly located adjacent to the site, at 4330 San Pablo Avenue. This type of facility often involves the presence of fuels, solvents, oils and waste oil. We recommend that at least one test boring/monitoring well be installed on-site, adjacent to the previous facility, to investigate the presence of these materials in the soil and groundwater.
