PRELIMINARY ENVIRONMENTAL ASSESSMENT
PHASE 2
EMERYVILLE SENIOR HOUSING PROJECT
4300-4310 SAN PABLO AVENUE
SCI 537.003

Subsurface Consultants, Inc.
171 12th Street, Suite 201
Oakland, California 94607
(415) 268-0461

July 13, 1990

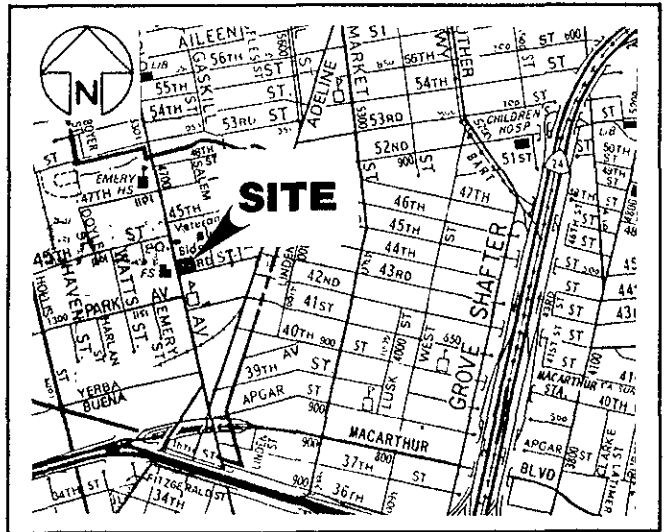
SITE PLAN

Based upon the results of the probes, two groundwater monitoring wells were installed in the areas with the highest OVM readings in soil. Both wells are located at 4300 San Pablo Avenue. A third well was installed at 4310 San Pablo Avenue. The well locations are shown on the Site Plan. The wells extend to depths ranging from 21 to 25 feet.

We judge that the contamination appears to be associated with the past use of the site at 4300 San Pablo Avenue as a service station. In particular, it appears that the former tanks, fuel pipelines and/or pumps may have leaked. Our research of available records, and subsurface exploration (with probes), did not result in identification of the former underground tank location(s). However, relatively high organic vapor concentrations were measured in the two areas where Monitoring Wells MW-1 and MW-2 were installed. Higher vapor concentrations would be anticipated near former leaks in underground tanks and/or fuel pipelines.

contaminated soil, and/or tank excavation backfill may be encountered during site demolition and/or grading. We recommend that the site be evaluated after site demolition to determine if additional soil sampling and analytical testing is necessary. Soil remediation may be required, depending upon the contaminant levels encountered during site development, and requirements of regulatory agencies. Additional investigation may also be required, based upon the results of the regulatory agency review.
