FAULT HAZARD INVESTIGATION
on
Former UNOCAL Station Site
11976 Dublin Boulevard
Dublin, California
for
UNOCAL

Project No. 6858
28 October 1994

Subject: Former UNOCAL Station Site
11976 Dublin Boulevard
Dublin, California
FAULT HAZARD INVESTIGATION

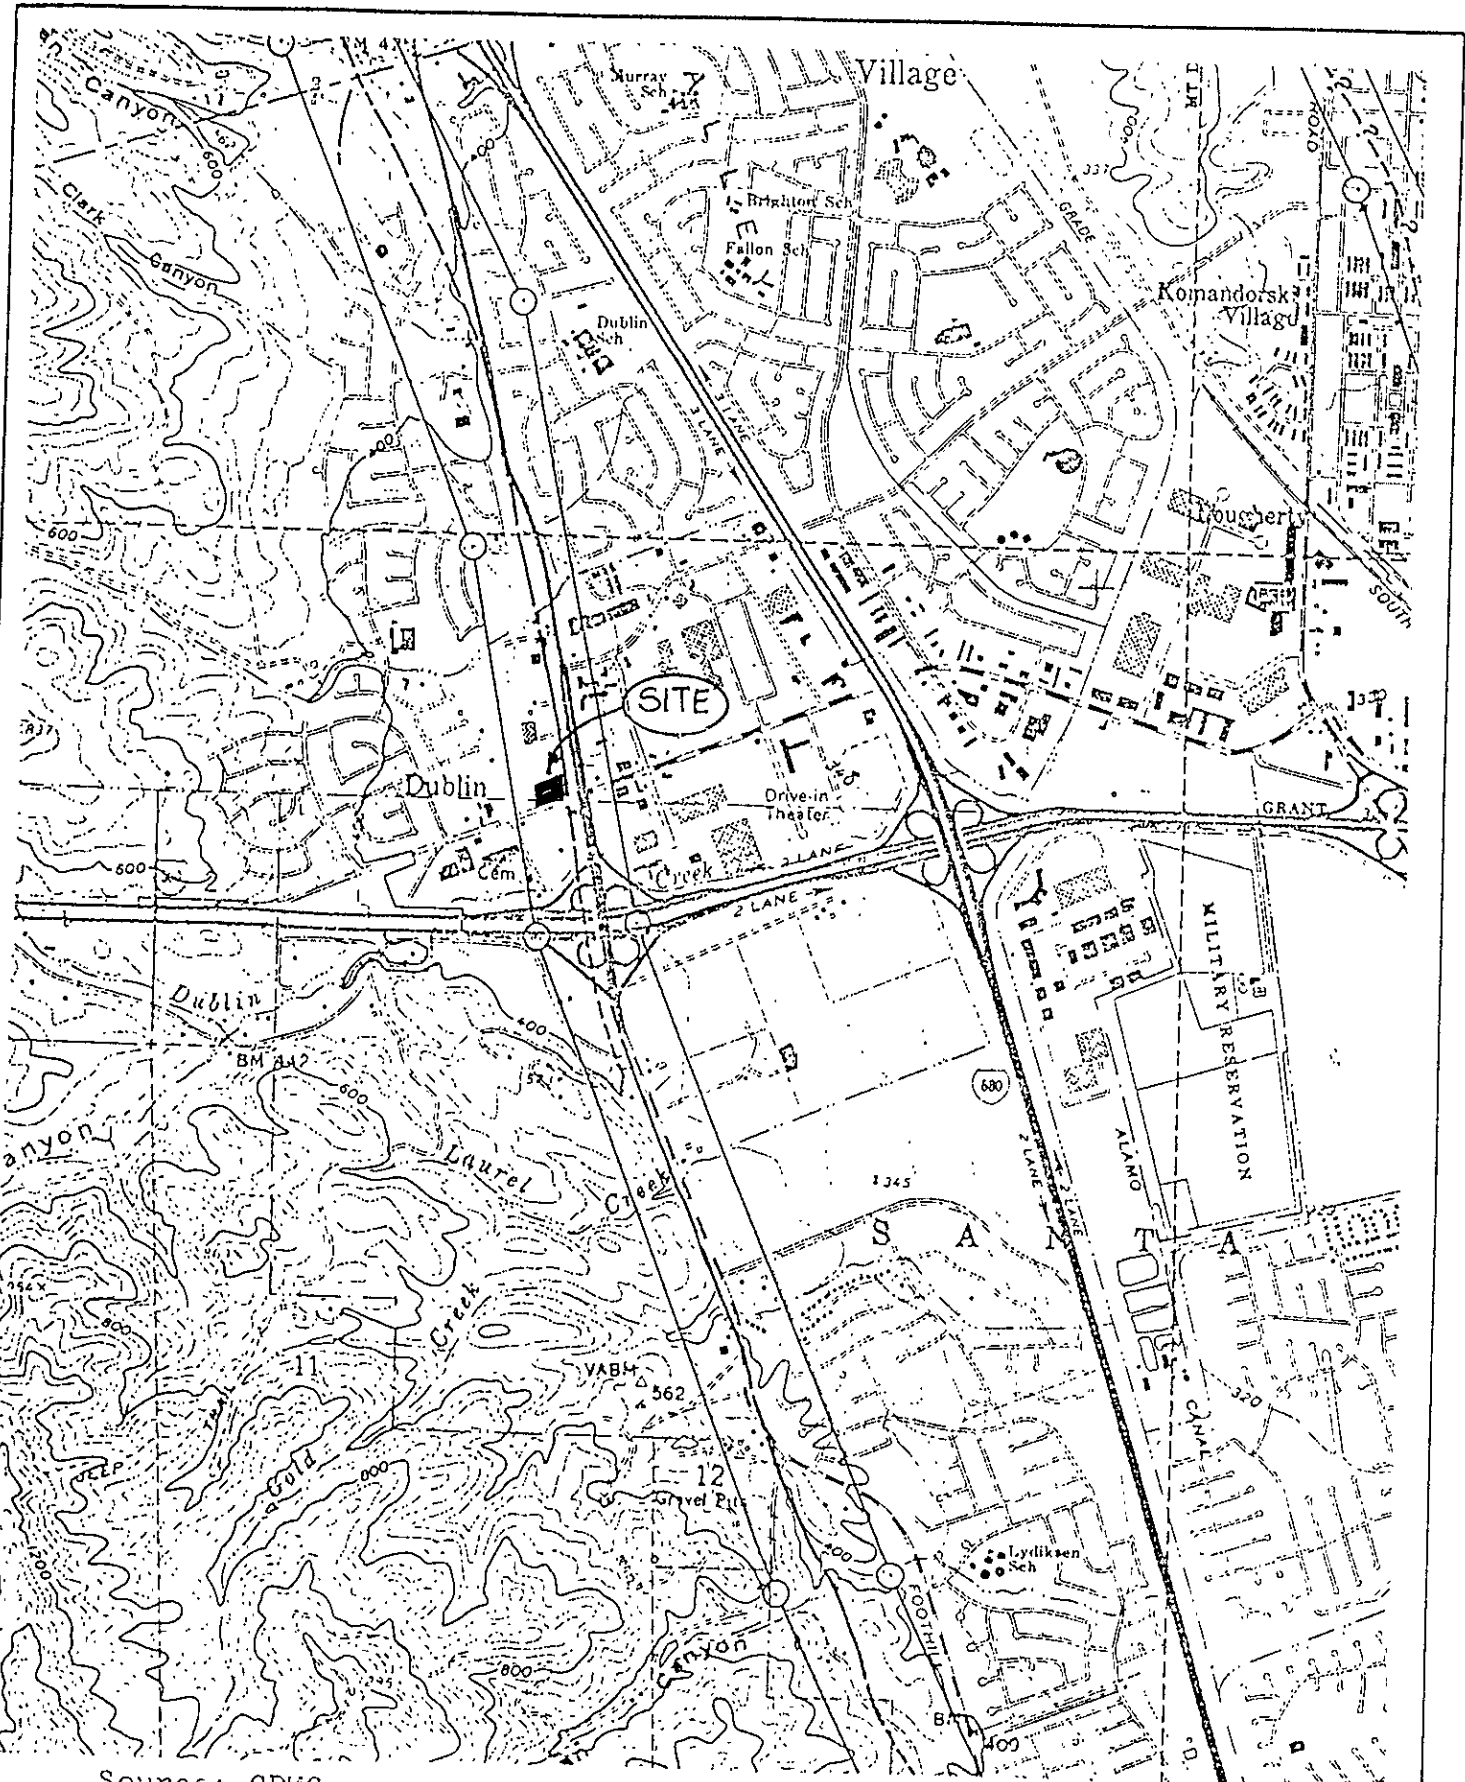
The subject site is located within the SSZ for the Calaveras Fault. See the location map, Figure 1, for the site location and the limits of SSZ. The Calaveras Fault is one of the major fault systems in the greater San Francisco Bay Area. The fault appears to be divided into distinct segments which have historically ruptured independently (Simpson, 1993). The Sunol to San Ramon segment is represented in the area of the site. This segment is considered active. Since 1969 virtually no seismicity has occurred on the northern portion of the fault between Calaveras Reservoir and Danville, which includes the local segment. For this reason, the fault is assumed to be accumulating elastic strain energy which may increase the probability of a significant earthquake of magnitude 6, somewhere along the fault, to about 30 percent over the next 30 years (Oppenheimer, 1993). Based on a fault segment model, the maximum magnitude earthquake for the segment of the fault in the site vicinity, is magnitude 6.25 to 6.5.

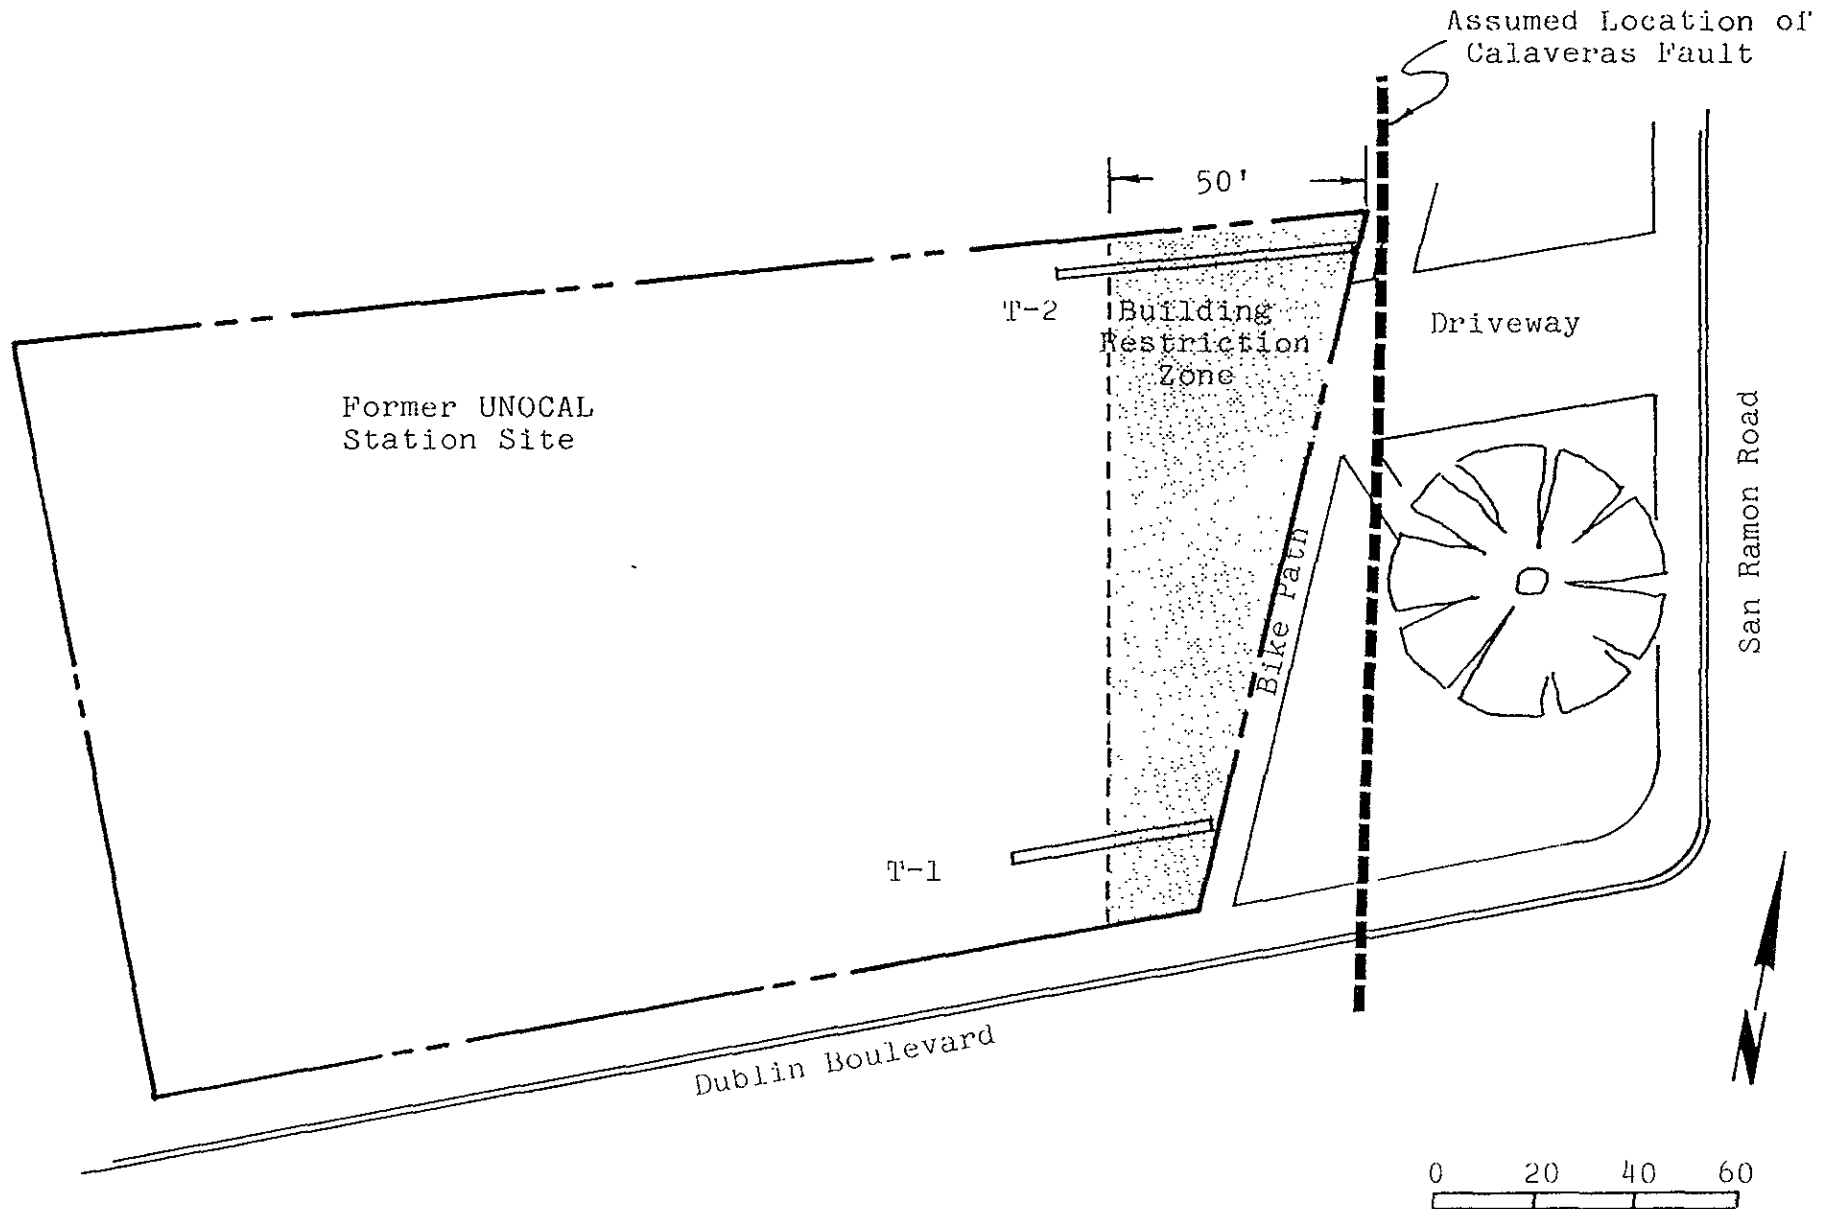
The project site is located in the northwest corner of the intersection of Dublin Boulevard and San Ramon Road in Dublin, California. The site is shown in the site plan, Figure 1. The property is the former site of a UNOCAL Station. The station and the underground facilities have been removed. Currently the site is a level vacant lot.

4. In addition to the seismic hazard of ground shaking, the hazard of surface rupture also exists due to the presence of the Calaveras fault immediately adjacent to the property. It was determined in this study that the fault does not cross the site. However, it must be assumed that the single main trace of the fault is located just to the east of the property. The site plan, Figure 2, shows the assumed alignment of the fault at the nearest possible location to the site. Based on this assumed location, a 50-foot wide Building Restriction Zone is recommended along the west side of the assumed alignment of the fault. The northern property line is roughly perpendicular to the alignment of the N10°W trending fault. The 50-foot zone can therefore be measured parallel to the northern property line and should begin at the northeast property corner.

5. It is recommended that no permanent habitable structures be placed within the Building Restriction Zone. Landscape areas, driveways, parking areas, and unoccupied structures may be placed within the Building Restriction Zone.

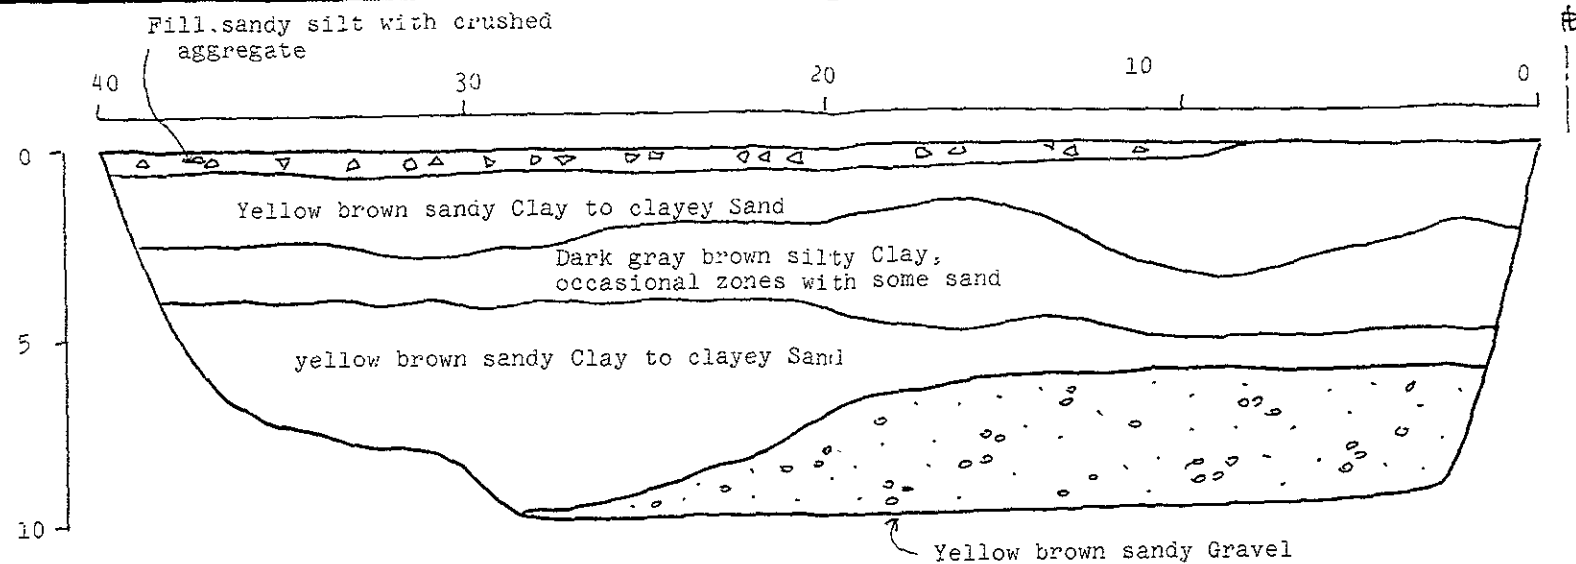
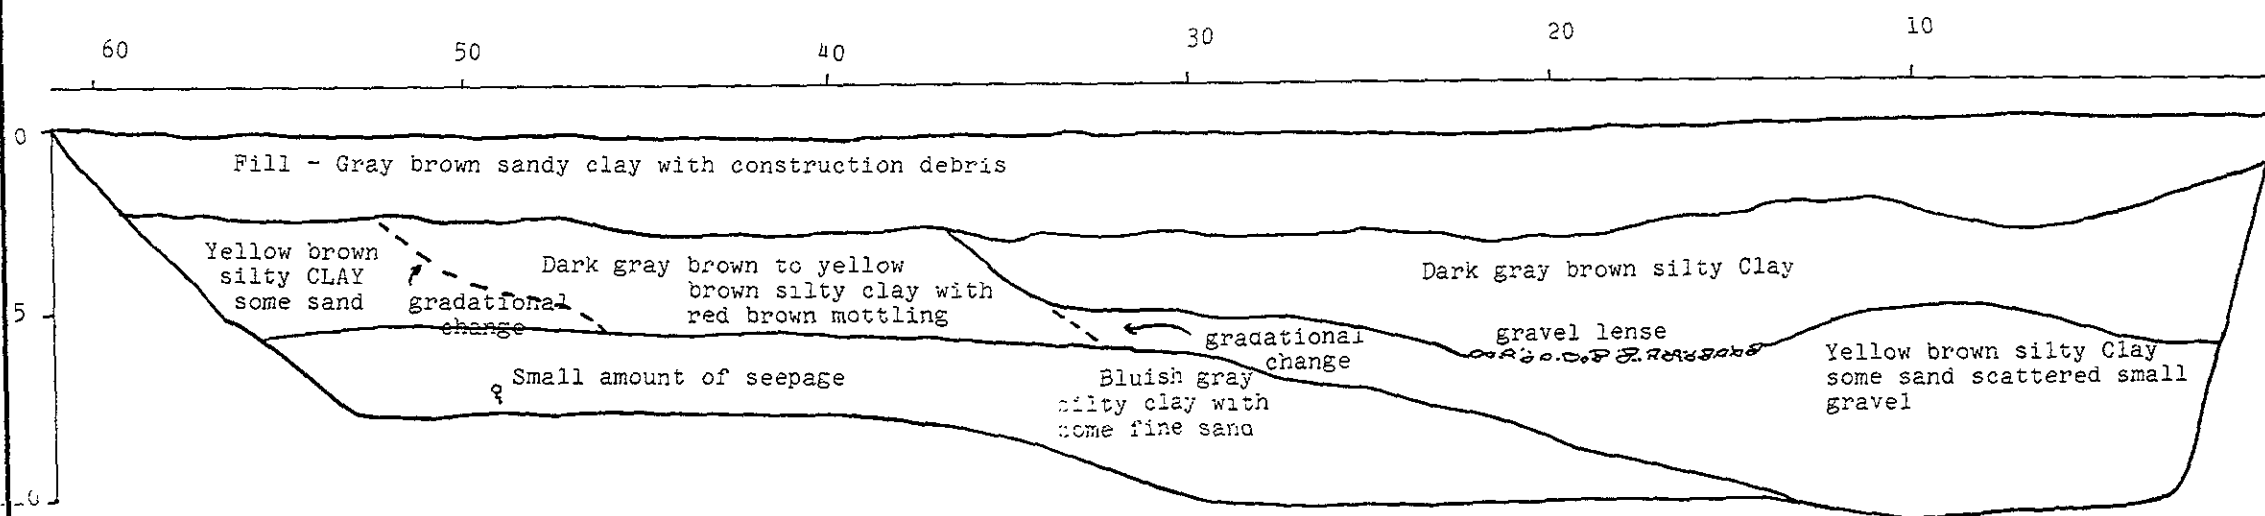
Trench 1 located in the southeast corner of the property, was 40 feet in length and 7 to 10 feet in depth. The excavation disclosed undisturbed alluvial soil deposits throughout the depth of the trench. The alluvial materials, occurred in somewhat irregular horizontal layers, consisted mainly of silty and sandy clay, but included granular channel deposits in the lower portion of

the trench. The soils were generally damp and fairly uniform in moisture content throughout the area exposed. No evidence of faulting was observed.

Trench 2, which was located in the northeast corner of the property, was 60 feet in length and 7 to 10 feet in depth. Materials encountered were similar to those in Trench 1 but displayed some variation, as would be expected in alluvial deposits. Minor seepage of subsurface water occurred at a depth of about 6 feet in the western end of the trench. The remainder of the soils were uniformly damp except the first 10 feet at the east end of the trench where the moisture content was considerably higher. Scattered small pockets of carbonates were also observed in this portion of the trench. No discernable fault related features were found in the trench. The increased moisture content in the east end of the trench and the presence of disseminated carbonates in that area, may indicate a close proximity to the fault, indicating that the fault is located a short distance to the east of the trench, i.e., east of the property line.

Increased moisture content
 ← and scattered carbonate
 pockets in this end of trench.

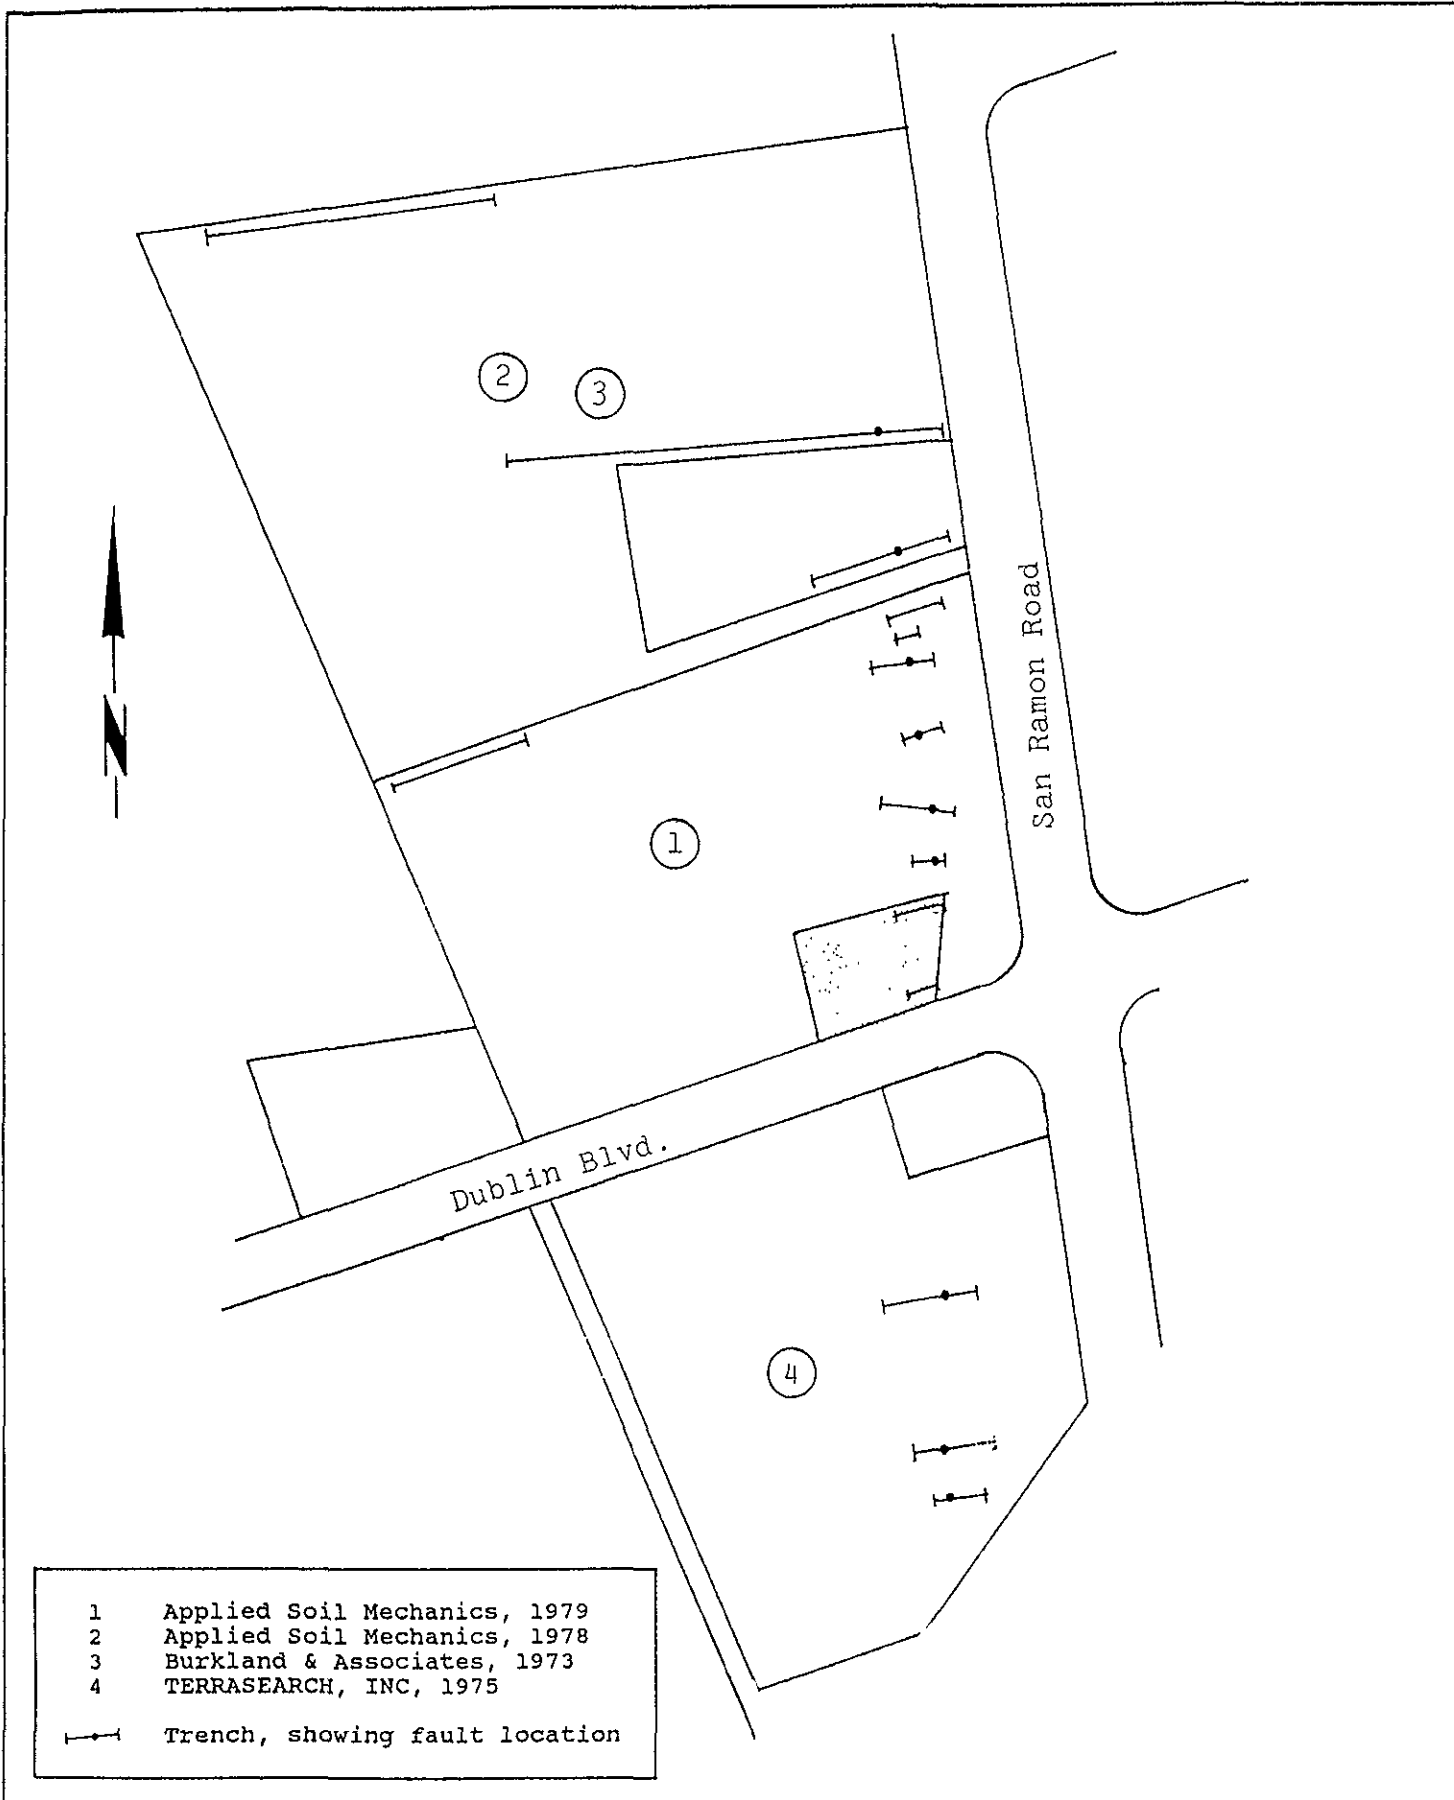
Test trenches from nearby investigations are shown on Figure 4. The trench locations are compiled from a number of reports which vary in scale and degree of accuracy of the original plotting. The relative positions of the plotted trenches on the air photo based map on Figure 4 are as accurate as the existing data allows.
