CITY OF SAN LEANDRO

MEMORANDUM

DATE: April 6, 1995
TO: Debbie Potter, Redevelopment Administrator
FROM: Michael Bakaldin, Hazardous Materials Coordinator
SUBJECT: 960 San Leandro Boulevard - Status Report

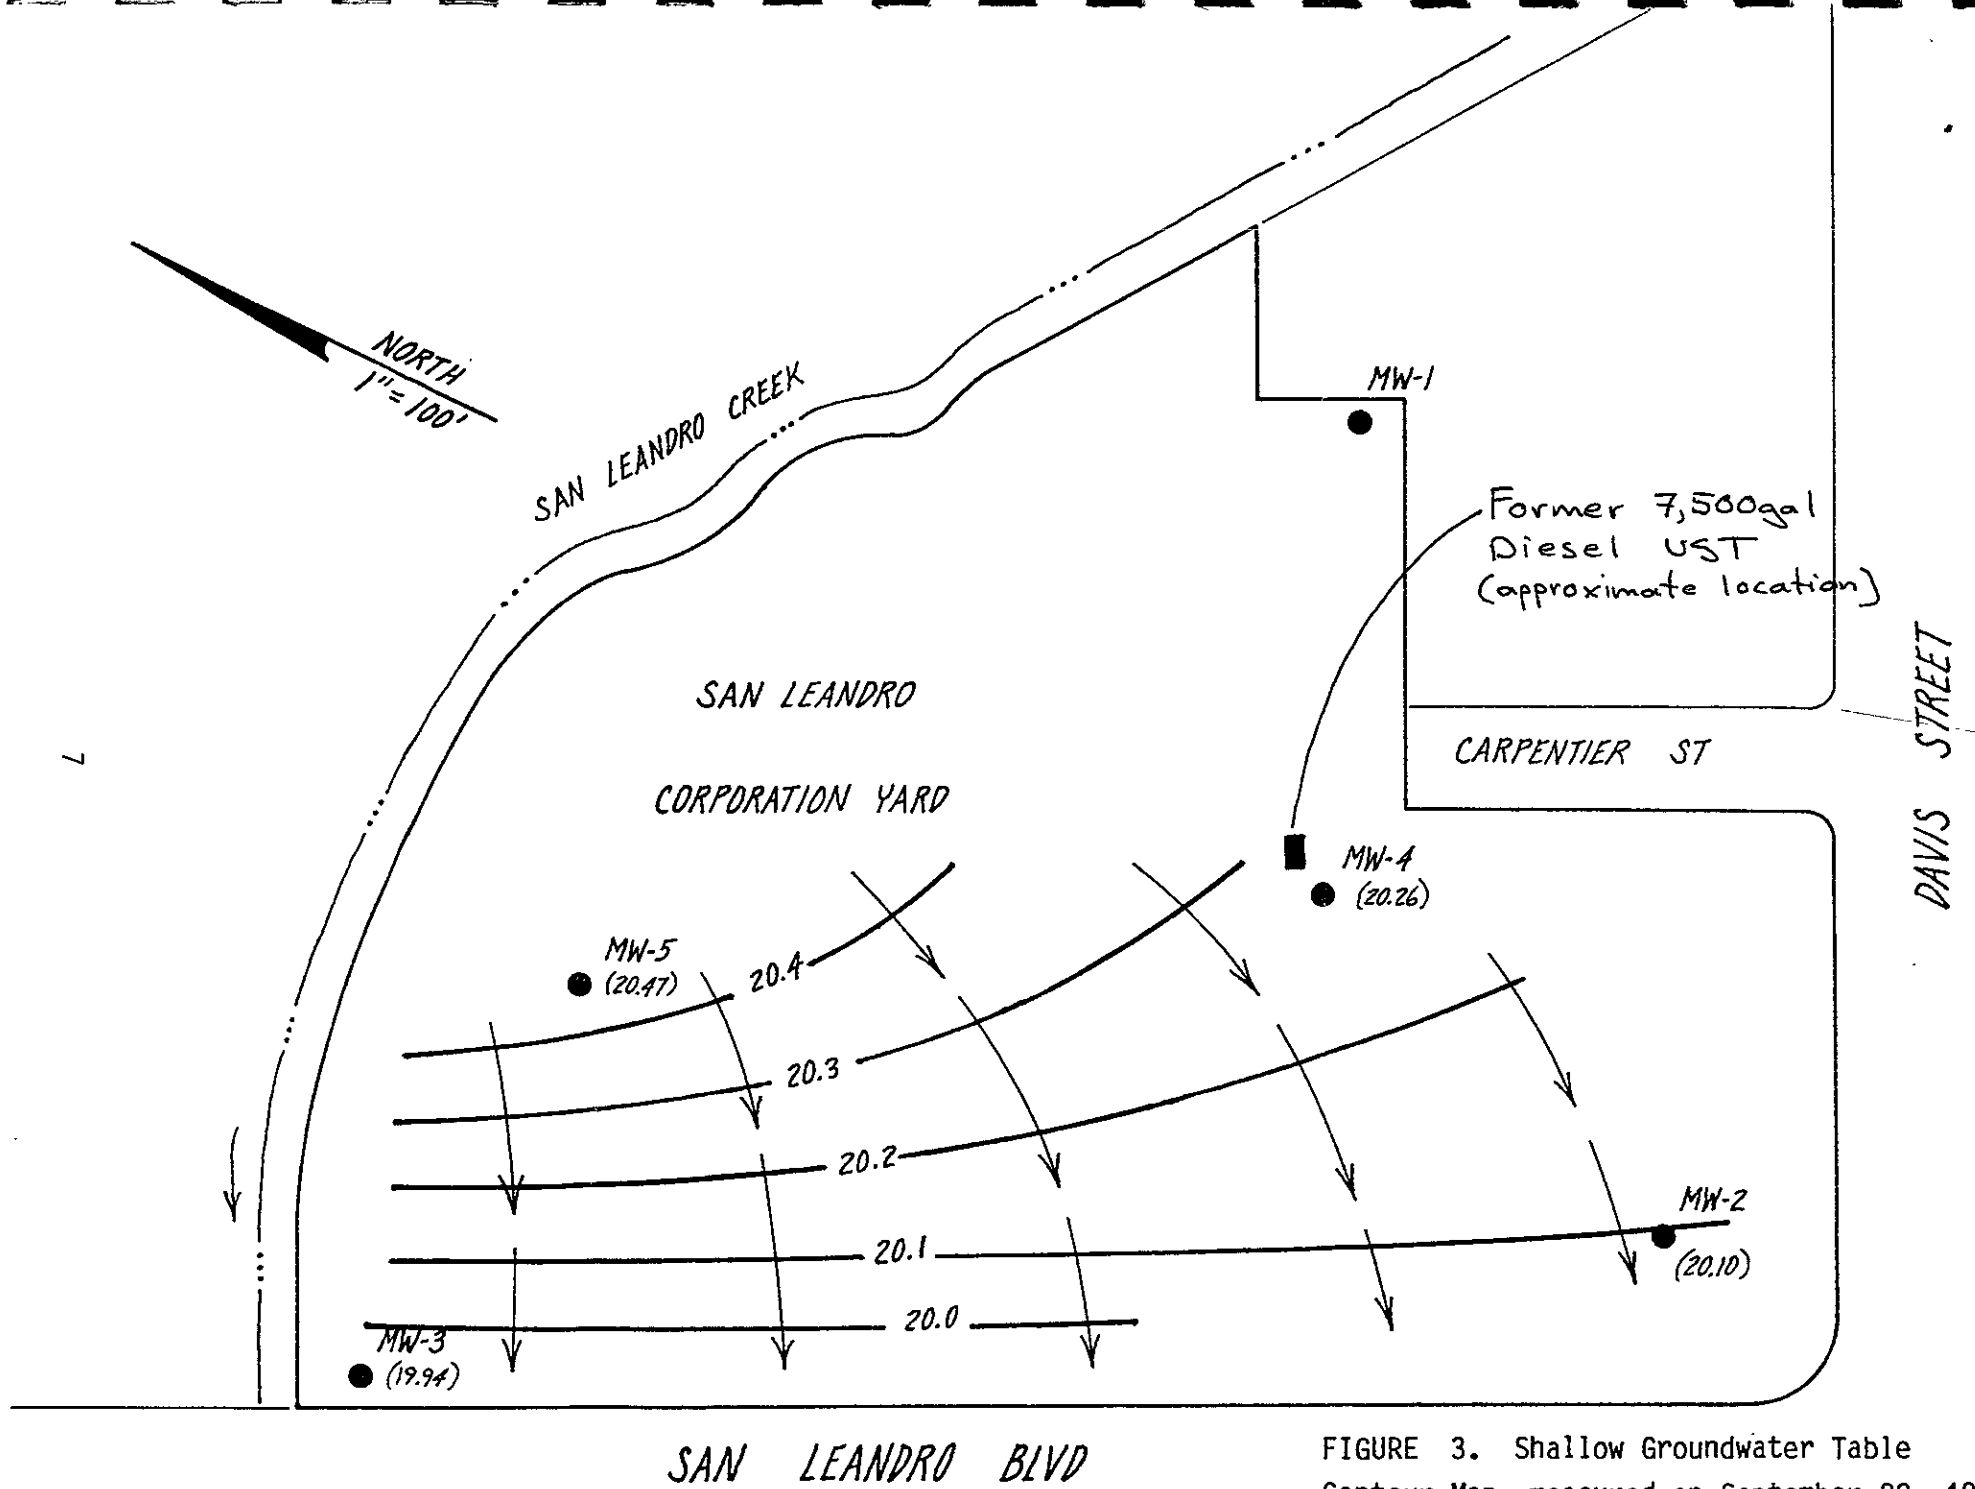
FIGURE 3. Shallow Groundwater Table Contour Map, measured on September 22, 1994.
