SITE: Z-RENTALS, 711 CLEVELAND STREET, ALBANY, CA 94710

Please find attached a brief report summarizing the geologic findings at the referenced site based on the Caltrans subsurface investigation. Included are partial drawings of the Caltrans soil boring logs and vicinity drawings.

Z-RENTALS, 711 CLEVELAND STREET, ALBANY, CA 94710

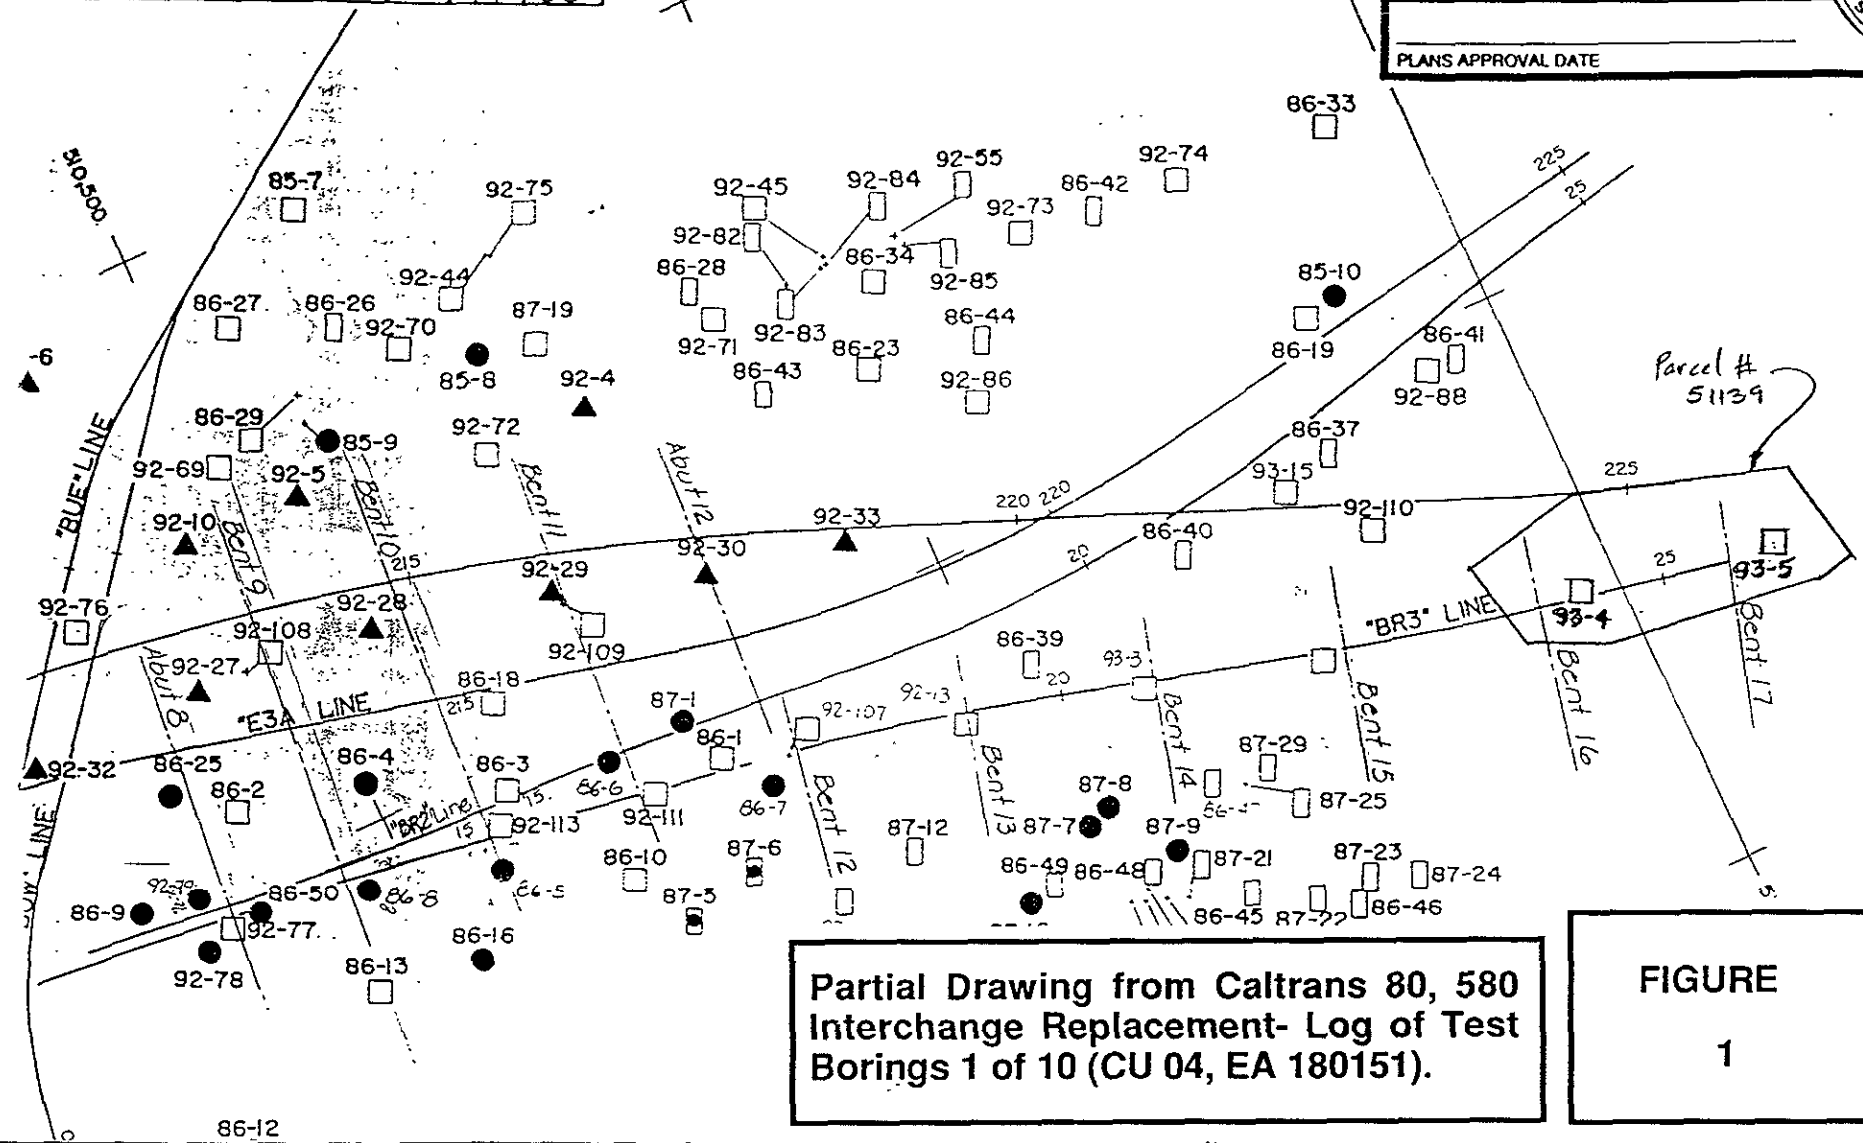
FIGURE 1

On January 9, 1993, Caltrans drilled two soil borings on the subject site for a structural investigation. Figures 1 and 2 show the locations of the two borings (labeled 93-4 and 93-5, located in Parcel #51139). The borings extended approximately 43 feet into the subsurface (twenty feet below mean sea level). Groundwater was not detected in either boring. Graywacke sandstone was encountered at one foot below surface grade (bsg) in boring 93-5 (Figure 4) and seven feet bsg in boring 93-4 (Figure 3). The borings were advanced with diamond core drilling due to the hardness of the sandstone. Both borings were closed immediately after drilling.

Partial Drawing from Caltrans 80, 580 Interchange Replacement- Log of Test Borings 1 of 10 (CU 04, EA 180151).

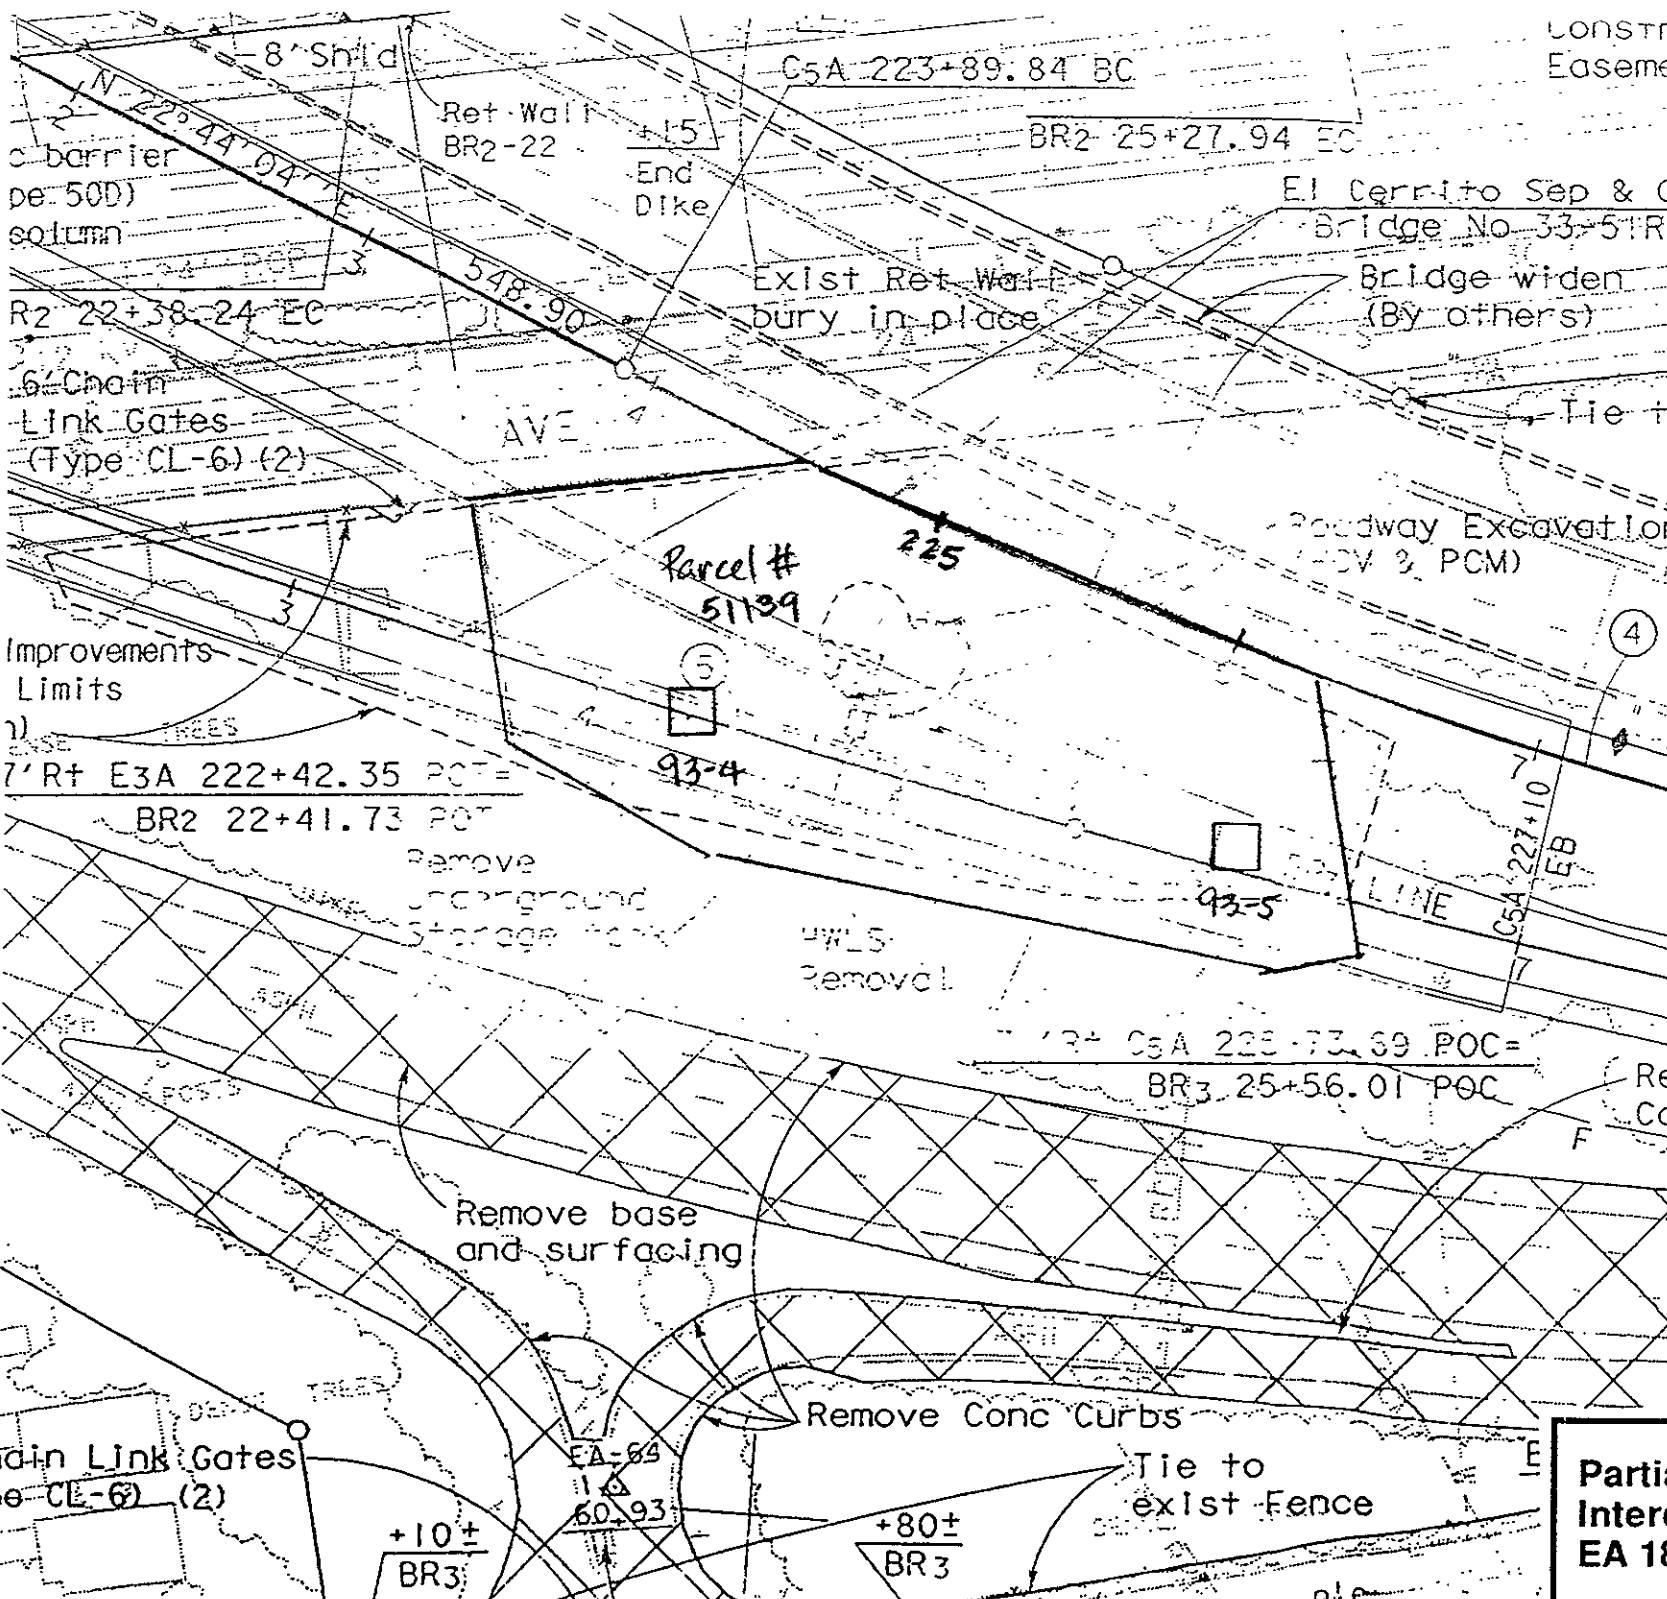
FIGURE 2

Partial Drawing from Caltrans 80, 580 Interchange Replacement (CU 04175, EA 180151).

93-4 boring
w/in the area
of Zickler's property

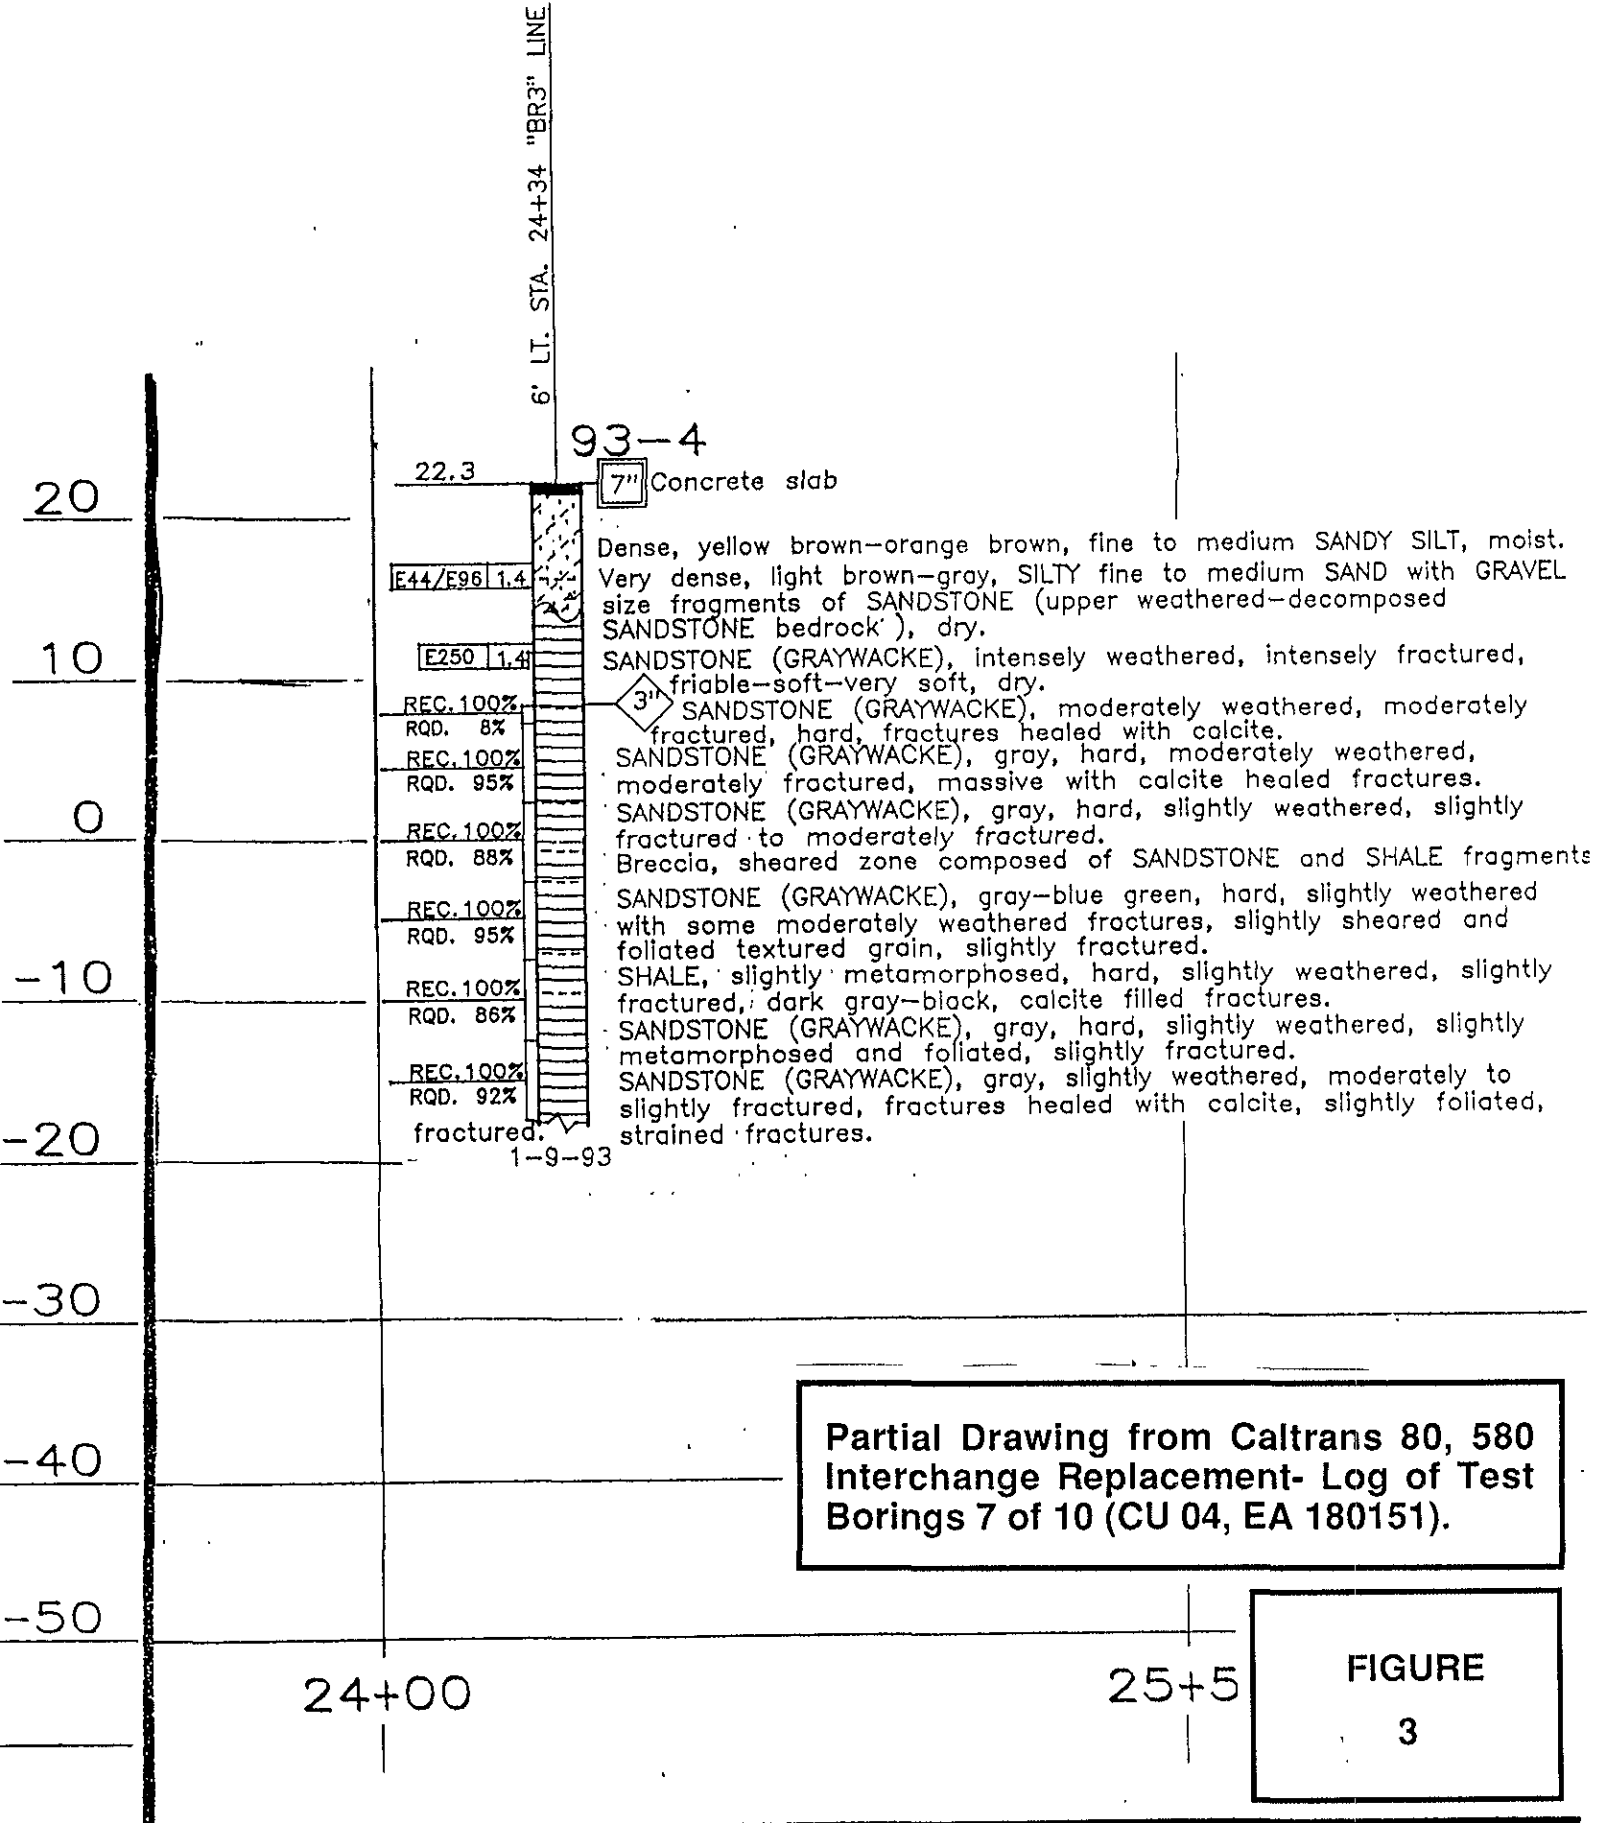
FIGURE 3

Partial Drawing from Caltrans 80, 580 Interchange Replacement- Log of Test Borings 7 of 10 (CU 04, EA 180151).
