SUBJECT: **Red Cross Facility Located at 2017 Central Avenue, Alameda, California**

SUBJECT: Red Cross Facility Located at 2017 Central Avenue, Alameda, California

Environmental Science & Engineering, Inc. (ESE) is pleased to present the results of a subsurface investigation conducted at the subject facility. The investigation was initiated in response to a suspected unauthorized release of petroleum hydrocarbons from one or more existing underground storage tanks. The following letter report presents a summary of the site work conducted during this investigation.

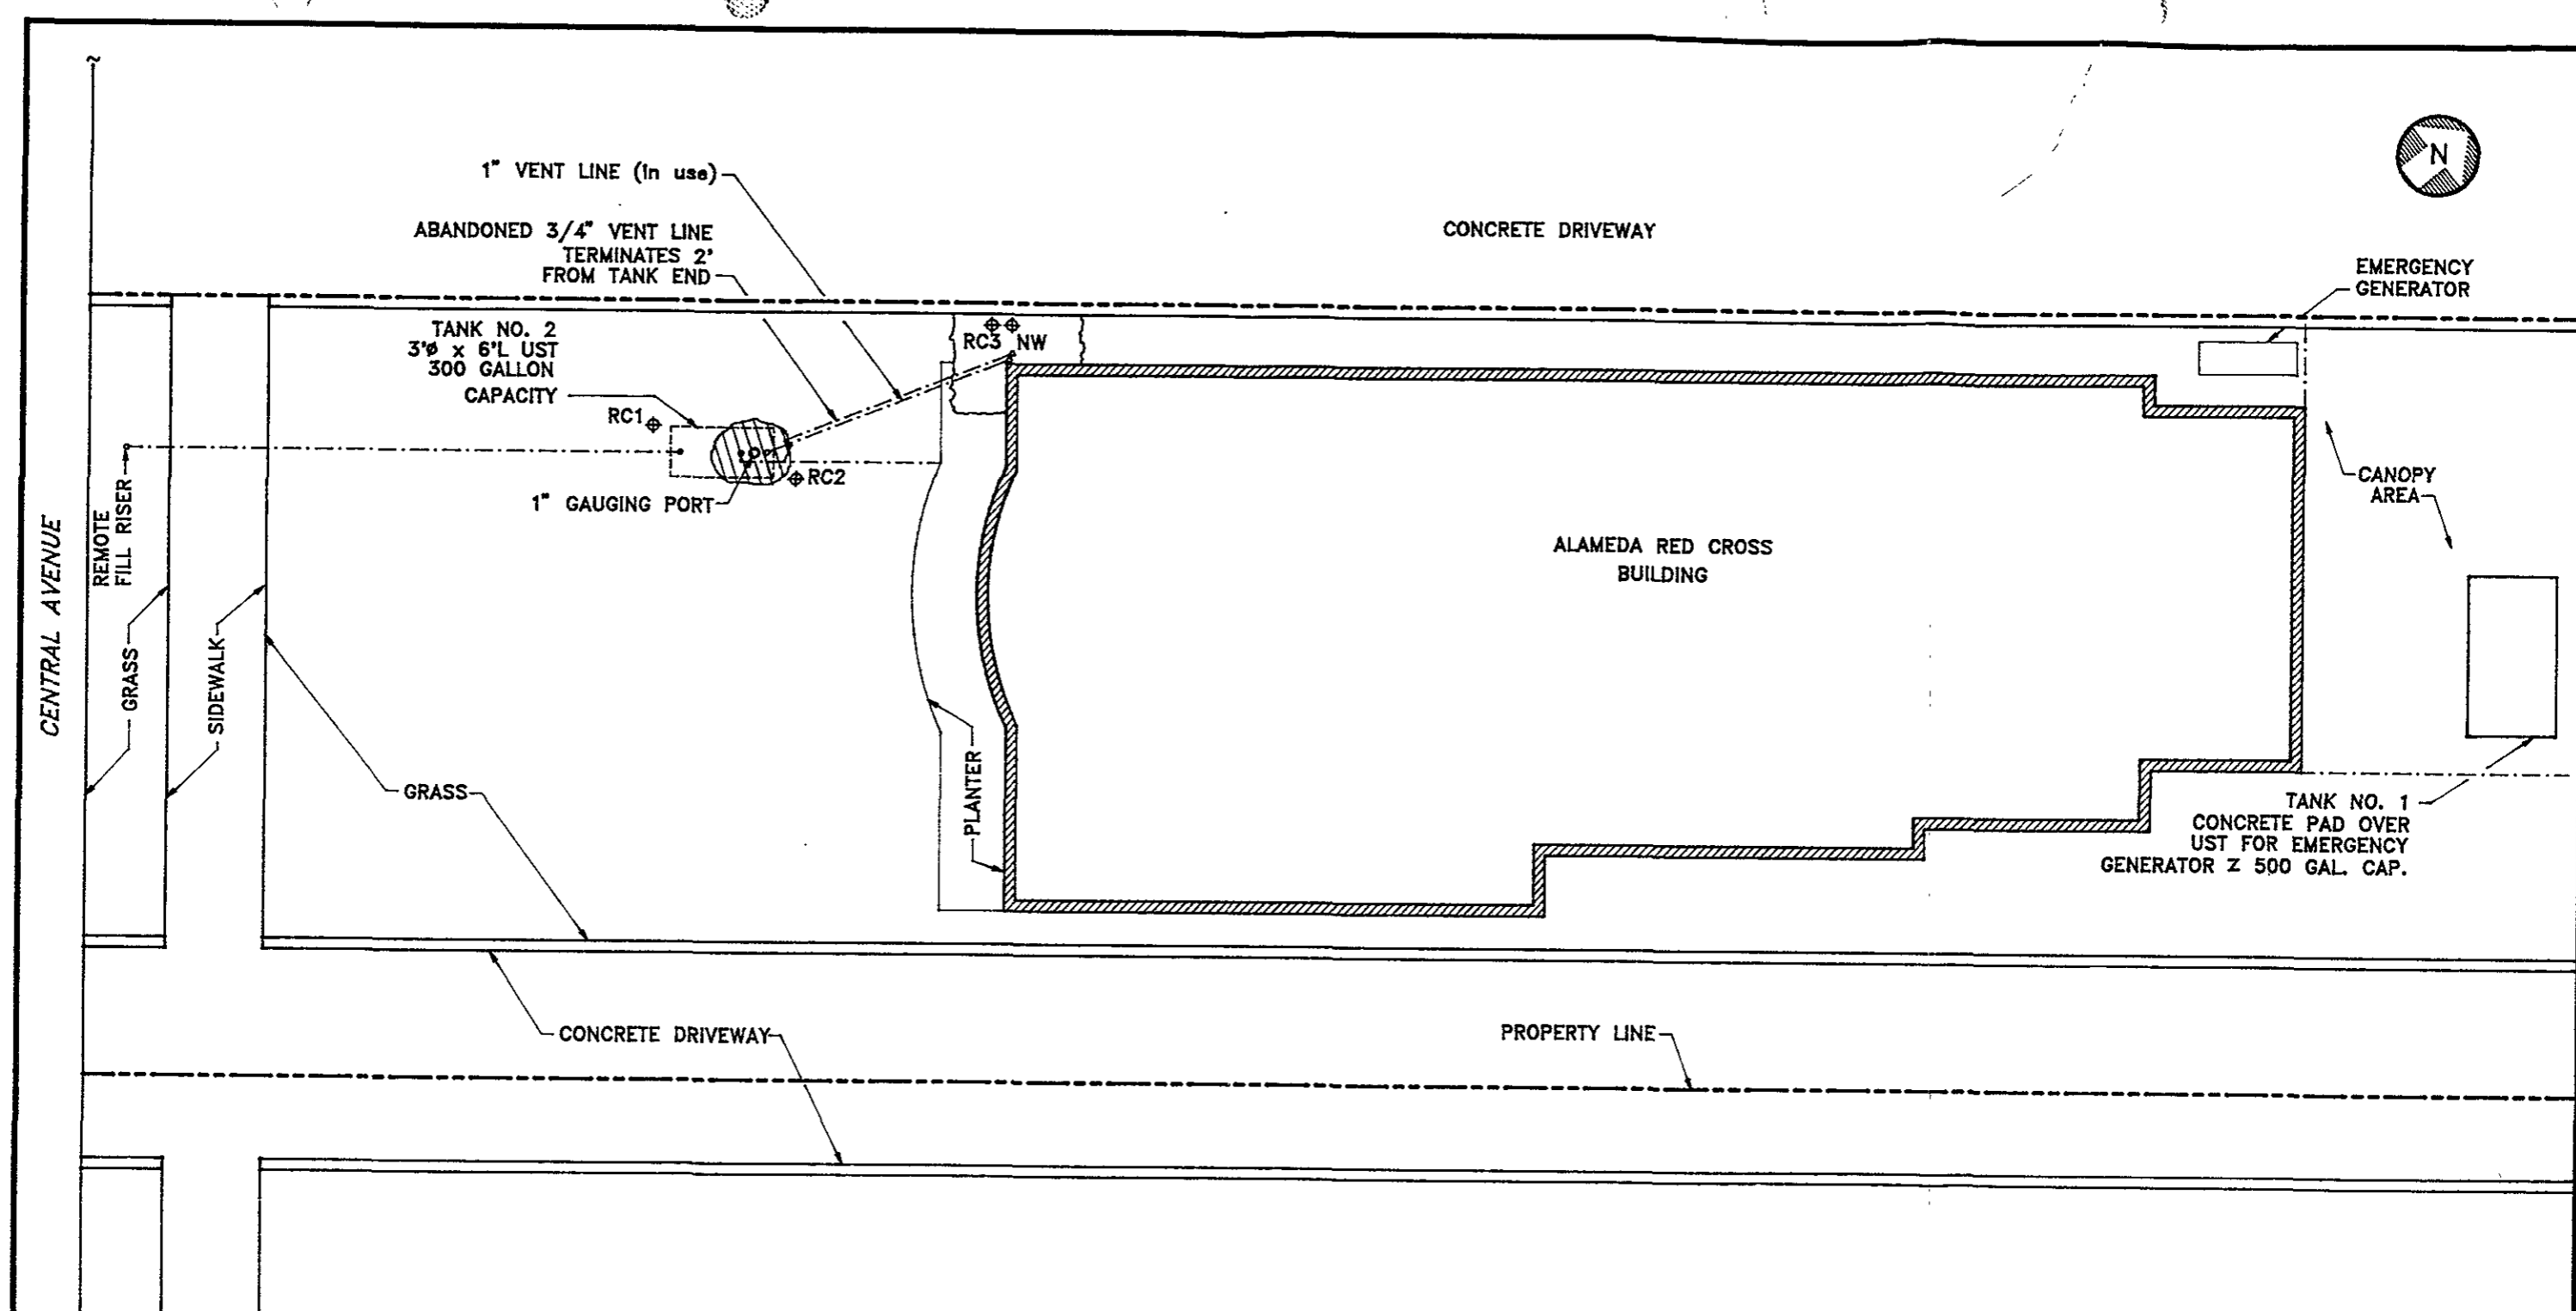
Environmental Science & Engineering, Inc. <small>A GILCORP COMPANY</small>	
RED CROSS 2017 CENTRAL AVENUE ALAMEDA, CALIFORNIA	
FIGURE 2 SITE MAP	
DRAWN BY DWR	APPROVED BY

Only one UST (Tank No. 2) was identified in the front (southwest) lawn area of the property. The UST is approximately three feet in diameter and six feet in length. The depth to tank invert is seven and one-half feet bgs. The UST is oriented to the Northeast (Figure 2). The estimated capacity is 300 gallons. The remote fill and the visible tank fill riser both serve this UST. The buried portion of the second vent pipe (attached to the west corner of the main building) is installed parallel to the first vent pipe but is severed underground approximately two feet short of the UST. It is unclear what purpose this second vent pipe served.

Soil samples were collected at five and ten feet bgs in boring RC1, located adjacent to and northwest of Tank No. 2. Laboratory analysis of these samples reports concentrations of TPH-D of 69 mg/Kg and 210 mg/Kg respectively. Gray discoloration and strong petroleum fuel odor was observed in the ten foot sample.

Soil samples were collected at four and one-half and nine and one-half feet bgs in boring RC2, located adjacent to and south east of Tank No. 2. Laboratory analysis of these samples reports nondetectable concentrations of TPH-D at 4.5 feet bgs and 86 mg/Kg of TPH-D at nine and one-half feet bgs. Gray discoloration and strong petroleum fuel odor was observed in the nine to ten foot interval.

Soil samples were collected at four and one-half and nine and one-half feet bgs in boring RC3, located adjacent to the existing vent risers at the north west corner of the building. Laboratory analysis of these samples report concentrations of TPH-D of 50 mg/Kg at four and one-half feet bgs and non-detectable concentrations of TPH-D at nine and one-half feet bgs. A slight odor and gray mottling was observed in the nine to ten foot interval.

- UST No. 2 should be immediately evacuated of all pumpable product. The tank and associated piping should be scheduled for removal. A Leaking Underground Storage Tank Unauthorized Release Form (attached) should be
