997 Grant Ave., San Lorenzo. 12-18-90.  
6k premium unleaded fuel tank.

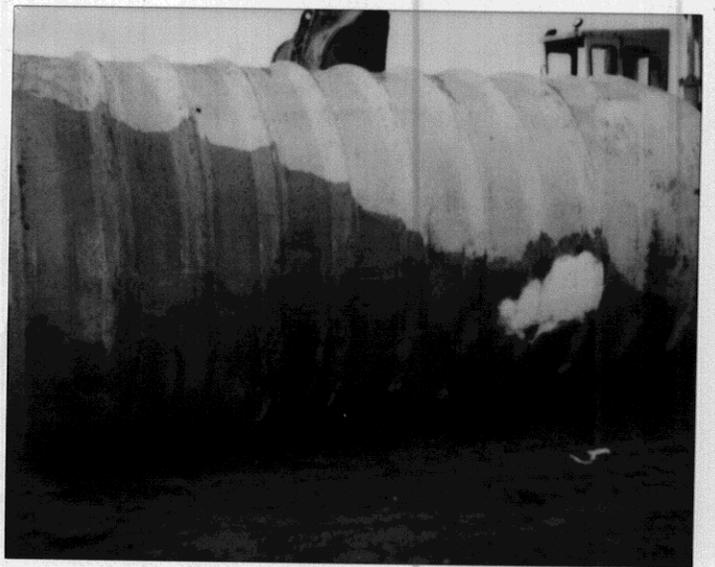
997 Grant Av., San Lorenzo. 12-18-90.  
6k unleaded premium fuel tank.

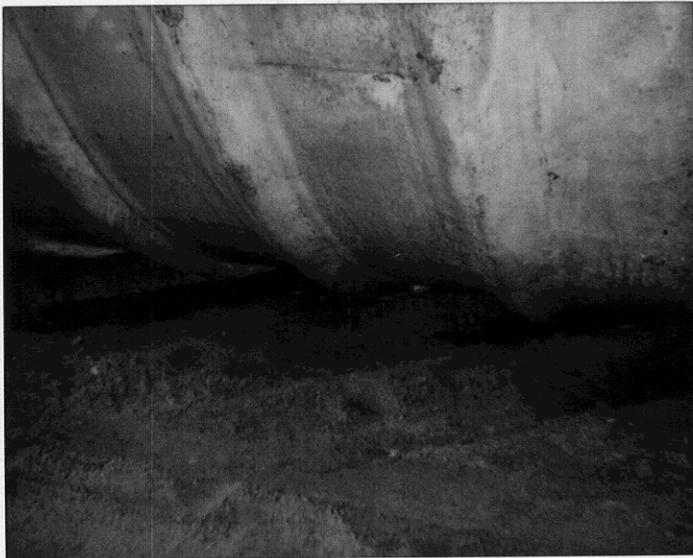
997 Grant Av., San Lorenzo. 12-18-90,  
middle tank 10k. Far left rib had  
pin hole to right. Note puddled water.

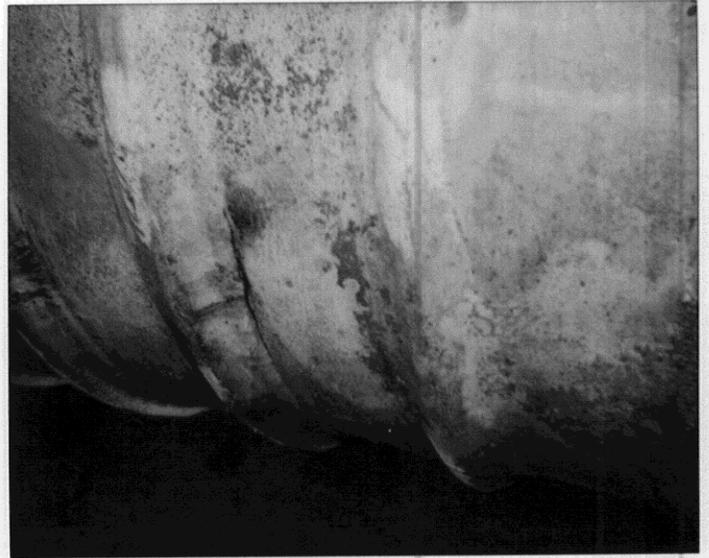
997 Grant Av., San Lorenzo. 12-18-90,  
middle 10k fuel tank. Crack noted  
next to rib in center of photo.

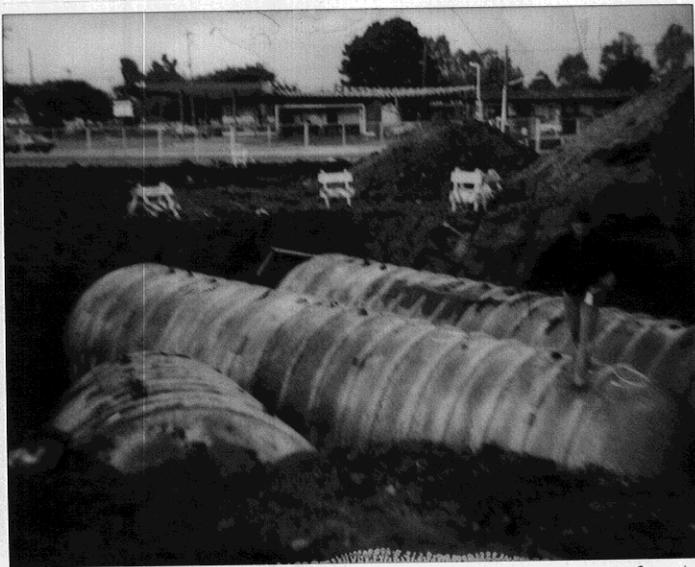
997 Grant Av., San Lorenzo. 12-18-90.  
3 fuel tanks before removal.

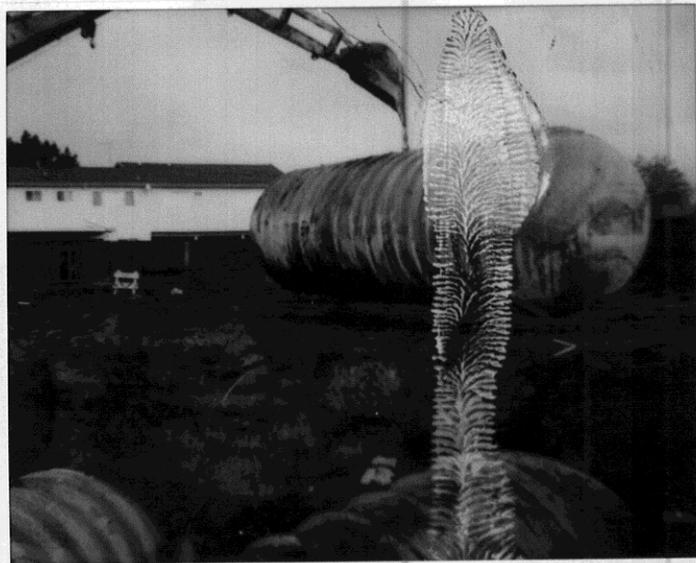
997 Grant Av., San Lorenzo. 12-18-90.  
North 10 K tank. Apparently in good  
condition.

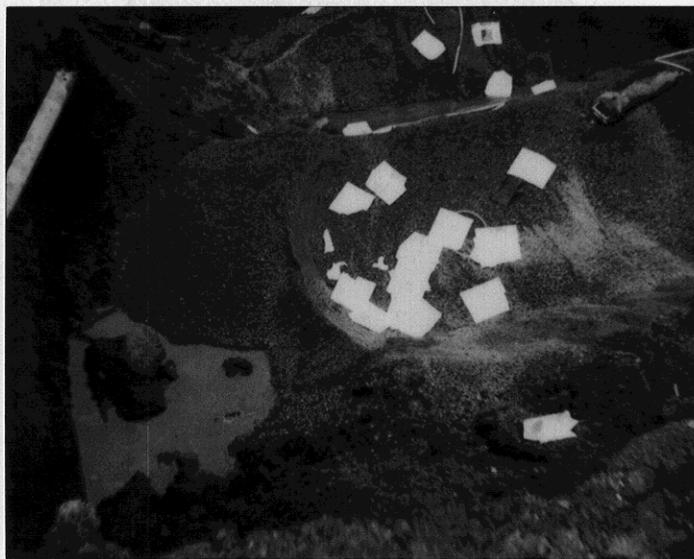
997 Grant Av., San Lorenzo. 12-18-90.  
Pooled water, w. side of fuel tank pit.

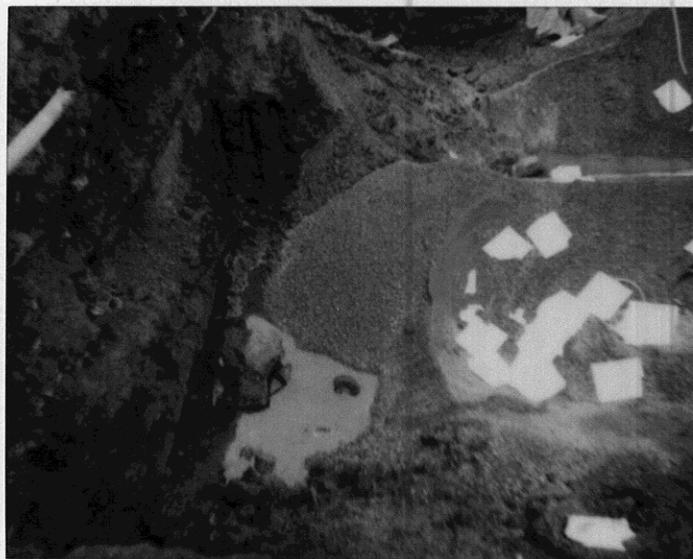
997 Grant Av., San Lorenzo. 12-18-90.  
Pooled water - w. side of fuel tank pit.  
Oily sheen present - ~ 11 feet deep.

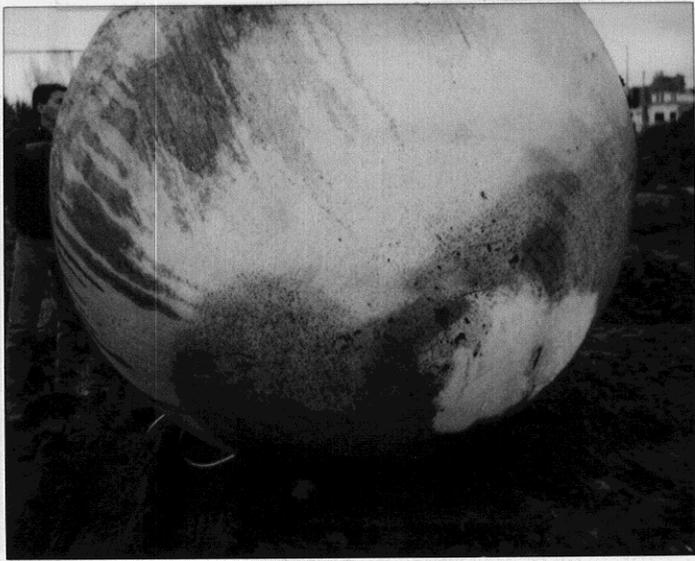
997 Grant Av. San Lorenzo. 12-18-90.  
Waste oil tank - bottom. No noticeable  
breaches.

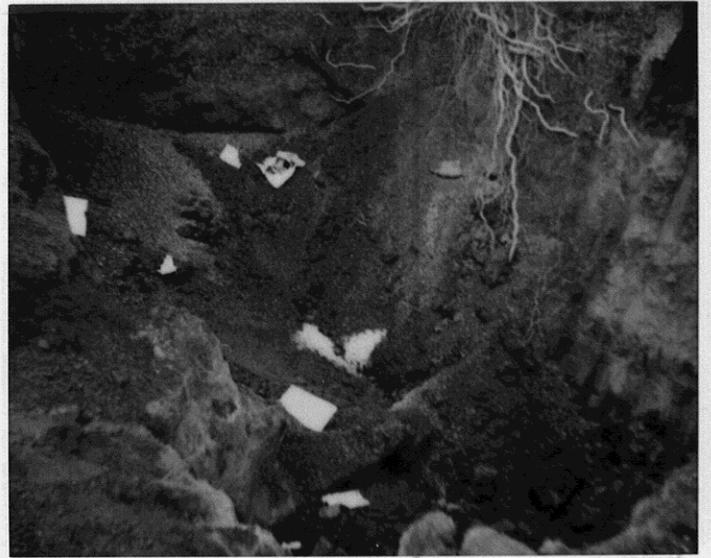
997 Grant Av., San Lorenzo. 12-18-90  
Waste oil tank pit bottom immediately after  
tank removal. 9-10' depth.

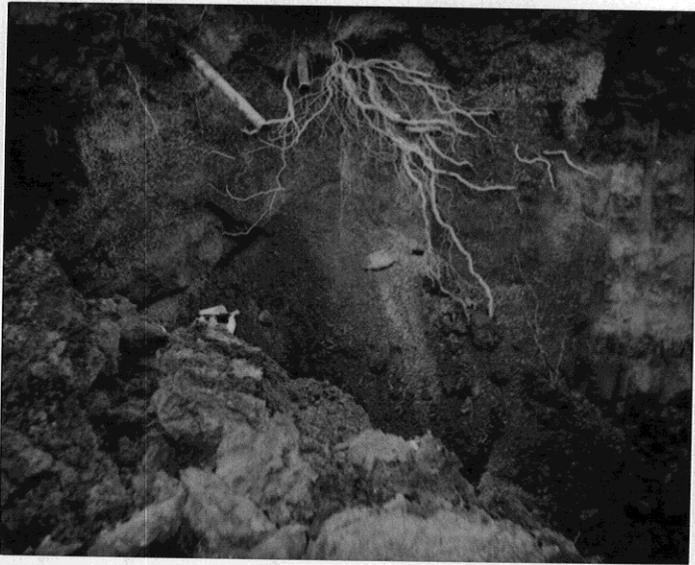
997 Grant Av., San Lorenzo. 12-18-90  
Waste oil pit NW wall - surface to ~ 7'.
