REPORT OF FINDINGS  
UNDERGROUND STORAGE TANK REMOVAL

EDEN HOSPITAL  
20103 LAKE CHABOT ROAD  
HAYWARD, CALIFORNIA

December 1991

Project No. 323  
December 5, 1991  
EPA# CAC000636776

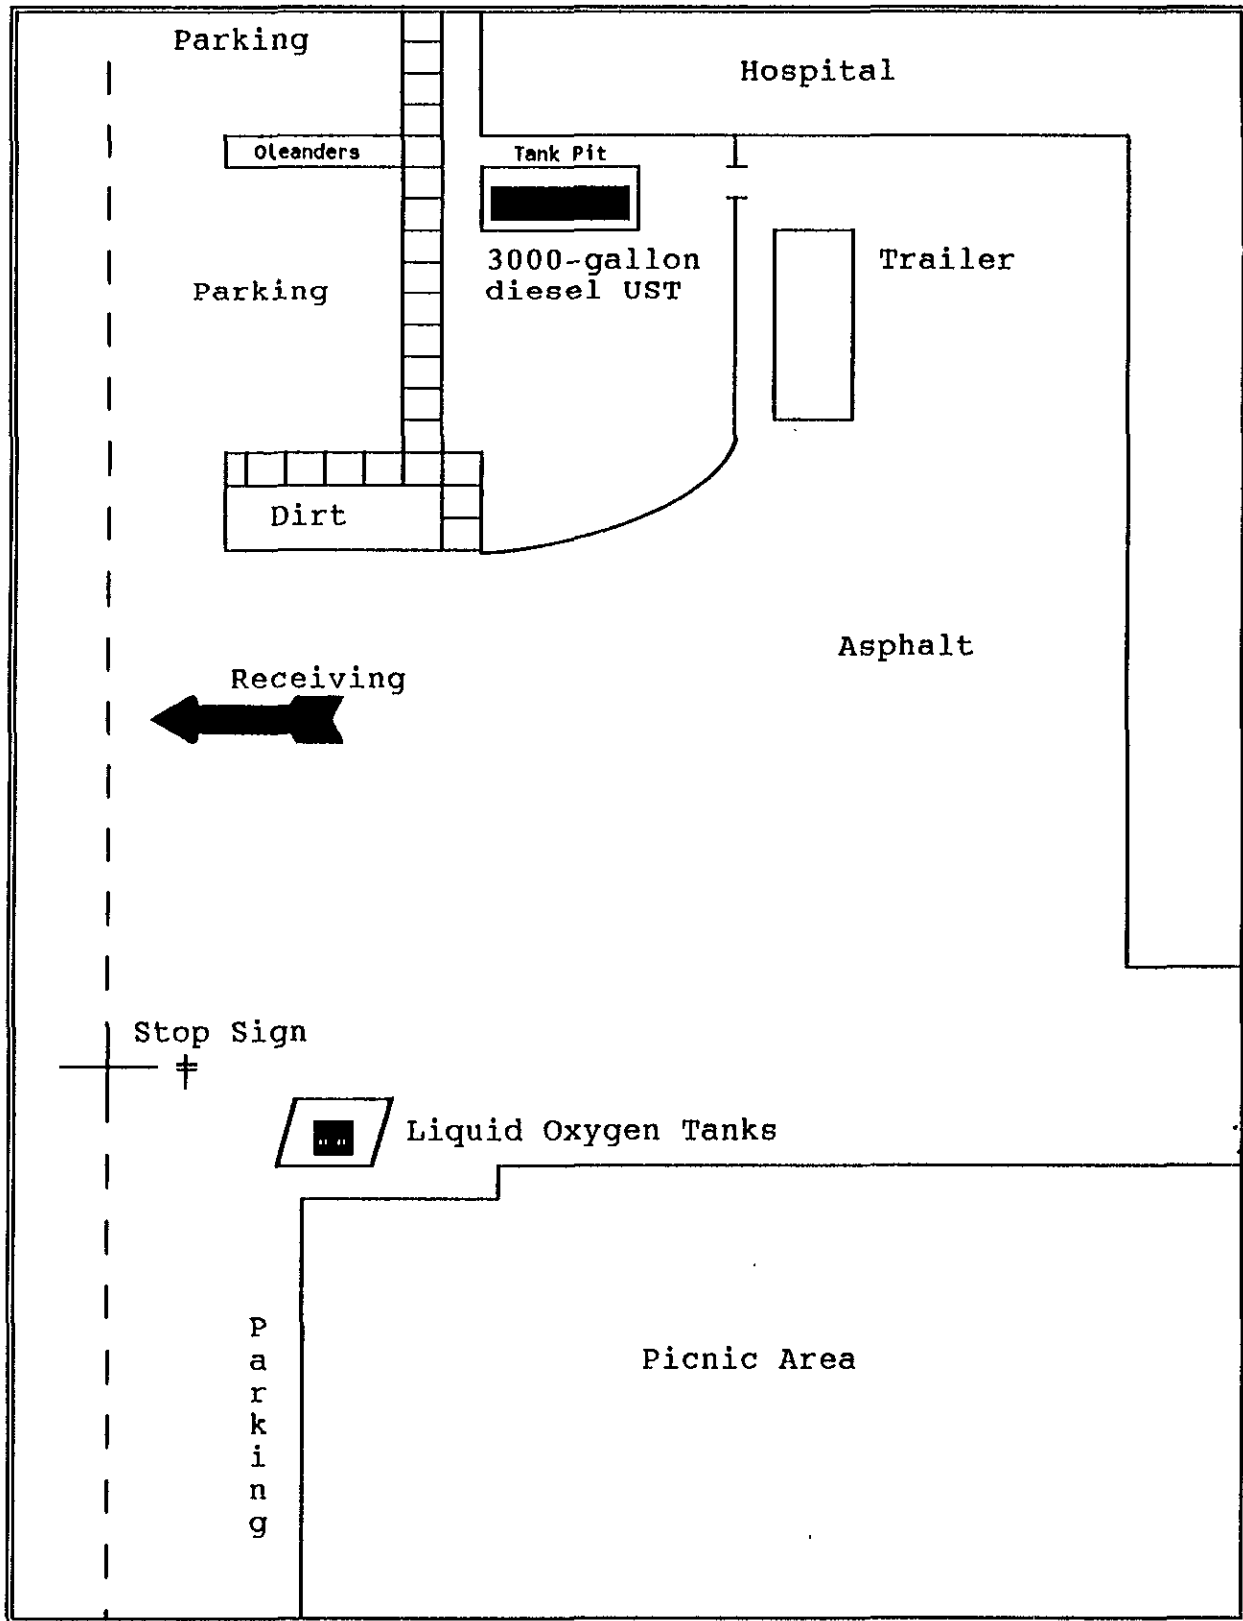
FIGURE 3

The majority of the tank pit was filled with a well-sorted, medium-grained sand, which apparently was the material used as back-fill during the initial tank installation. The subsurface native soil encountered along the tank pit walls consisted of slightly sticky, moderately plastic, light to medium yellowish-brown silty clay with minor gravel from ground surface to approximately six feet below ground surface and medium yellowish brown to dark brown gravelly clay and silty clay from six feet to approximately 16 feet below ground surface. Hydrocarbon staining (greenish-gray discoloration) was noted in the tank pit in the soil surrounding the southeastern side of the tank and in the northeastern corner of the tank pit; a moderate to strong hydrocarbon odor emanated from the soil excavated from these areas. Figure 3 shows the subsurface location of the tank.

SUBSURFACE TANK LOCATION MAP

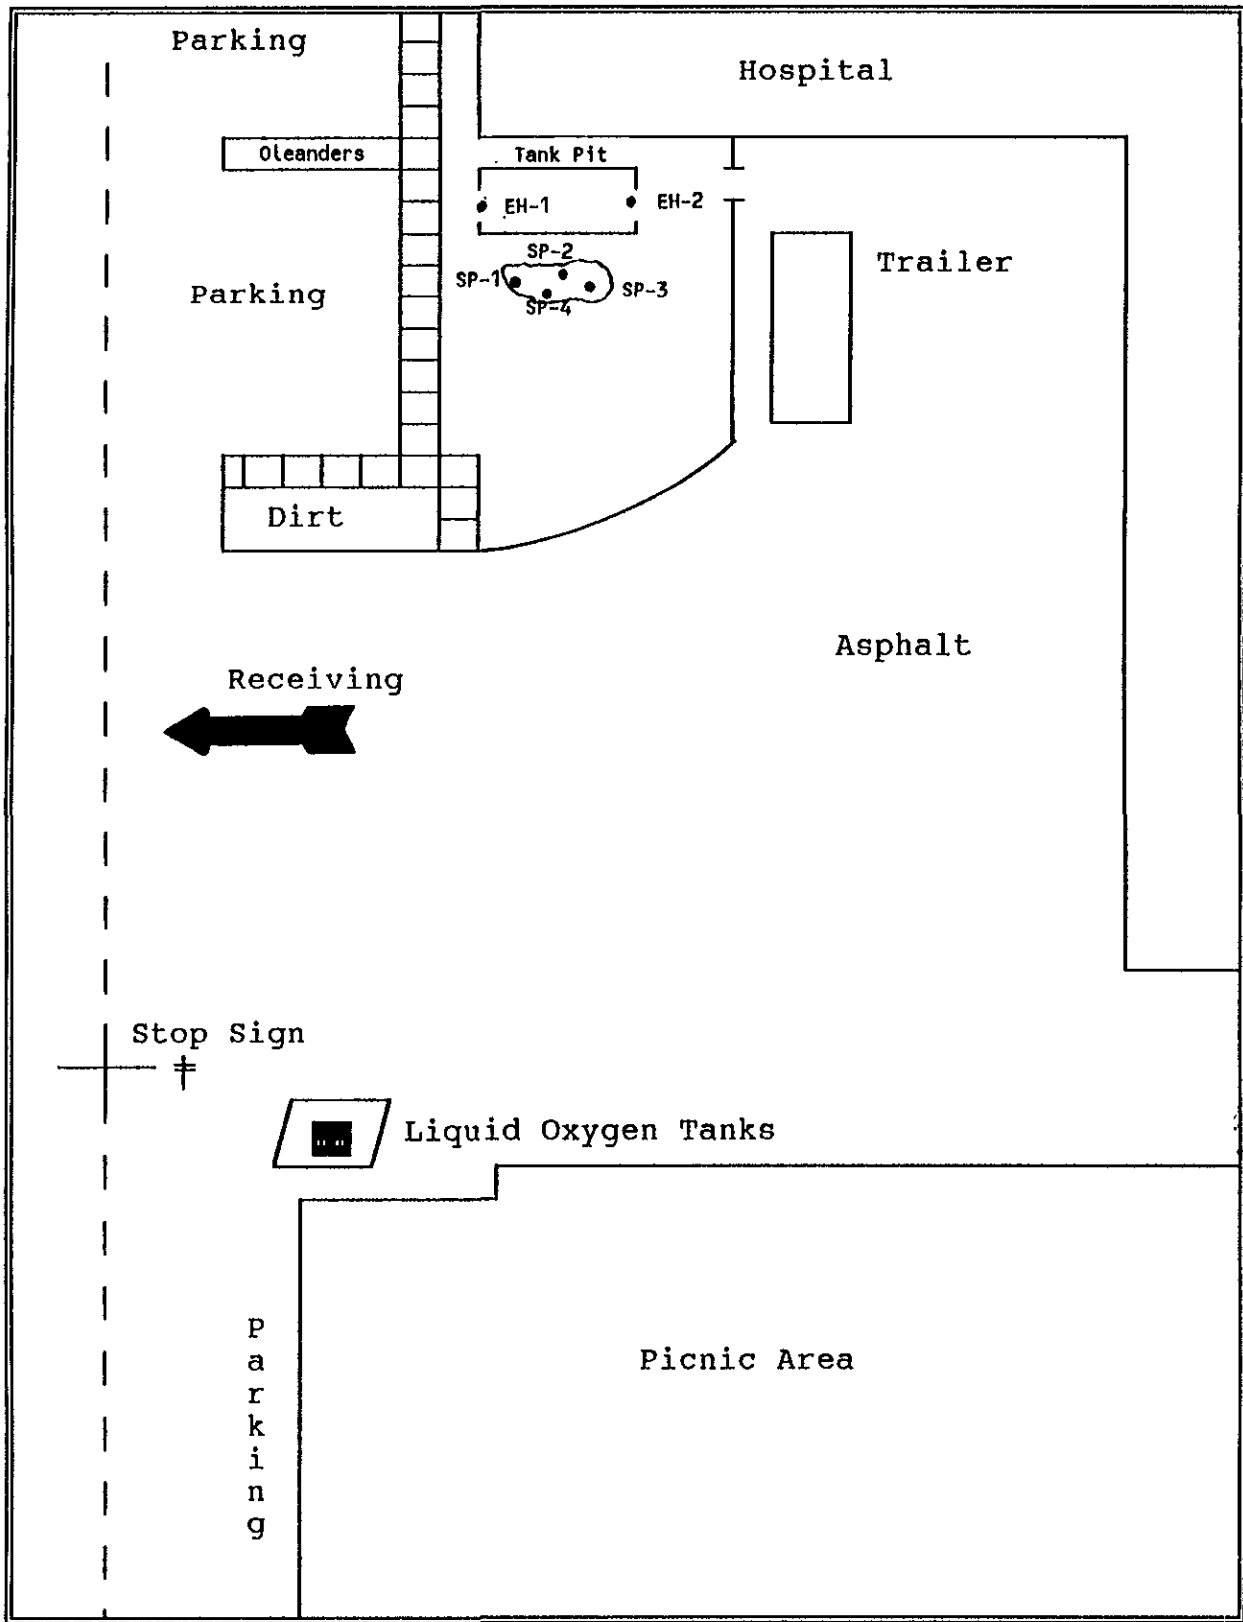
FIGURE 4

Soil sample EH-1 was collected from the southeastern end of the pit, in native soil consisting of moist, medium brown gravelly clay at approximately 15 feet below ground surface whereas sample EH-2 was collected from the northeastern end of the tank pit, in native soil consisting of medium brown silty clay, at approximately 12 feet below ground surface. No hydrocarbon staining or odor was noted in EH-1; however, slight staining and a mild odor were noted in EH-2.

SOIL SAMPLING LOCATION MAP
