Pacific Dry Dock and Repair Company Yard II

Oakland, California

Laboratory Analytical Results for Groundwater Samples Collected on June 21, 1995 and TGSP Samples Former Pacific Dry Dock & Repair Company Yard II Facility Oakland, California

April 1995 Analytical Results for Area 5  
 Pacific Dry Dock & Repair Company Yard II  
 Oakland, California

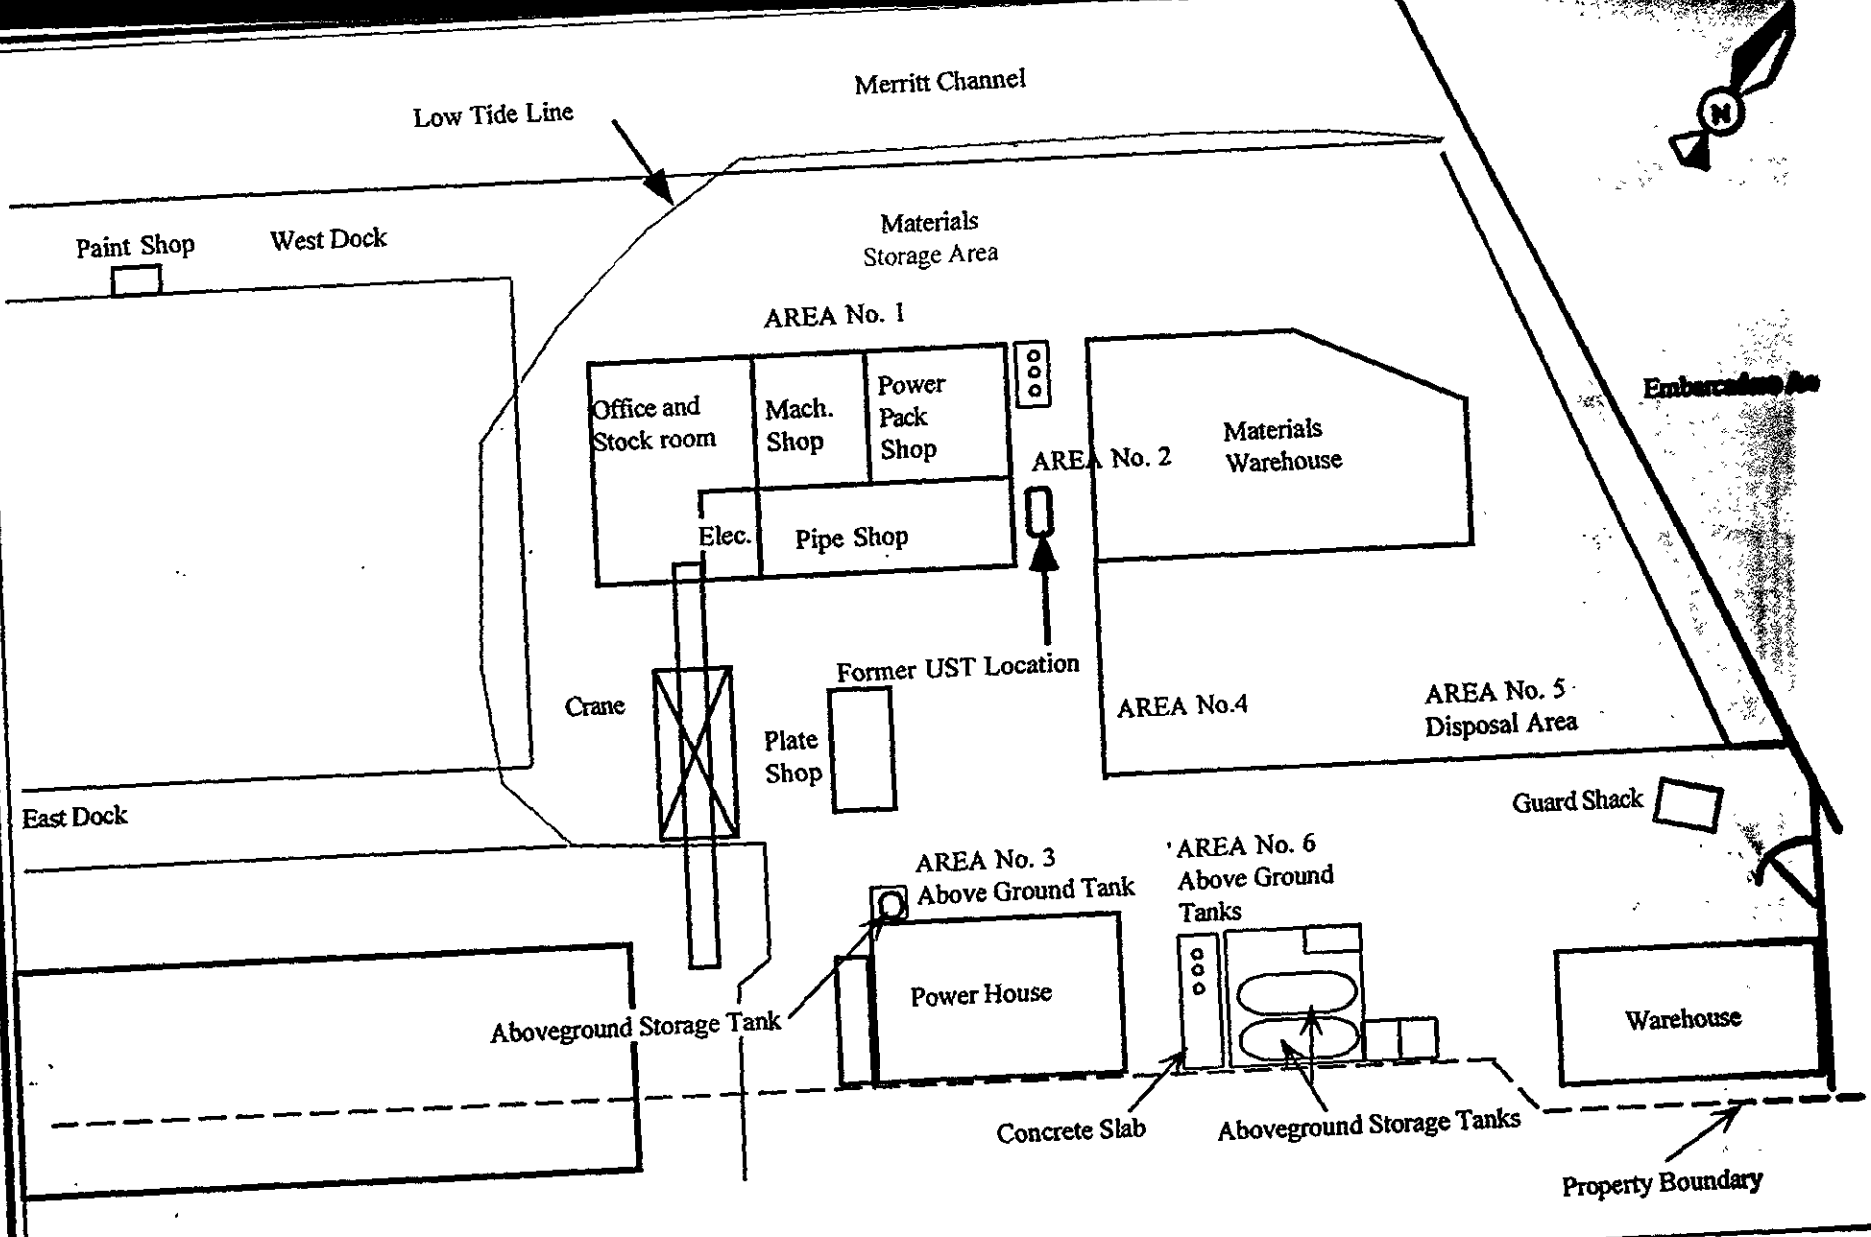
Figure 1

**TGSP1**  
TPH-D: 71  
Mercury: ND  
Gas/BTEX: ND

**TGSP8**  
TPH-D: 870  
TPH-G: 1,900  
Benzene: 58  
Toluene: 3.0  
Ethylbenzene: 2.6  
Xylenes: 400  
Chlorobenzene: 310  
1,4-Dichlorobenzene: 13

**TGSP7**  
TPH-D: 770  
TPH-G: 1,700  
Benzene: 22  
Toluene: ND  
Ethylbenzene: ND  
Xylenes: 310  
1,4-Dichlorobenzene: 8.1

**MW2**  
TPH-D: 3,300  
TPH-G: 2,300  
Benzene: 65  
Toluene: 0.74  
Ethylbenzene: 1.3  
Xylenes: 810  
Chlorobenzene: 290  
1,2-Dichloroethene: 1.6  
1,3-Dichlorobenzene: 11  
1,4-Dichlorobenzene: 35

**TGSP10**  
TPH-D: 580  
TPH-G: 2,200  
Benzene: 47  
Toluene: ND  
Ethylbenzene: 5.2  
Xylenes: ND  
EPA8010: ND

**TGSP9**  
TPH-D: 250  
TPH-G: 480  
Benzene: 2.1  
Toluene: 0.91  
Ethylbenzene: 2.2  
Xylenes: 3.6  
EPA8010: ND

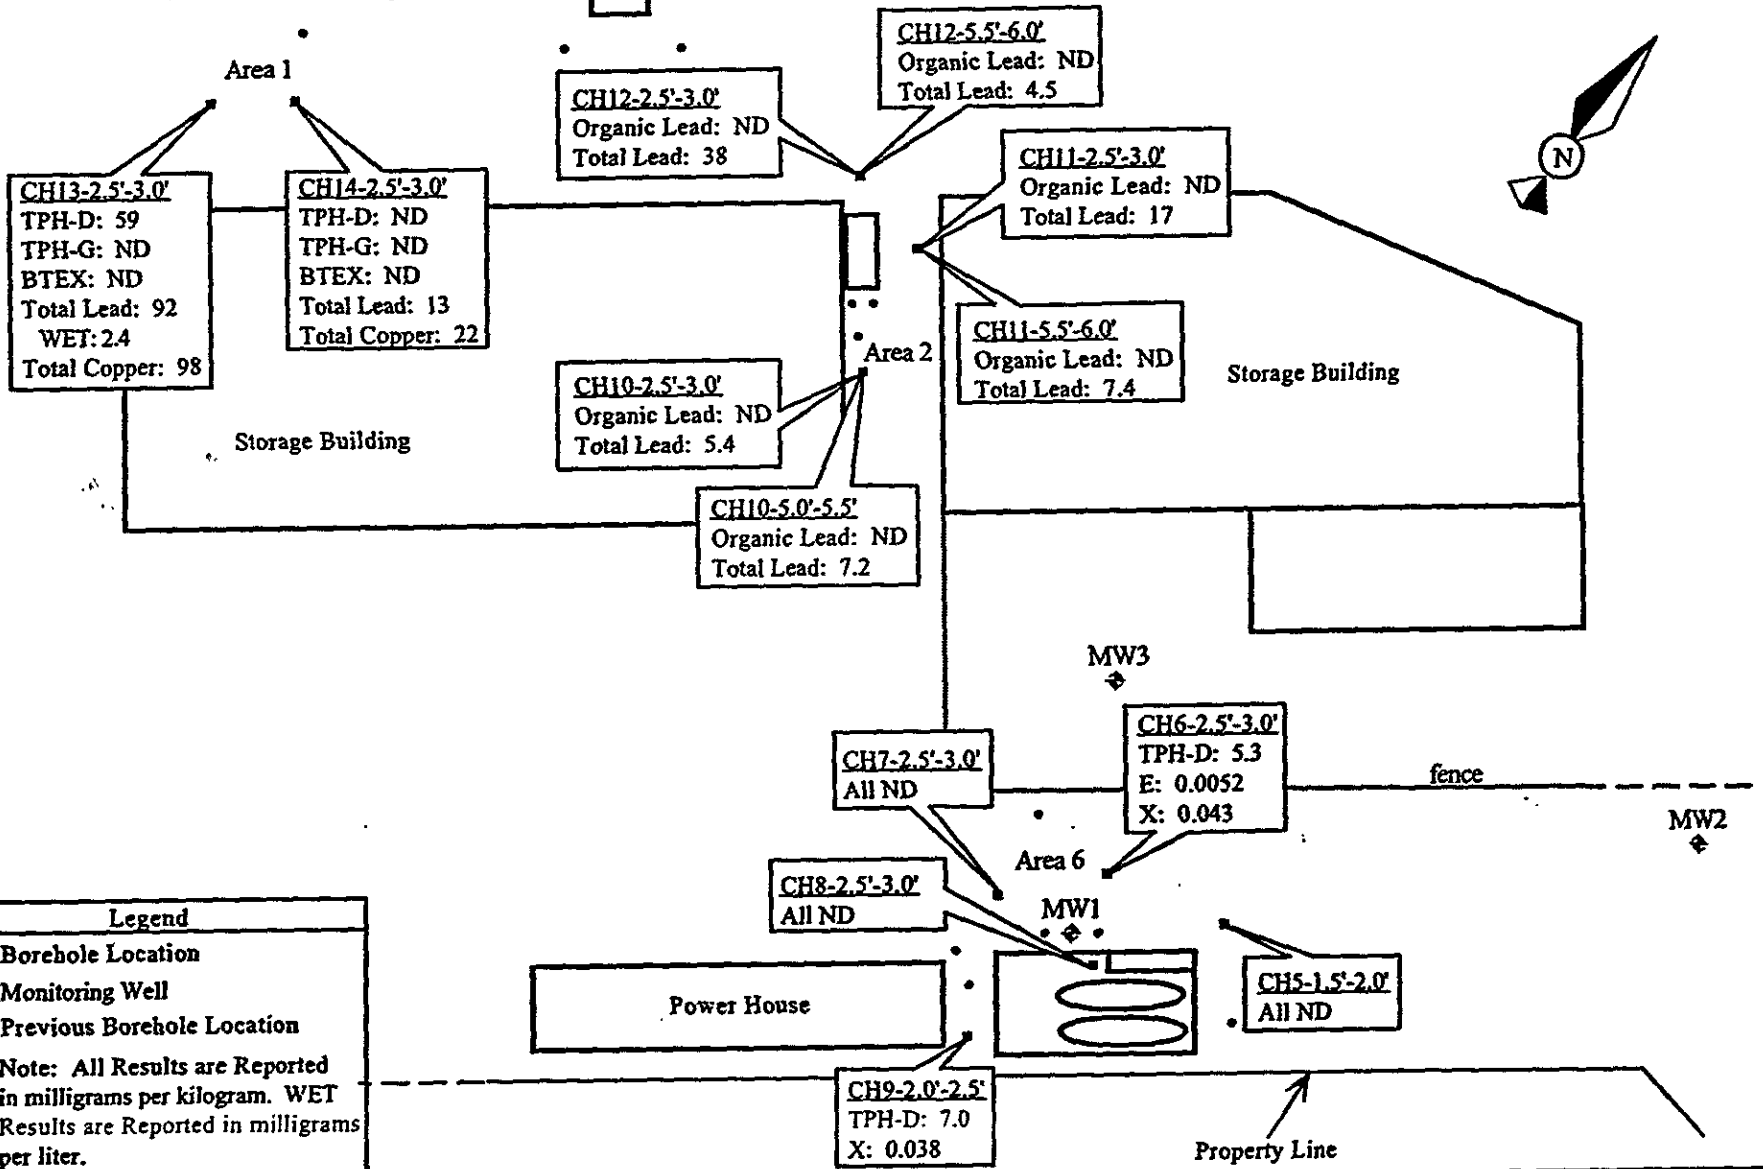
Figure 2

April 1995 Analytical Results for Areas 1, 2, and 6  
Former Pacific Dry Dock Facility & Repair Company Yard II  
Oakland, California

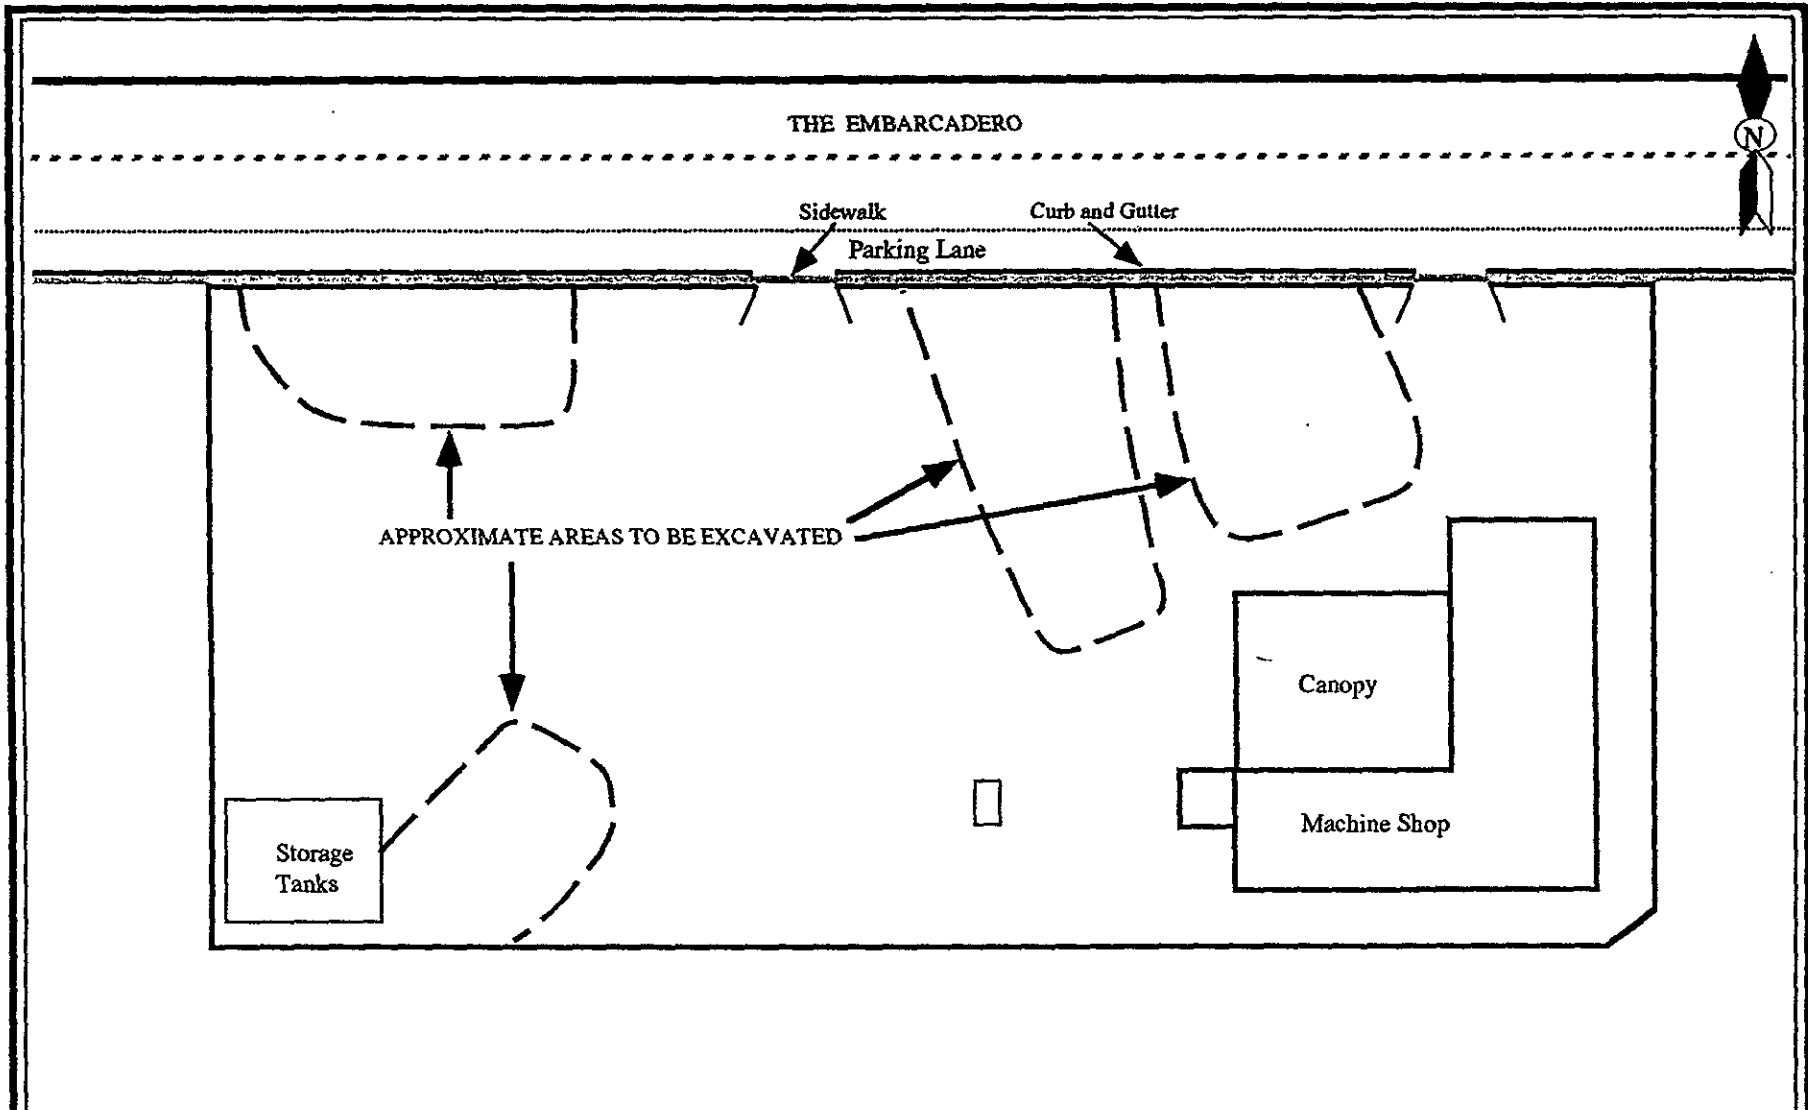
Figure 4

Proposed Areas of Excavation-Western Section

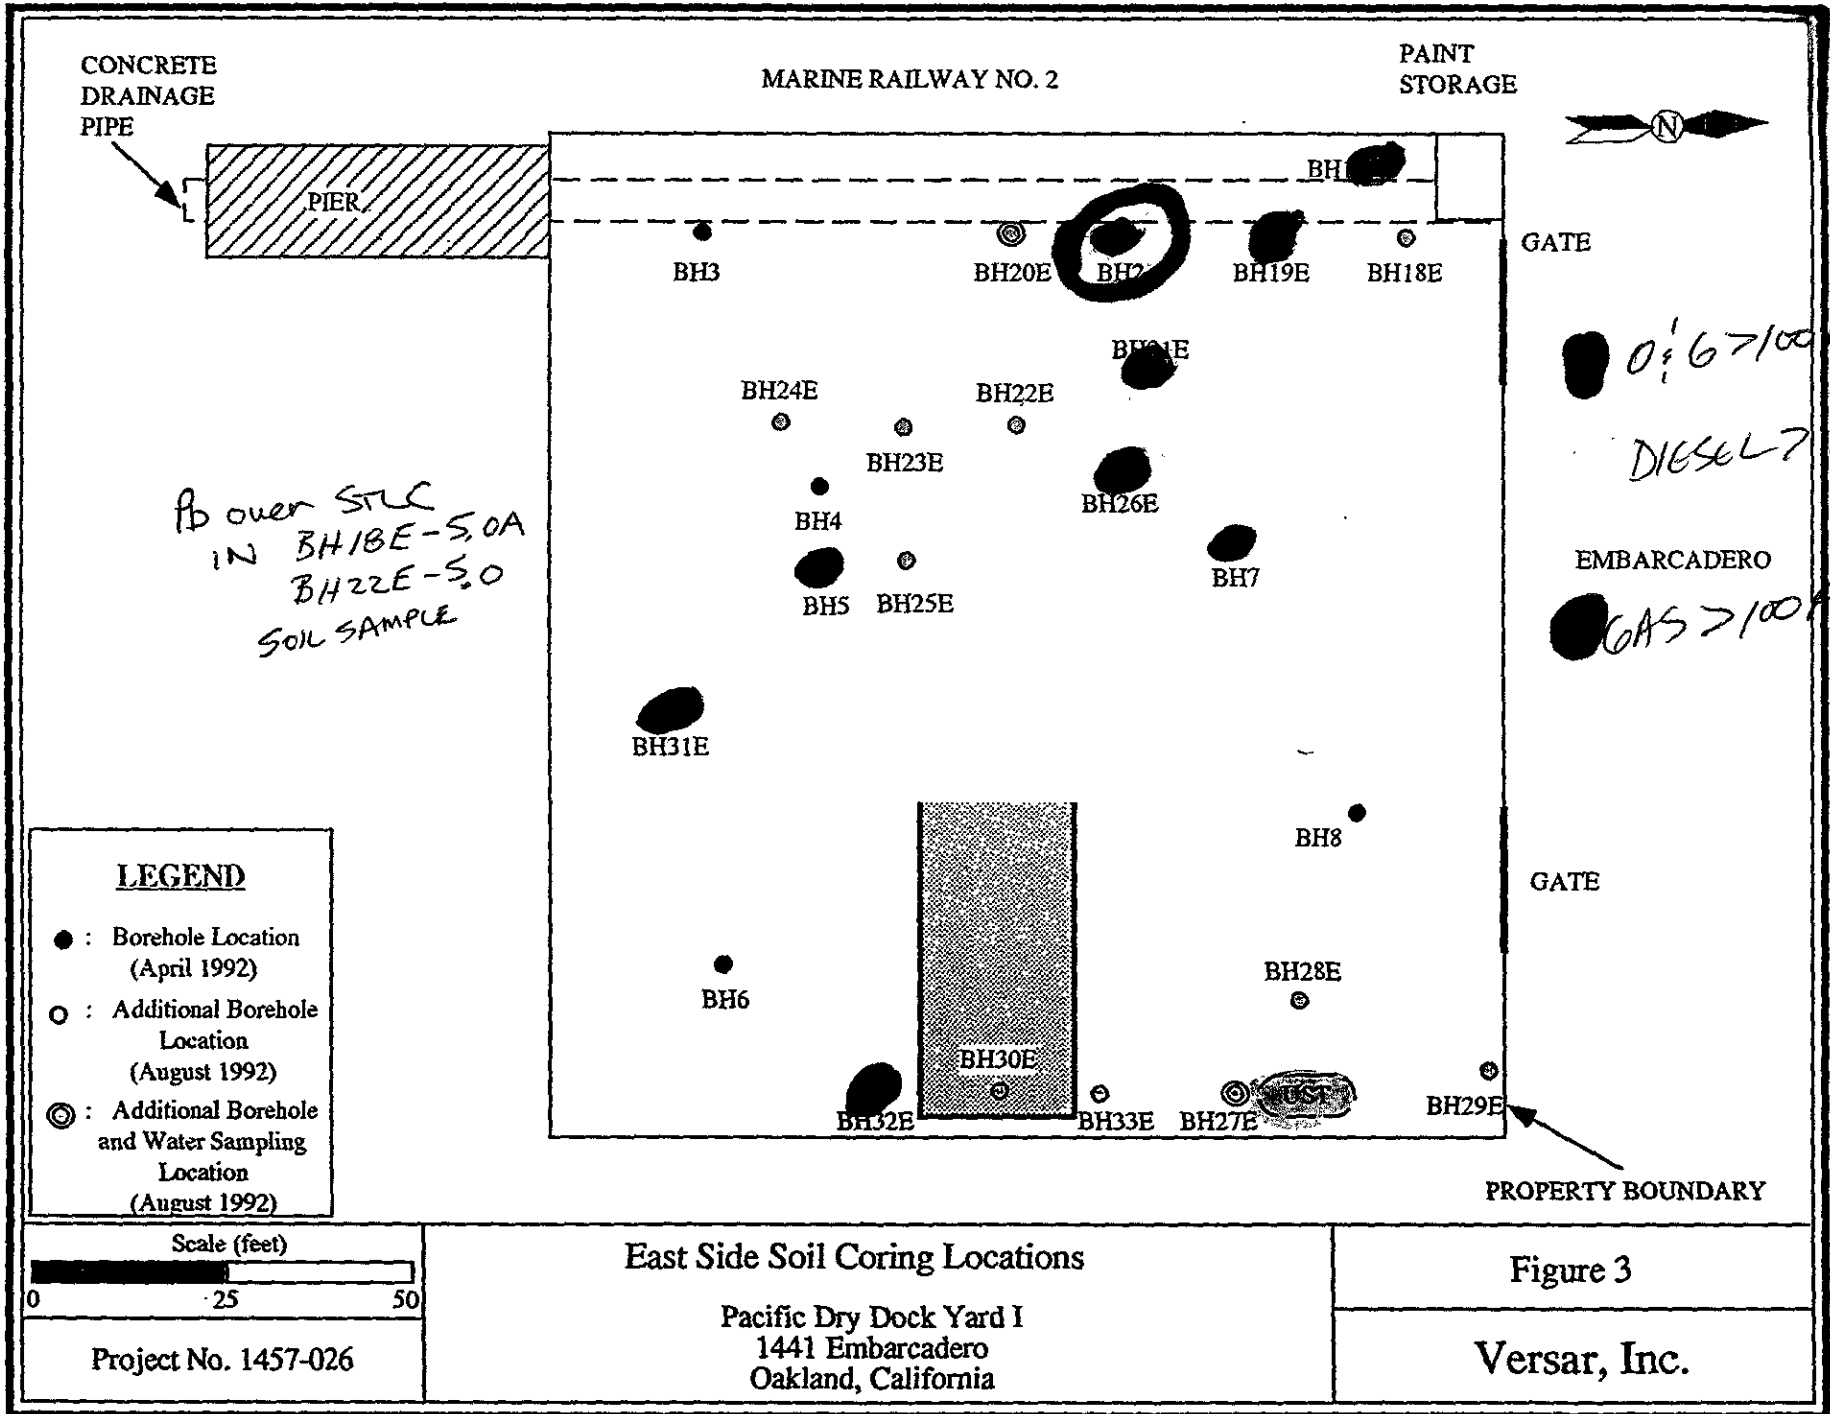
Figure 3

*Pd over STLC  
IN BH18E-S.OA  
BH22E-S.O  
SOIL SAMPLE*

*0:6 > 100 PPM  
DIESEL 7 100 PPM*

*GAS > 100 PPM*
