REMEDIAL ACTION COMPLETION CERTIFICATION

Re: Former State Shingle, 880 Fruitvale Ave., Oakland 94601

CASE CLOSURE SUMMARY Leaking Underground Fuel Storage Tank Program

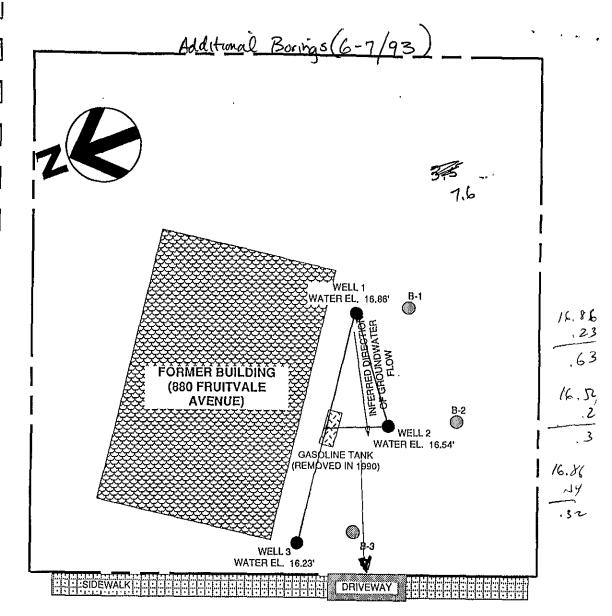
PROJECT NO: 930301		
GLOBE SOIL ENGINEERS	LOCATION:	880 FRUITVALE AVENUE OAKALND, CALIF.	
SITE MAP	DATE:	12/17/93	
	FIGURE: 6

Groundwater surface elevations based on the January 2, 1996 groundwater level measurements are presented on Figure 6. The groundwater surface elevation contours indicate that groundwater flow is towards Fruitvale Avenue in a primarily westerly direction.
